Comprehensive Coastal Management Plan Update

Palm Beach Island, Florida

June 1998

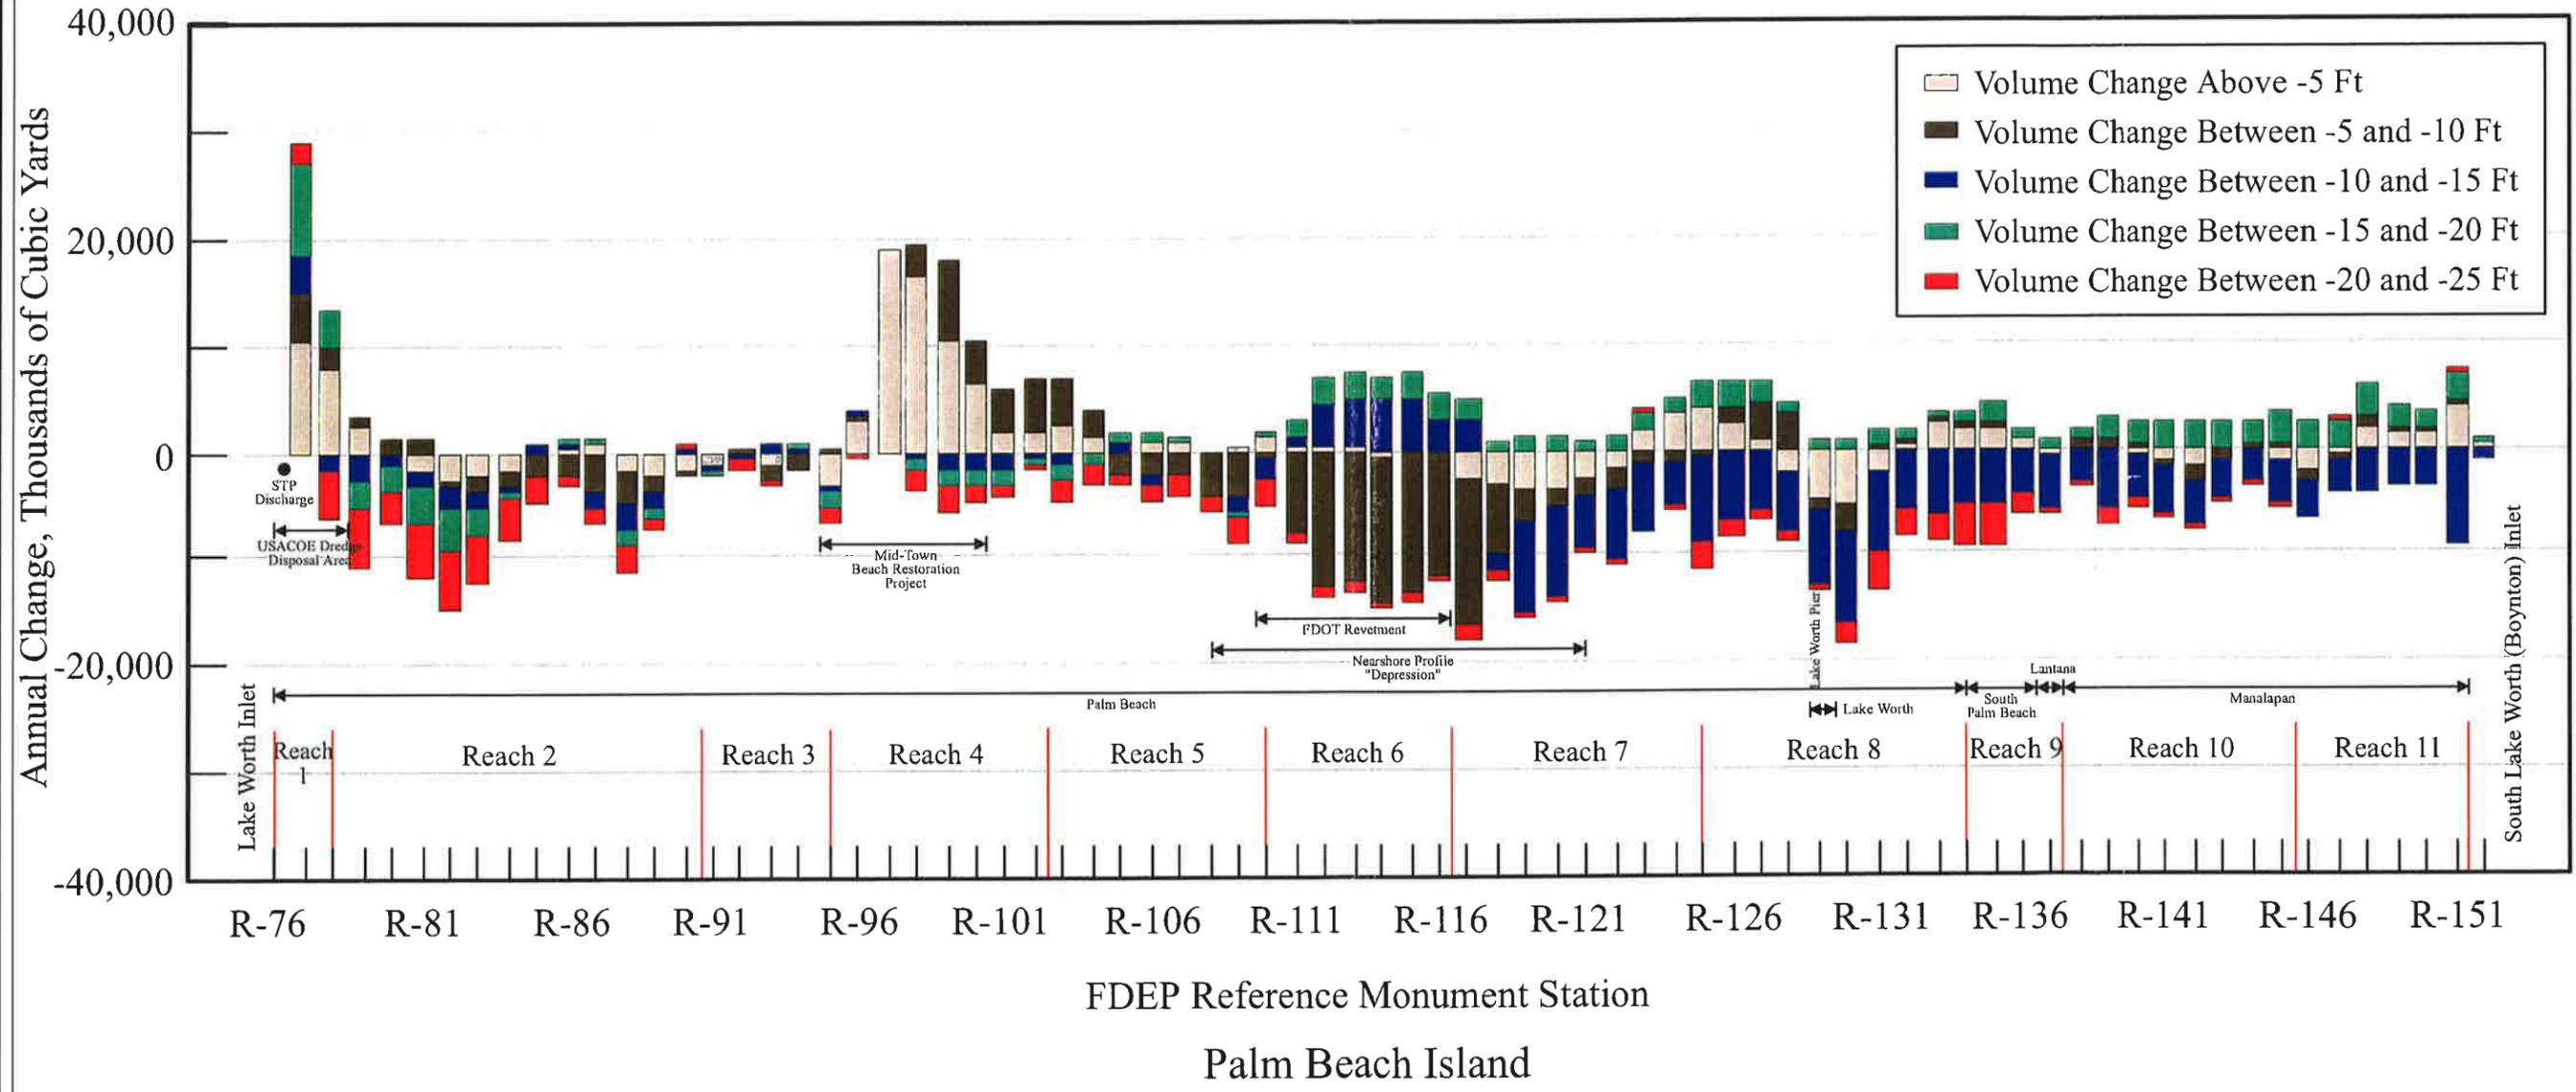
Incremental Volume Changes at Five Foot Elevation Intervals

Figure 4-1
Annual Volume Changes on Palm Beach Island, 1990 - 1997

Sand placed by the bypassing plant and maintenance dredging between 1990 and 1997 was confined to the northern 2,500 feet of the island between approximately R-76 and R-78. The southward movement of sand from this region is limited because of the sheltering effects of the south jetty. The reader is referred to the Lake Worth Inlet Management Plan Wave Refraction Analysis for additional details. Under northerly wave conditions, the most significant southward movement of sand occurs within the immediate nodal region at R-78, which is at the extreme southern end of the inlet maintenance spoil placement area. Under southerly wave conditions, however, sand along the entire placement area is readily moved and redeposited in the inlet or moved offshore.

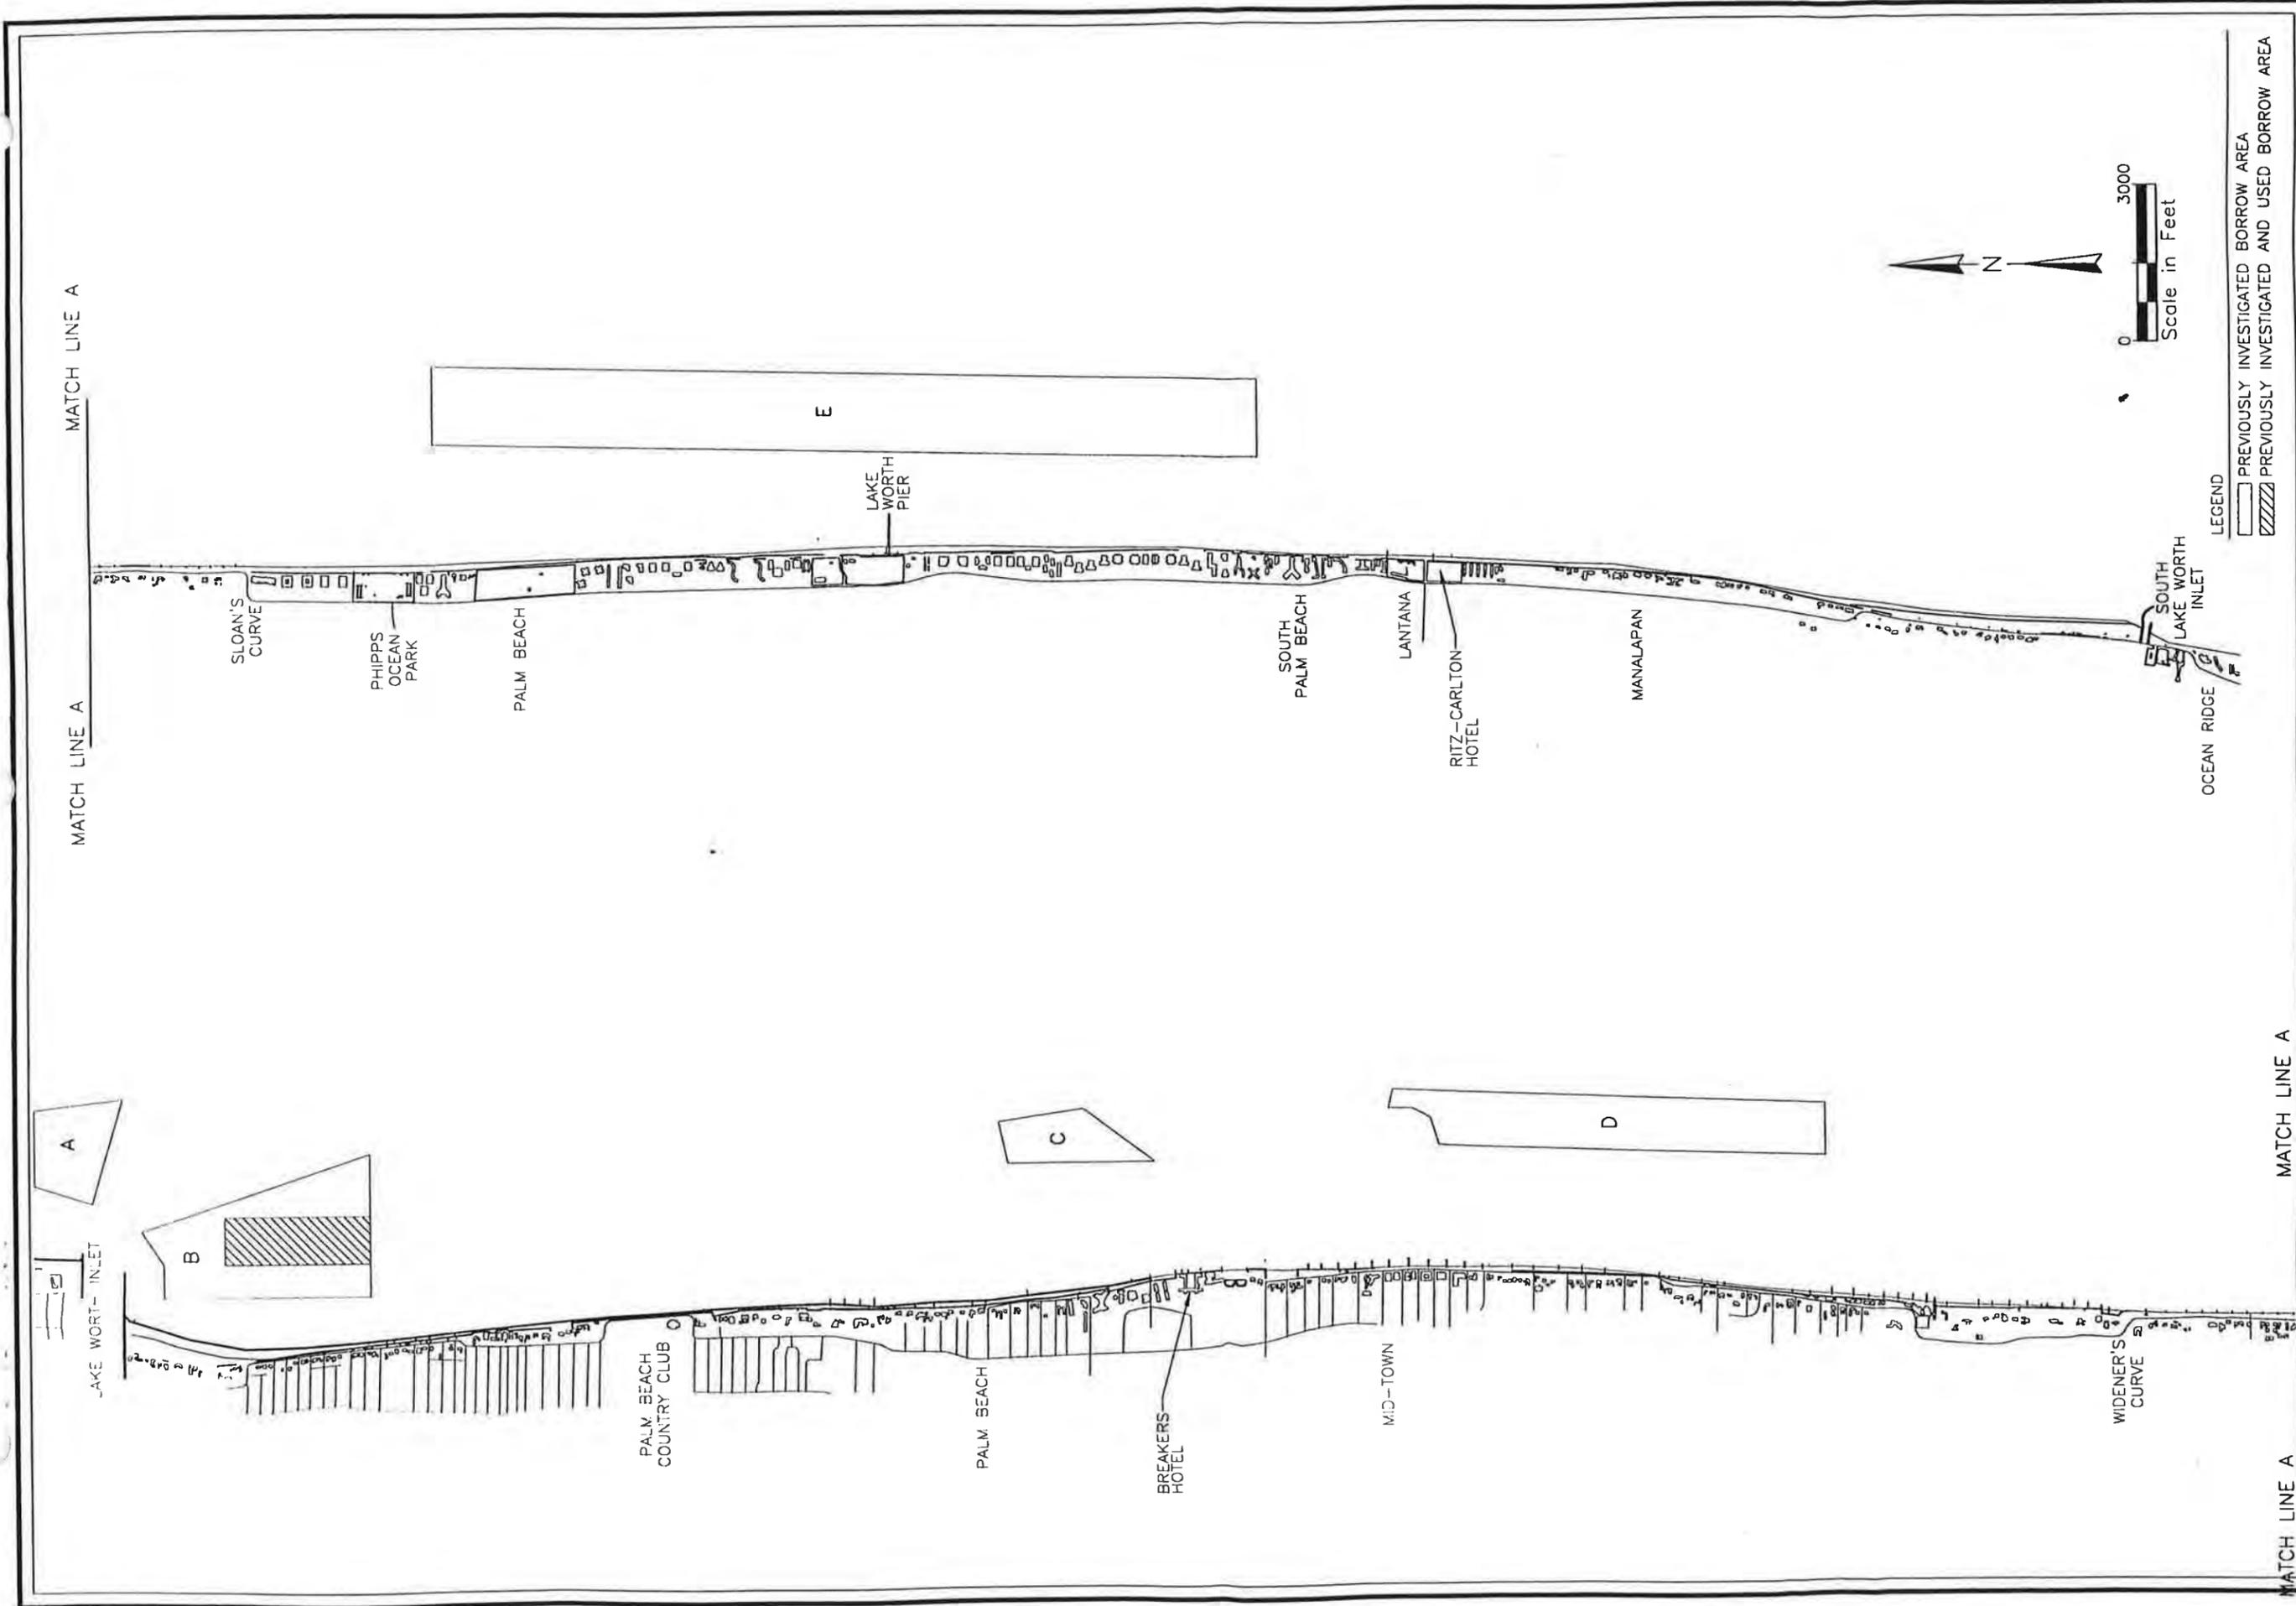
FIGURE 5-1
EXISTING SAND SOURCES OFFSHORE OF PALM BEACH ISLAND

A total of seven vibracores were obtained offshore of Palm Beach Island (PBCERM, 1993) in conjunction with the COFS. As with previous study findings summarized above, the physical location of the COFS vibracores are provided in Figures 6-7 through 6-12. A straight compositing of the samples analyzed within the vibracores indicates a mean grain size of 0.2 mm and a silt/clay content of 0.41 percent. Because the cores were taken some distance apart and due to relatively consistent sampling depths within each extracted core, a weighted composite does not appear to lend benefit to determining such values. Clearly, the sand samples extracted at these discrete locations indicates that relatively fine-grained sand deposits reside offshore of Palm Beach Island.

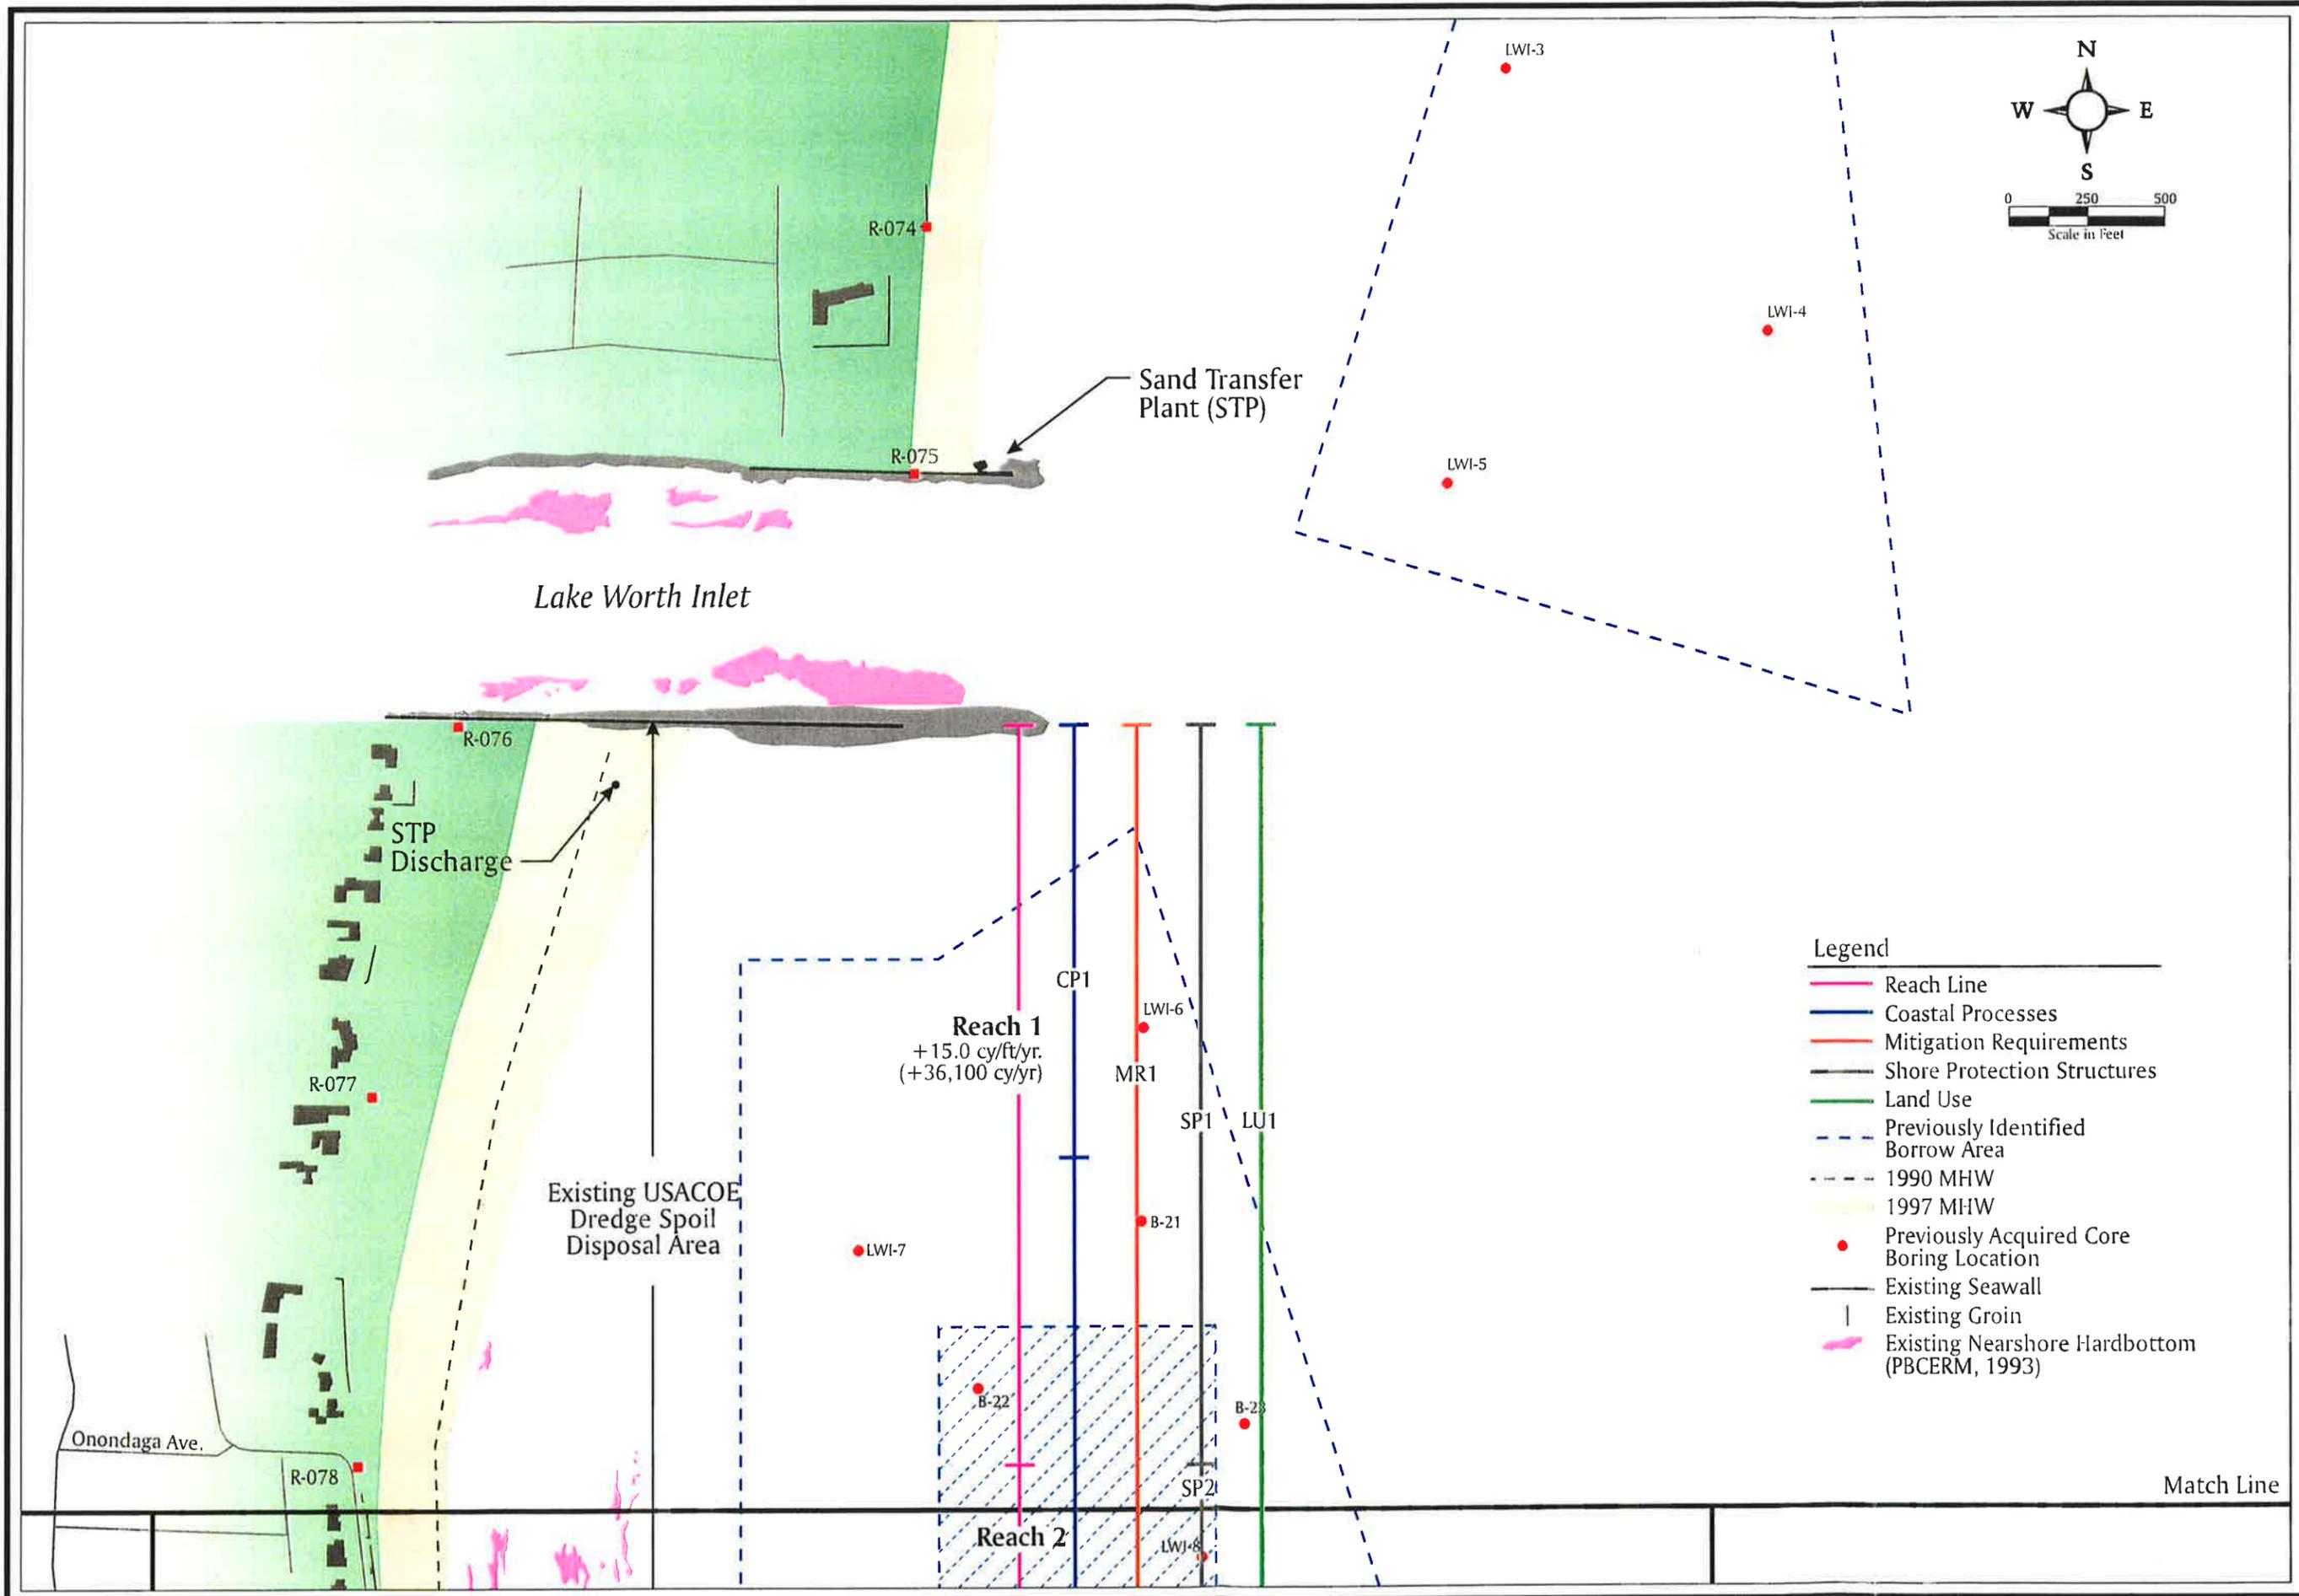
Figure 6-1
 Town of Palm Beach, Florida
 Comprehensive Coastal Management Plan
 Designation of Shoreline Zone and Reach Boundaries

A shoreline characterization by structural type and consistency was performed to determine distinct changes along the Atlantic Ocean. The characterization utilized the findings of the structures survey, the Florida Department of Natural Resources' (FDNR) Coastal Construction Control Line aerial photographs and the FDEP video assessments of the County conducted in July 1995 and June 1996. The Island was divided into 8 zones after referring to the above information. Zone references are provided with physical features, street names, or upland development features identified. In Table 6 - 1, the FDNR Range Monument designations are furnished to more precisely delineate the zones.*

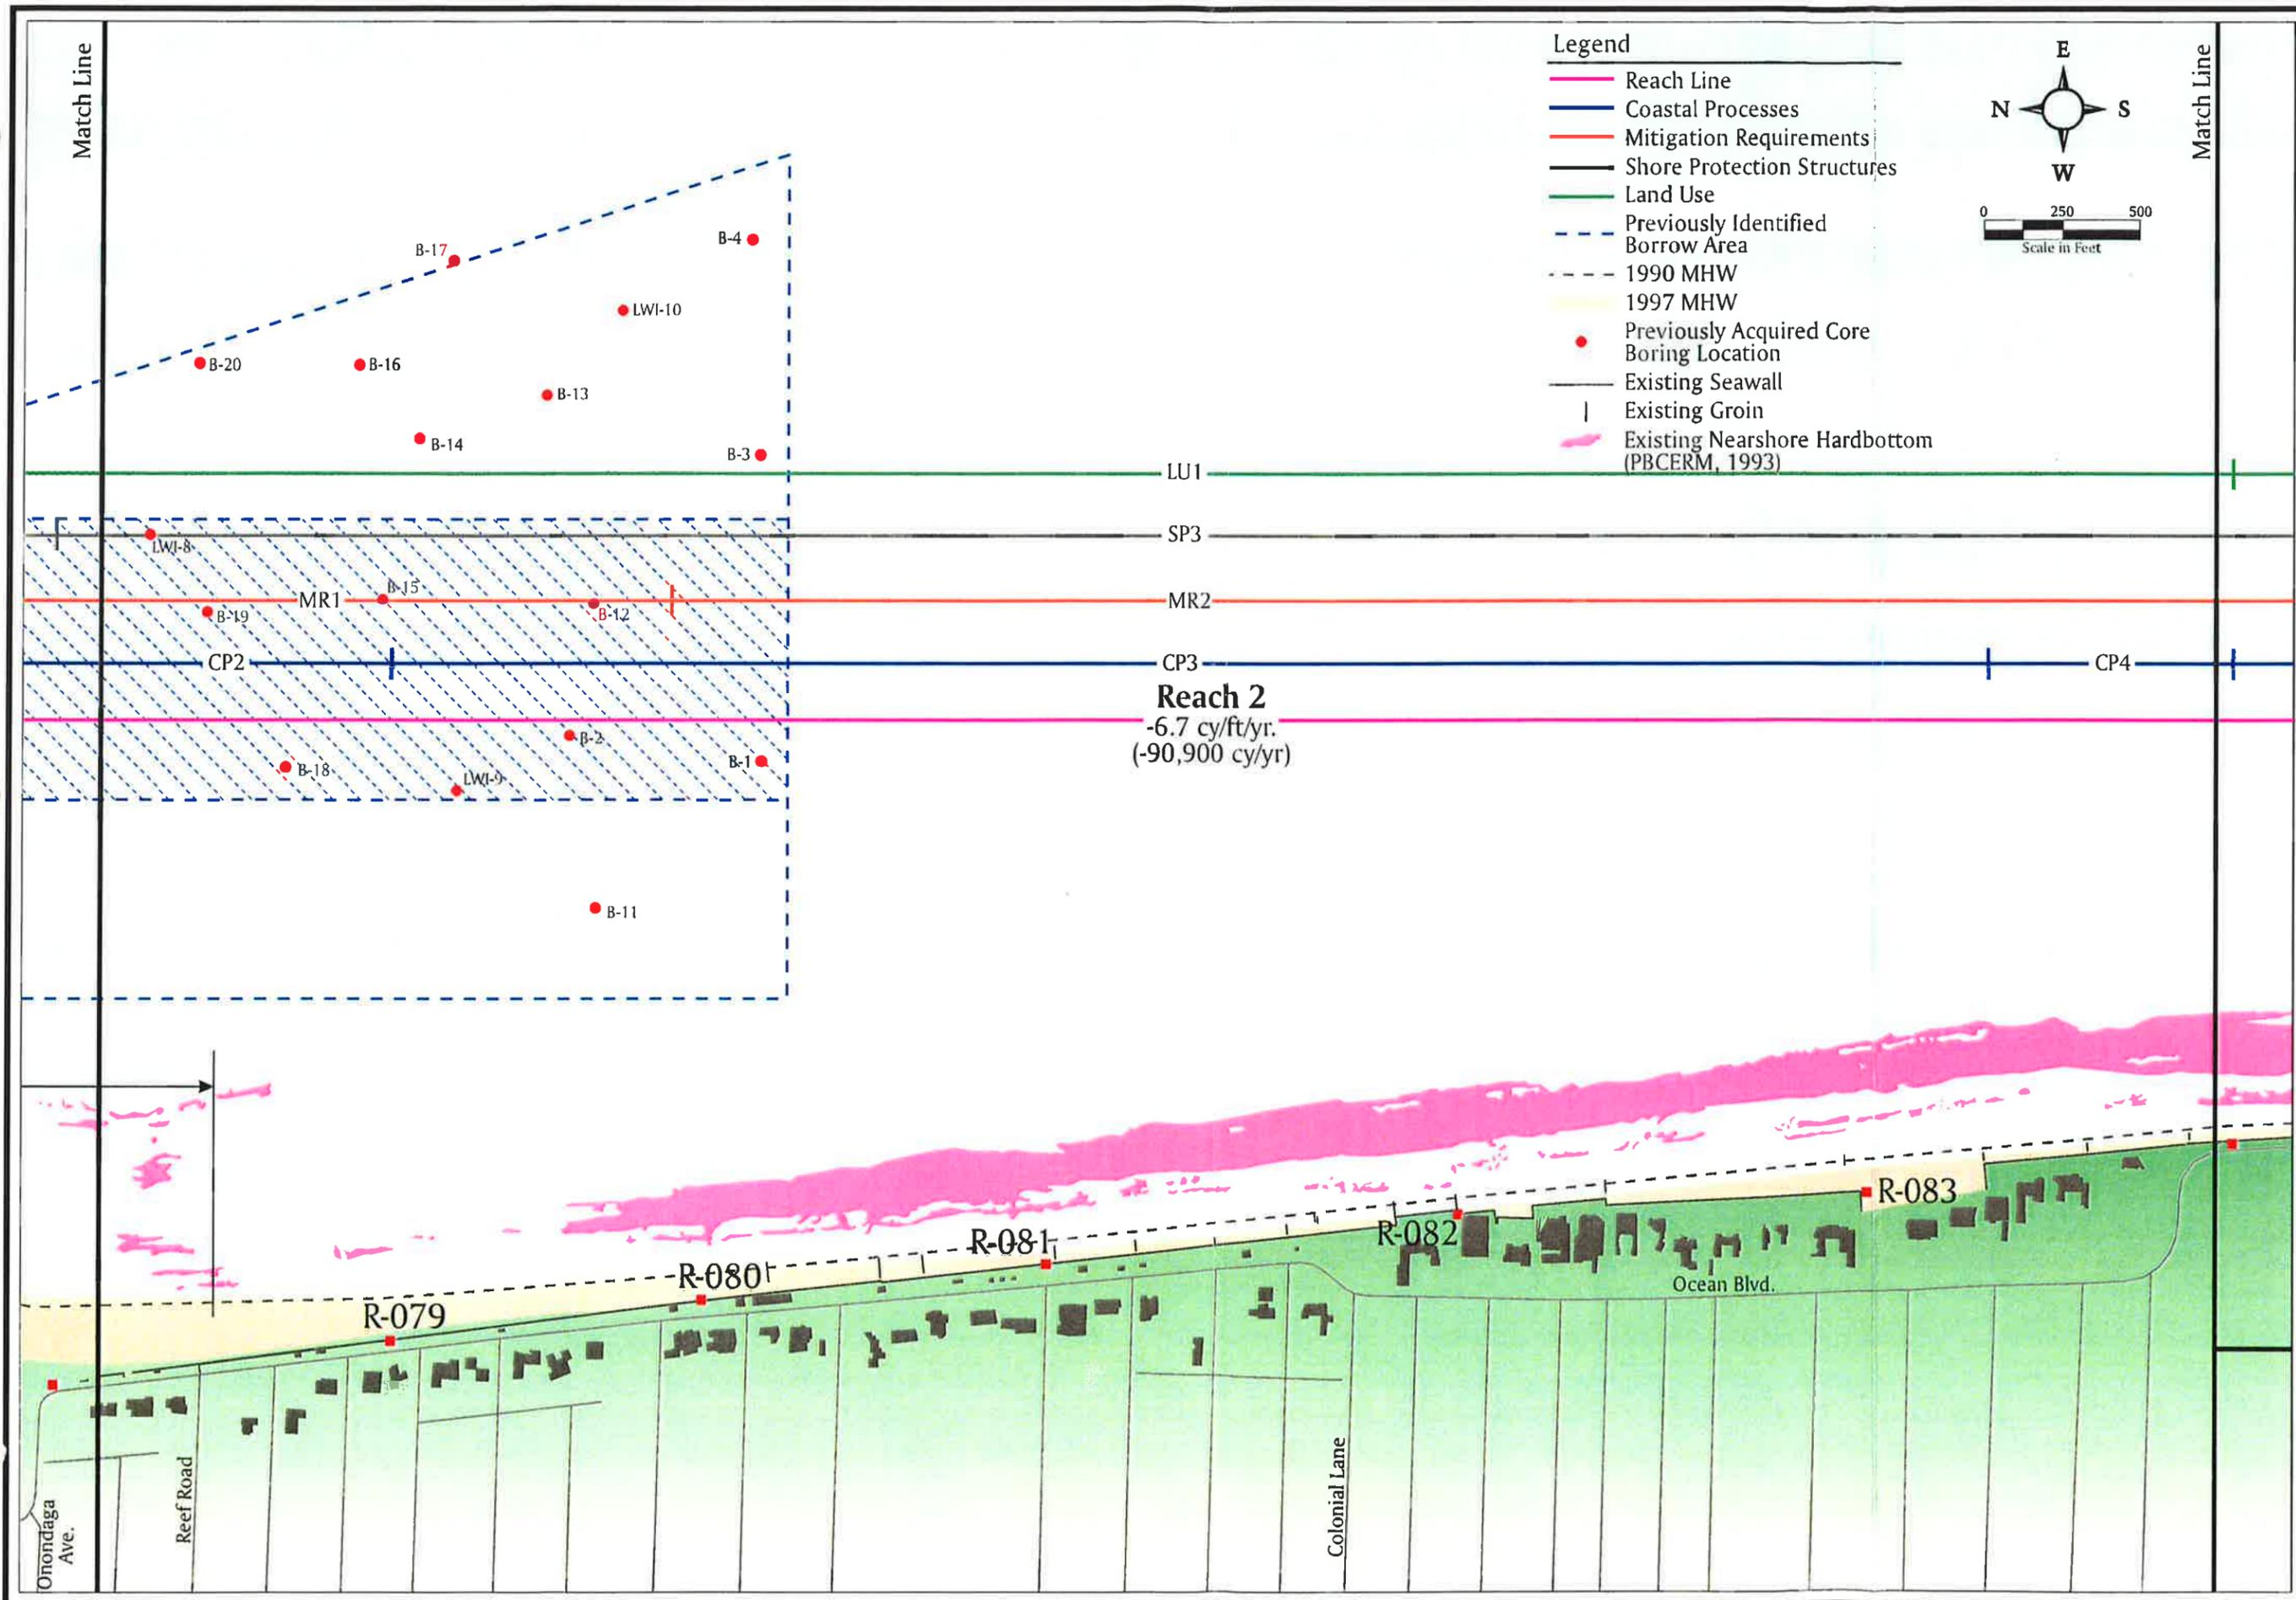
Figure 6-2
Town of Palm Beach, Florida
Comprehensive Coastal Management Plan
Designation of Shoreline Zone and Reach Boundaries

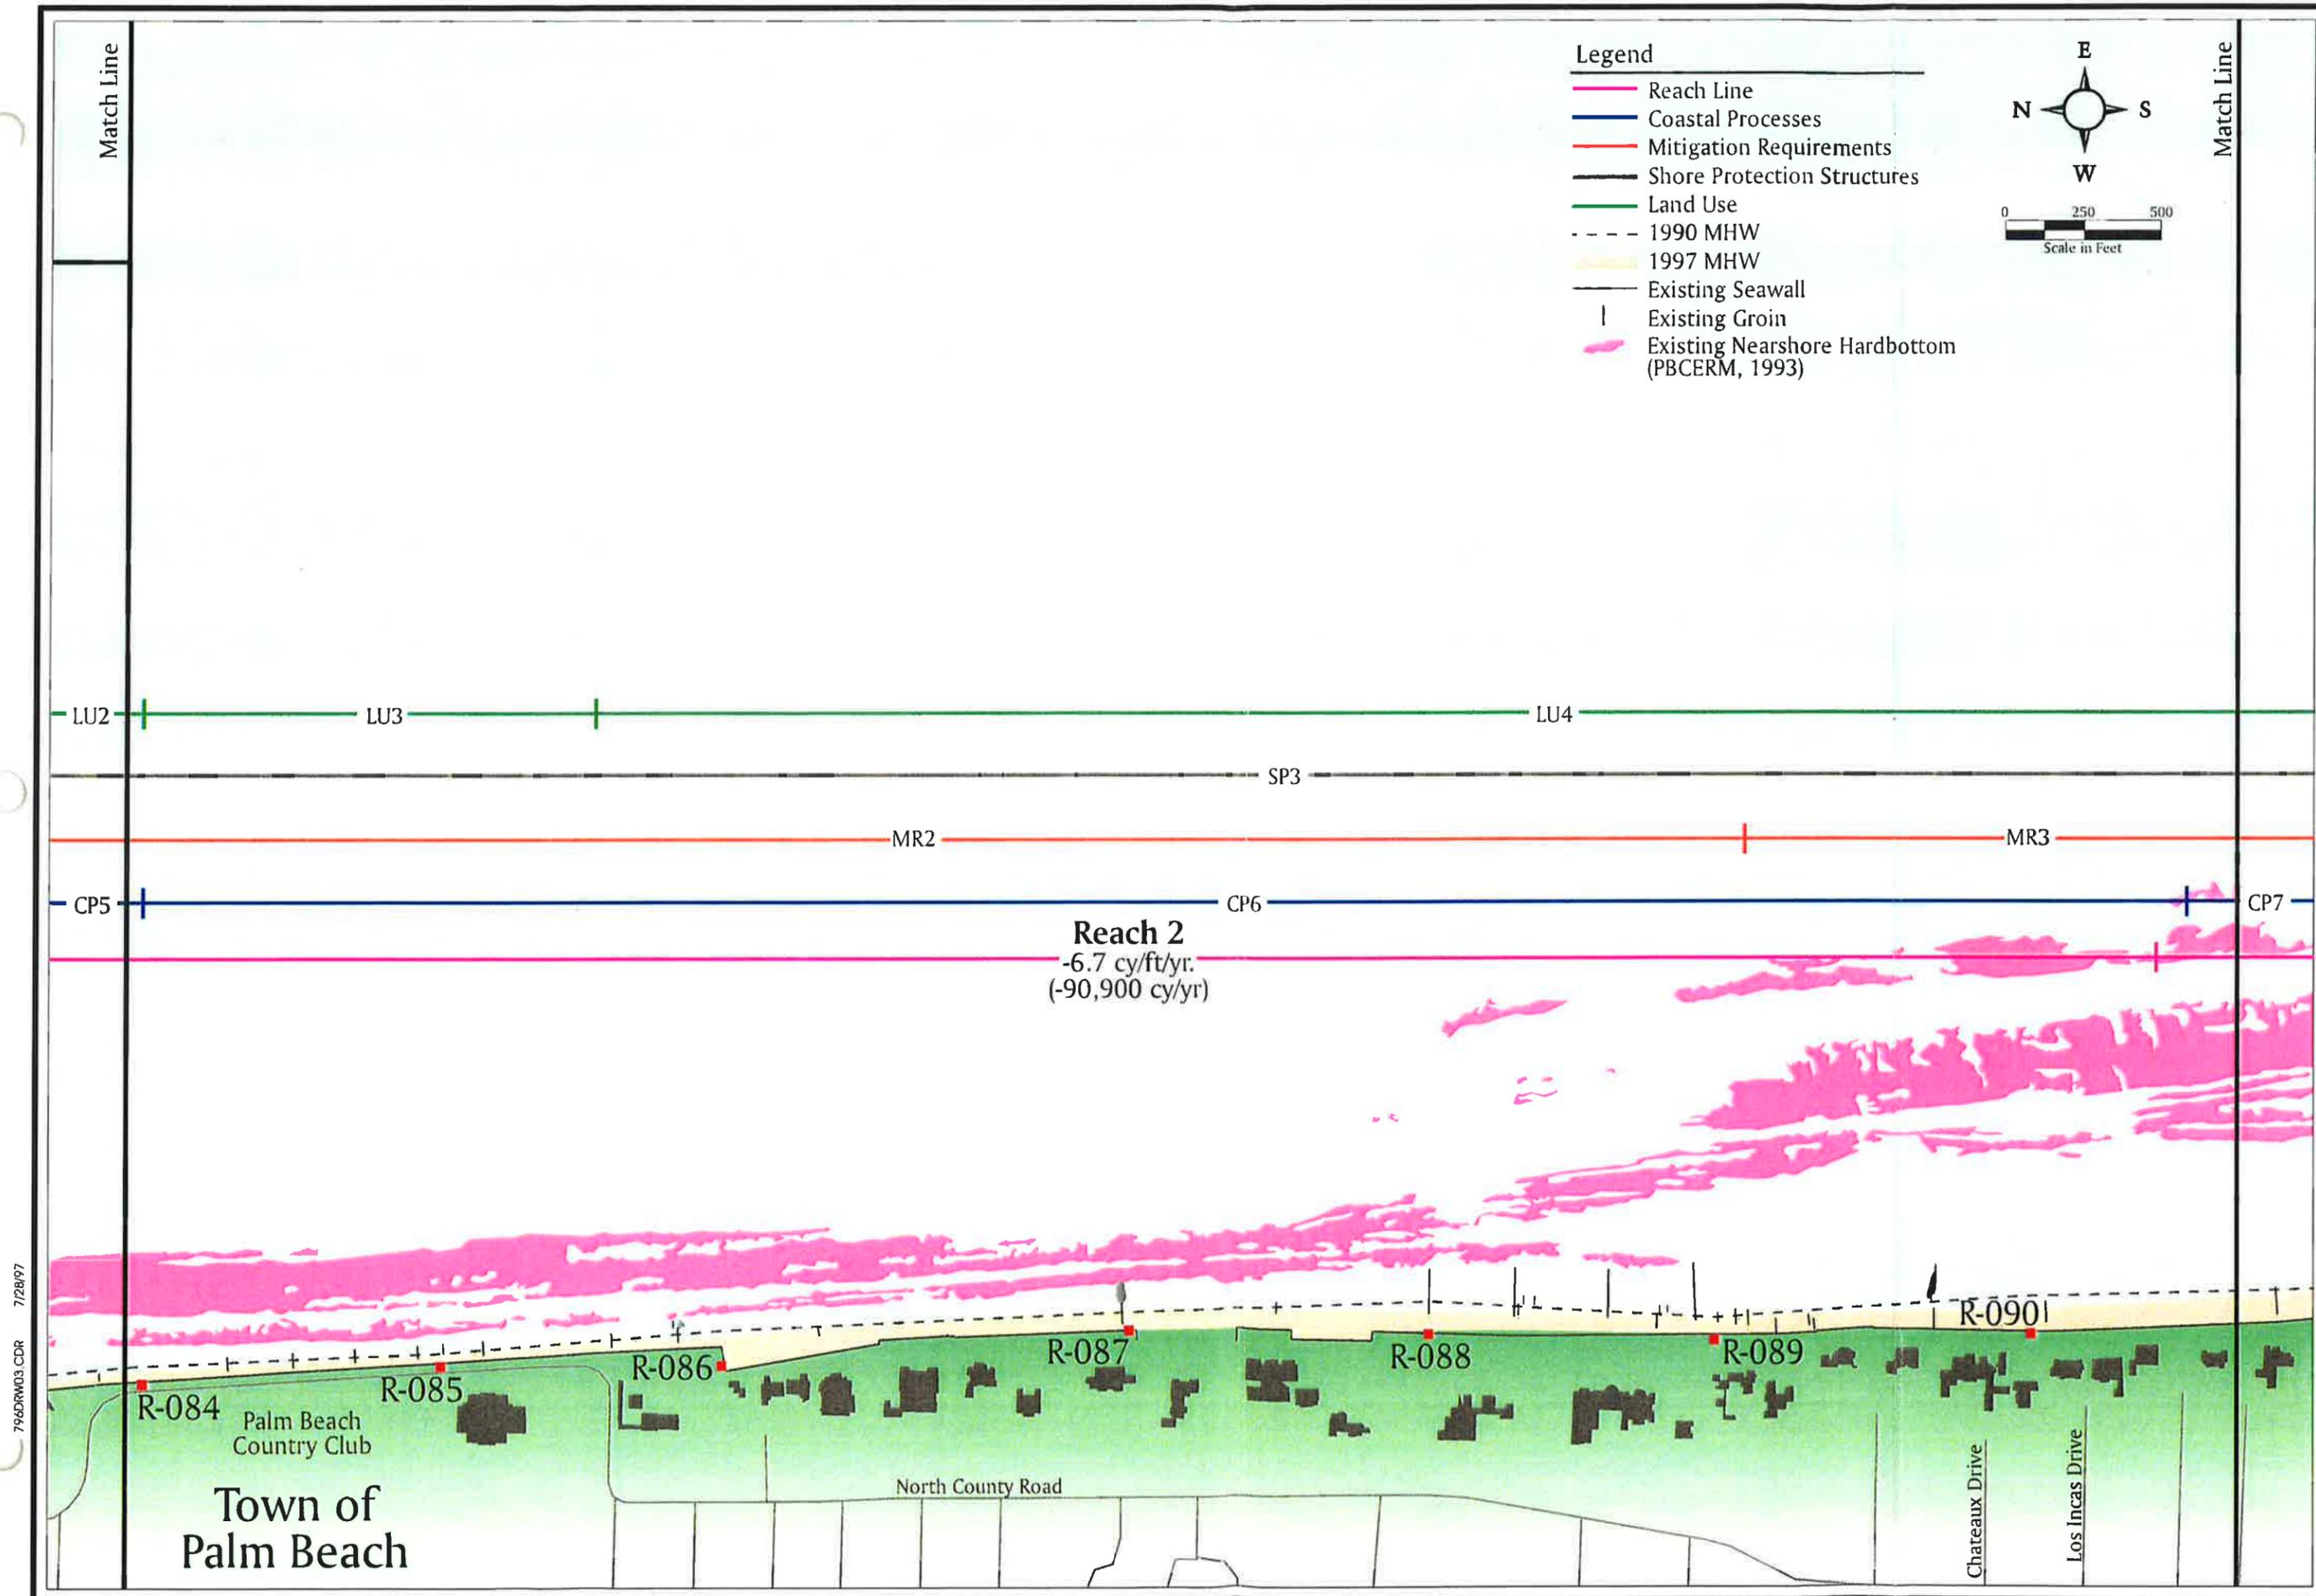
Figure 6-3
Town of Palm Beach, Florida
Comprehensive Coastal Management Plan
Designation of Shoreline Zone and Reach Boundaries

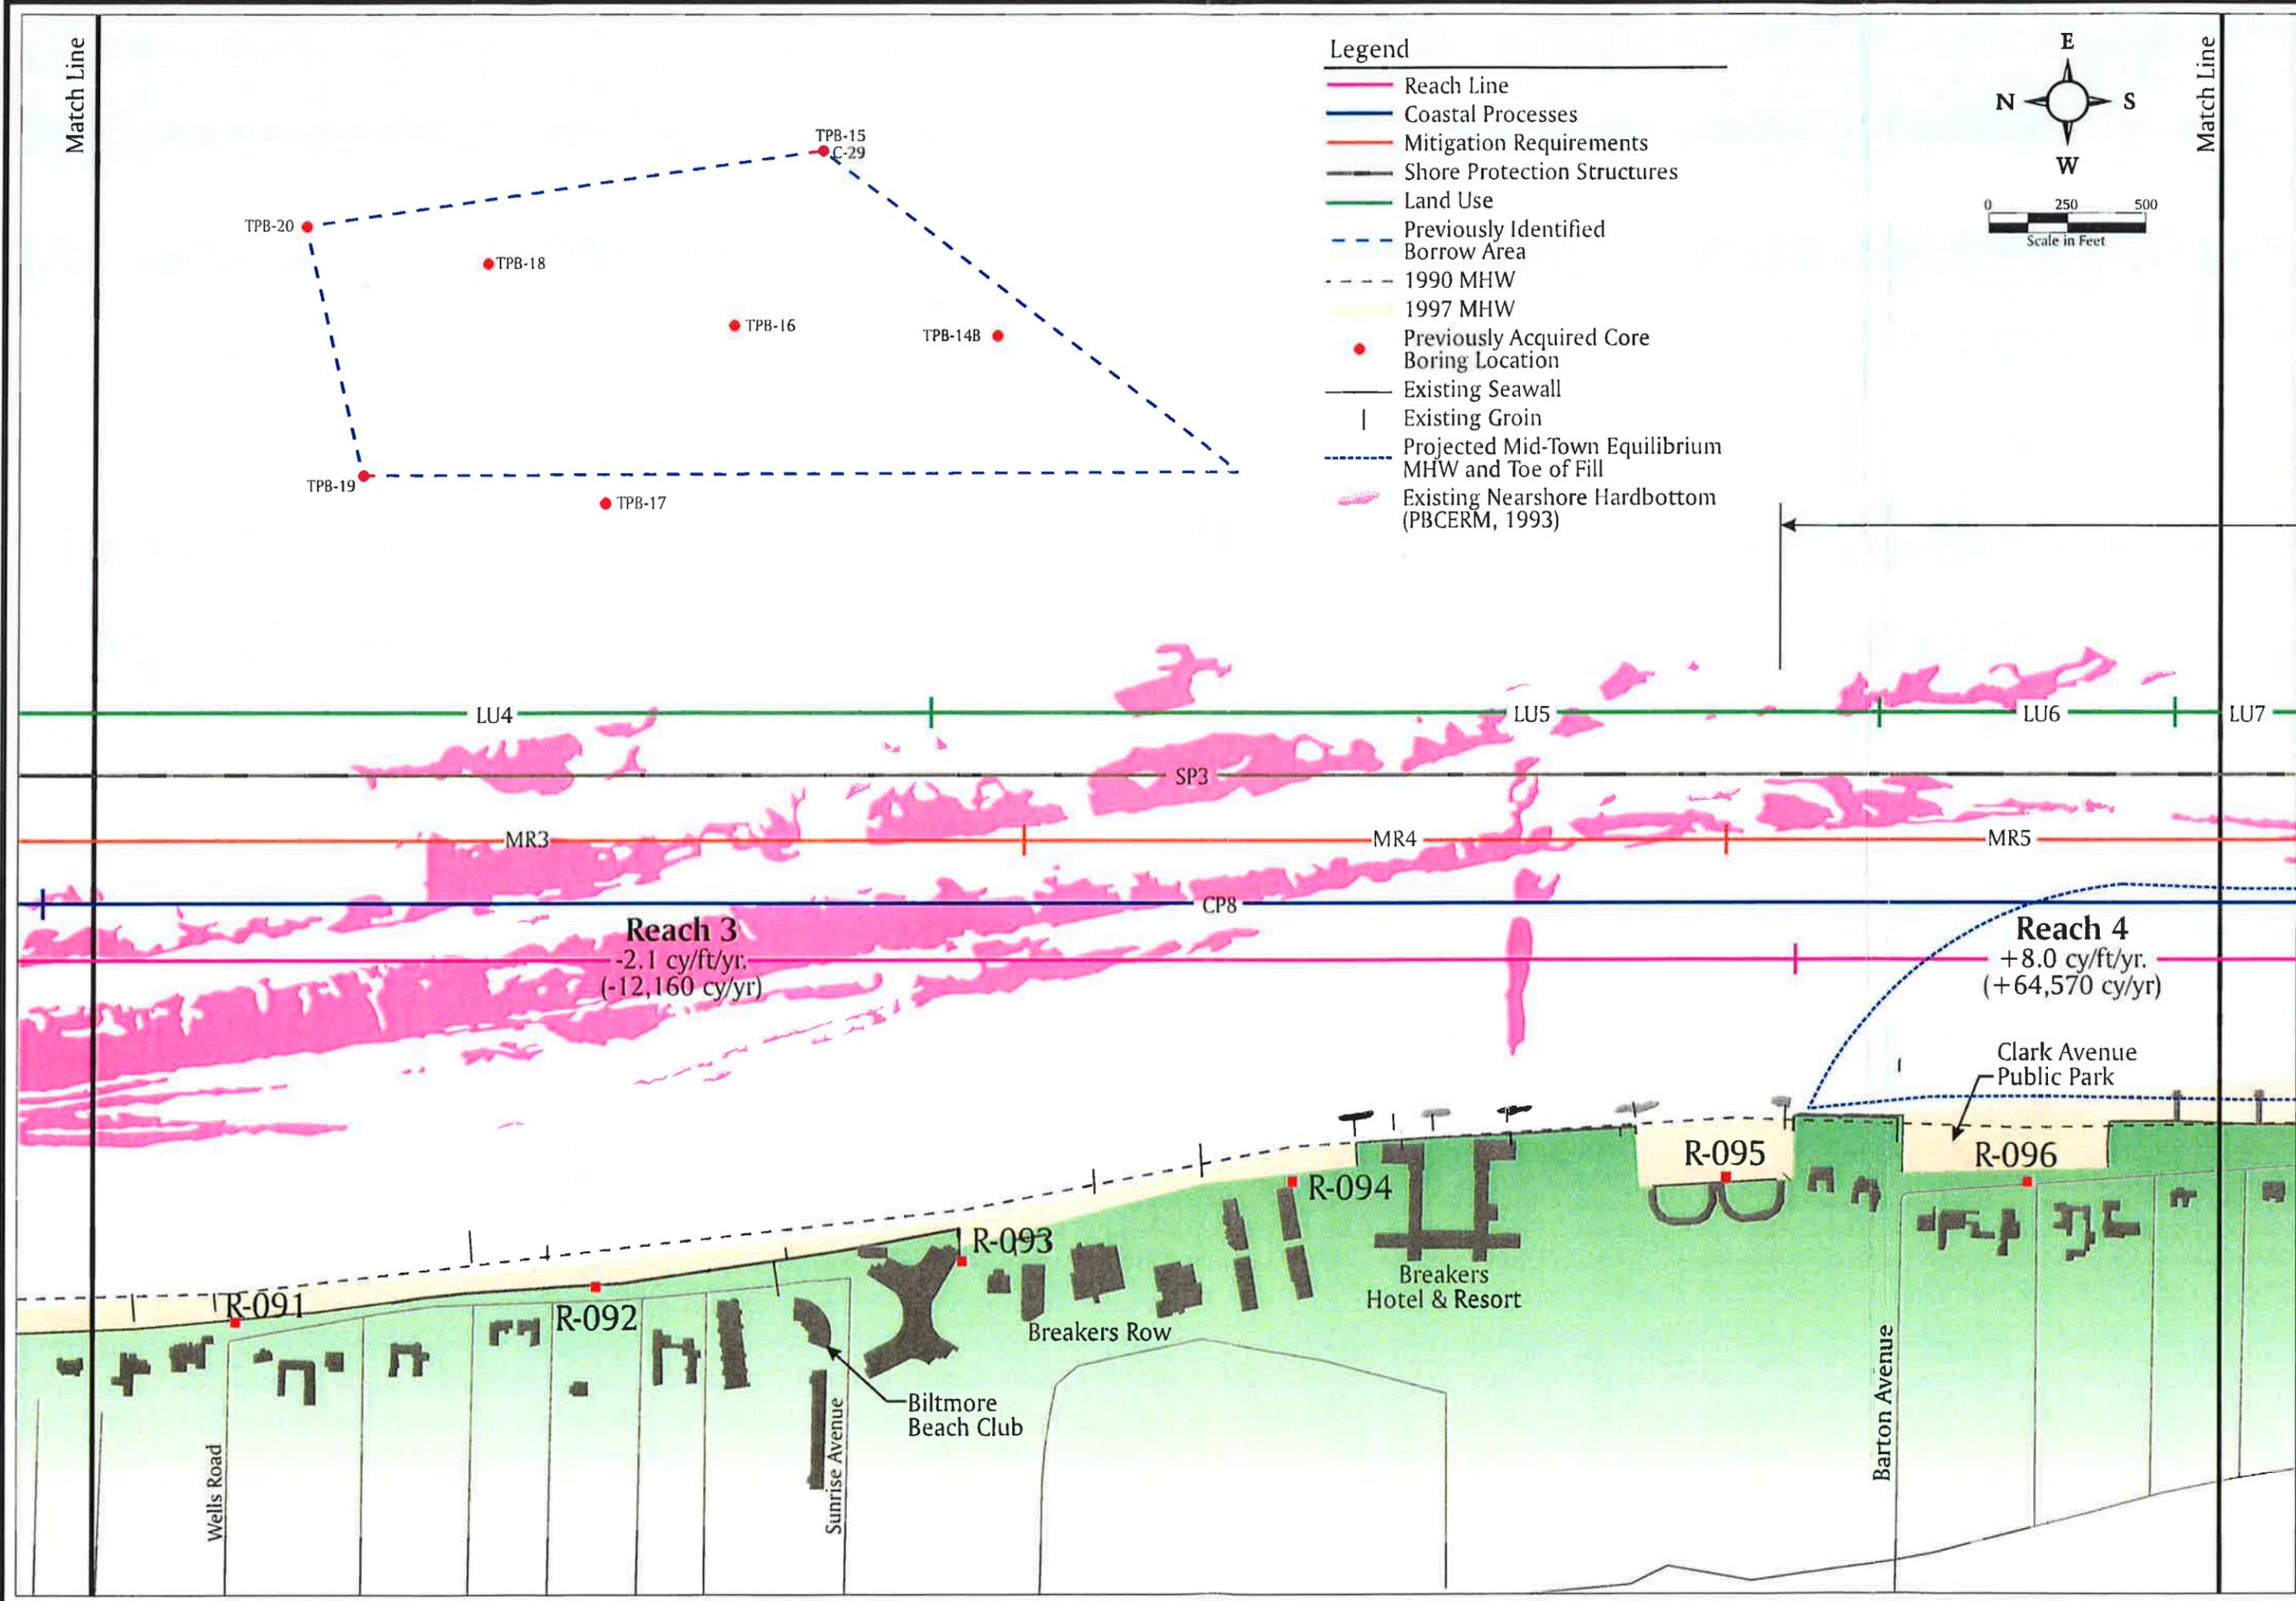
Figure 6-4
Town of Palm Beach, Florida
Comprehensive Coastal Management Plan
Designation of Shoreline Zone and Reach Boundaries
