Comprehensive Coastal Management Plan Update

Palm Beach Island, Florida

June 1998

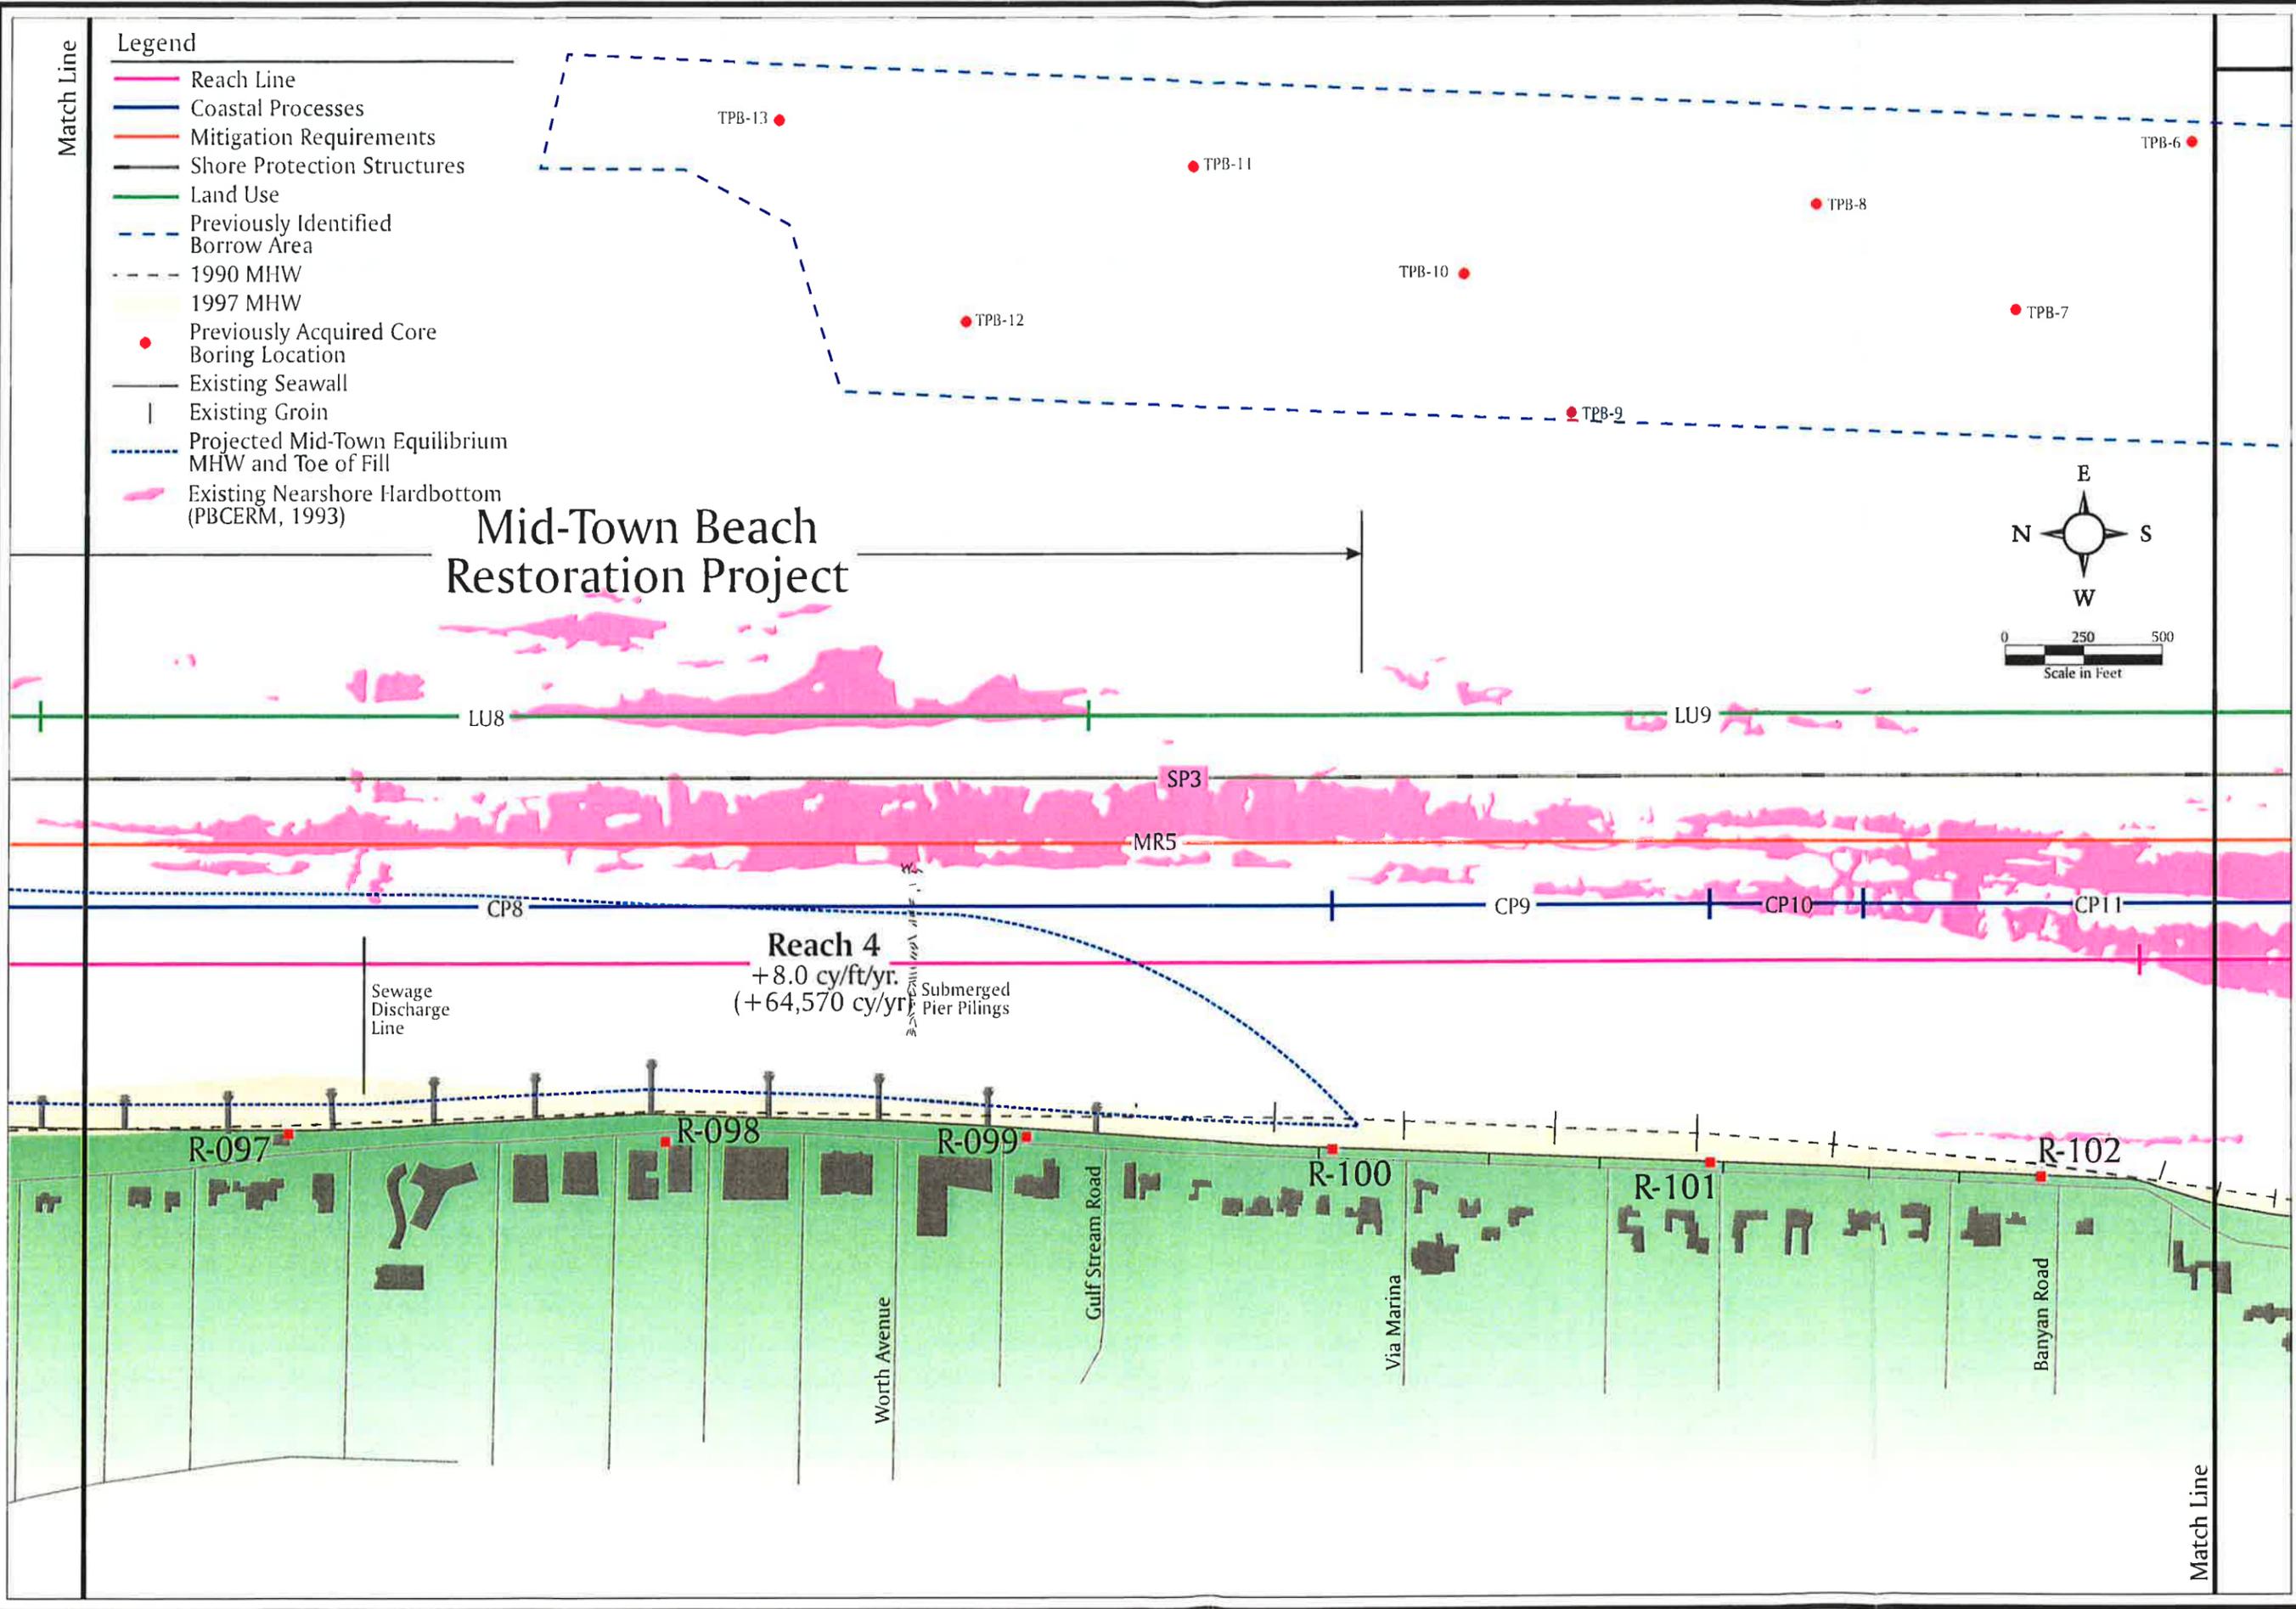
Figure 6-5
Town of Palm Beach, Florida
Comprehensive Coastal Management Plan
Designation of Shoreline Zone and Reach Boundaries

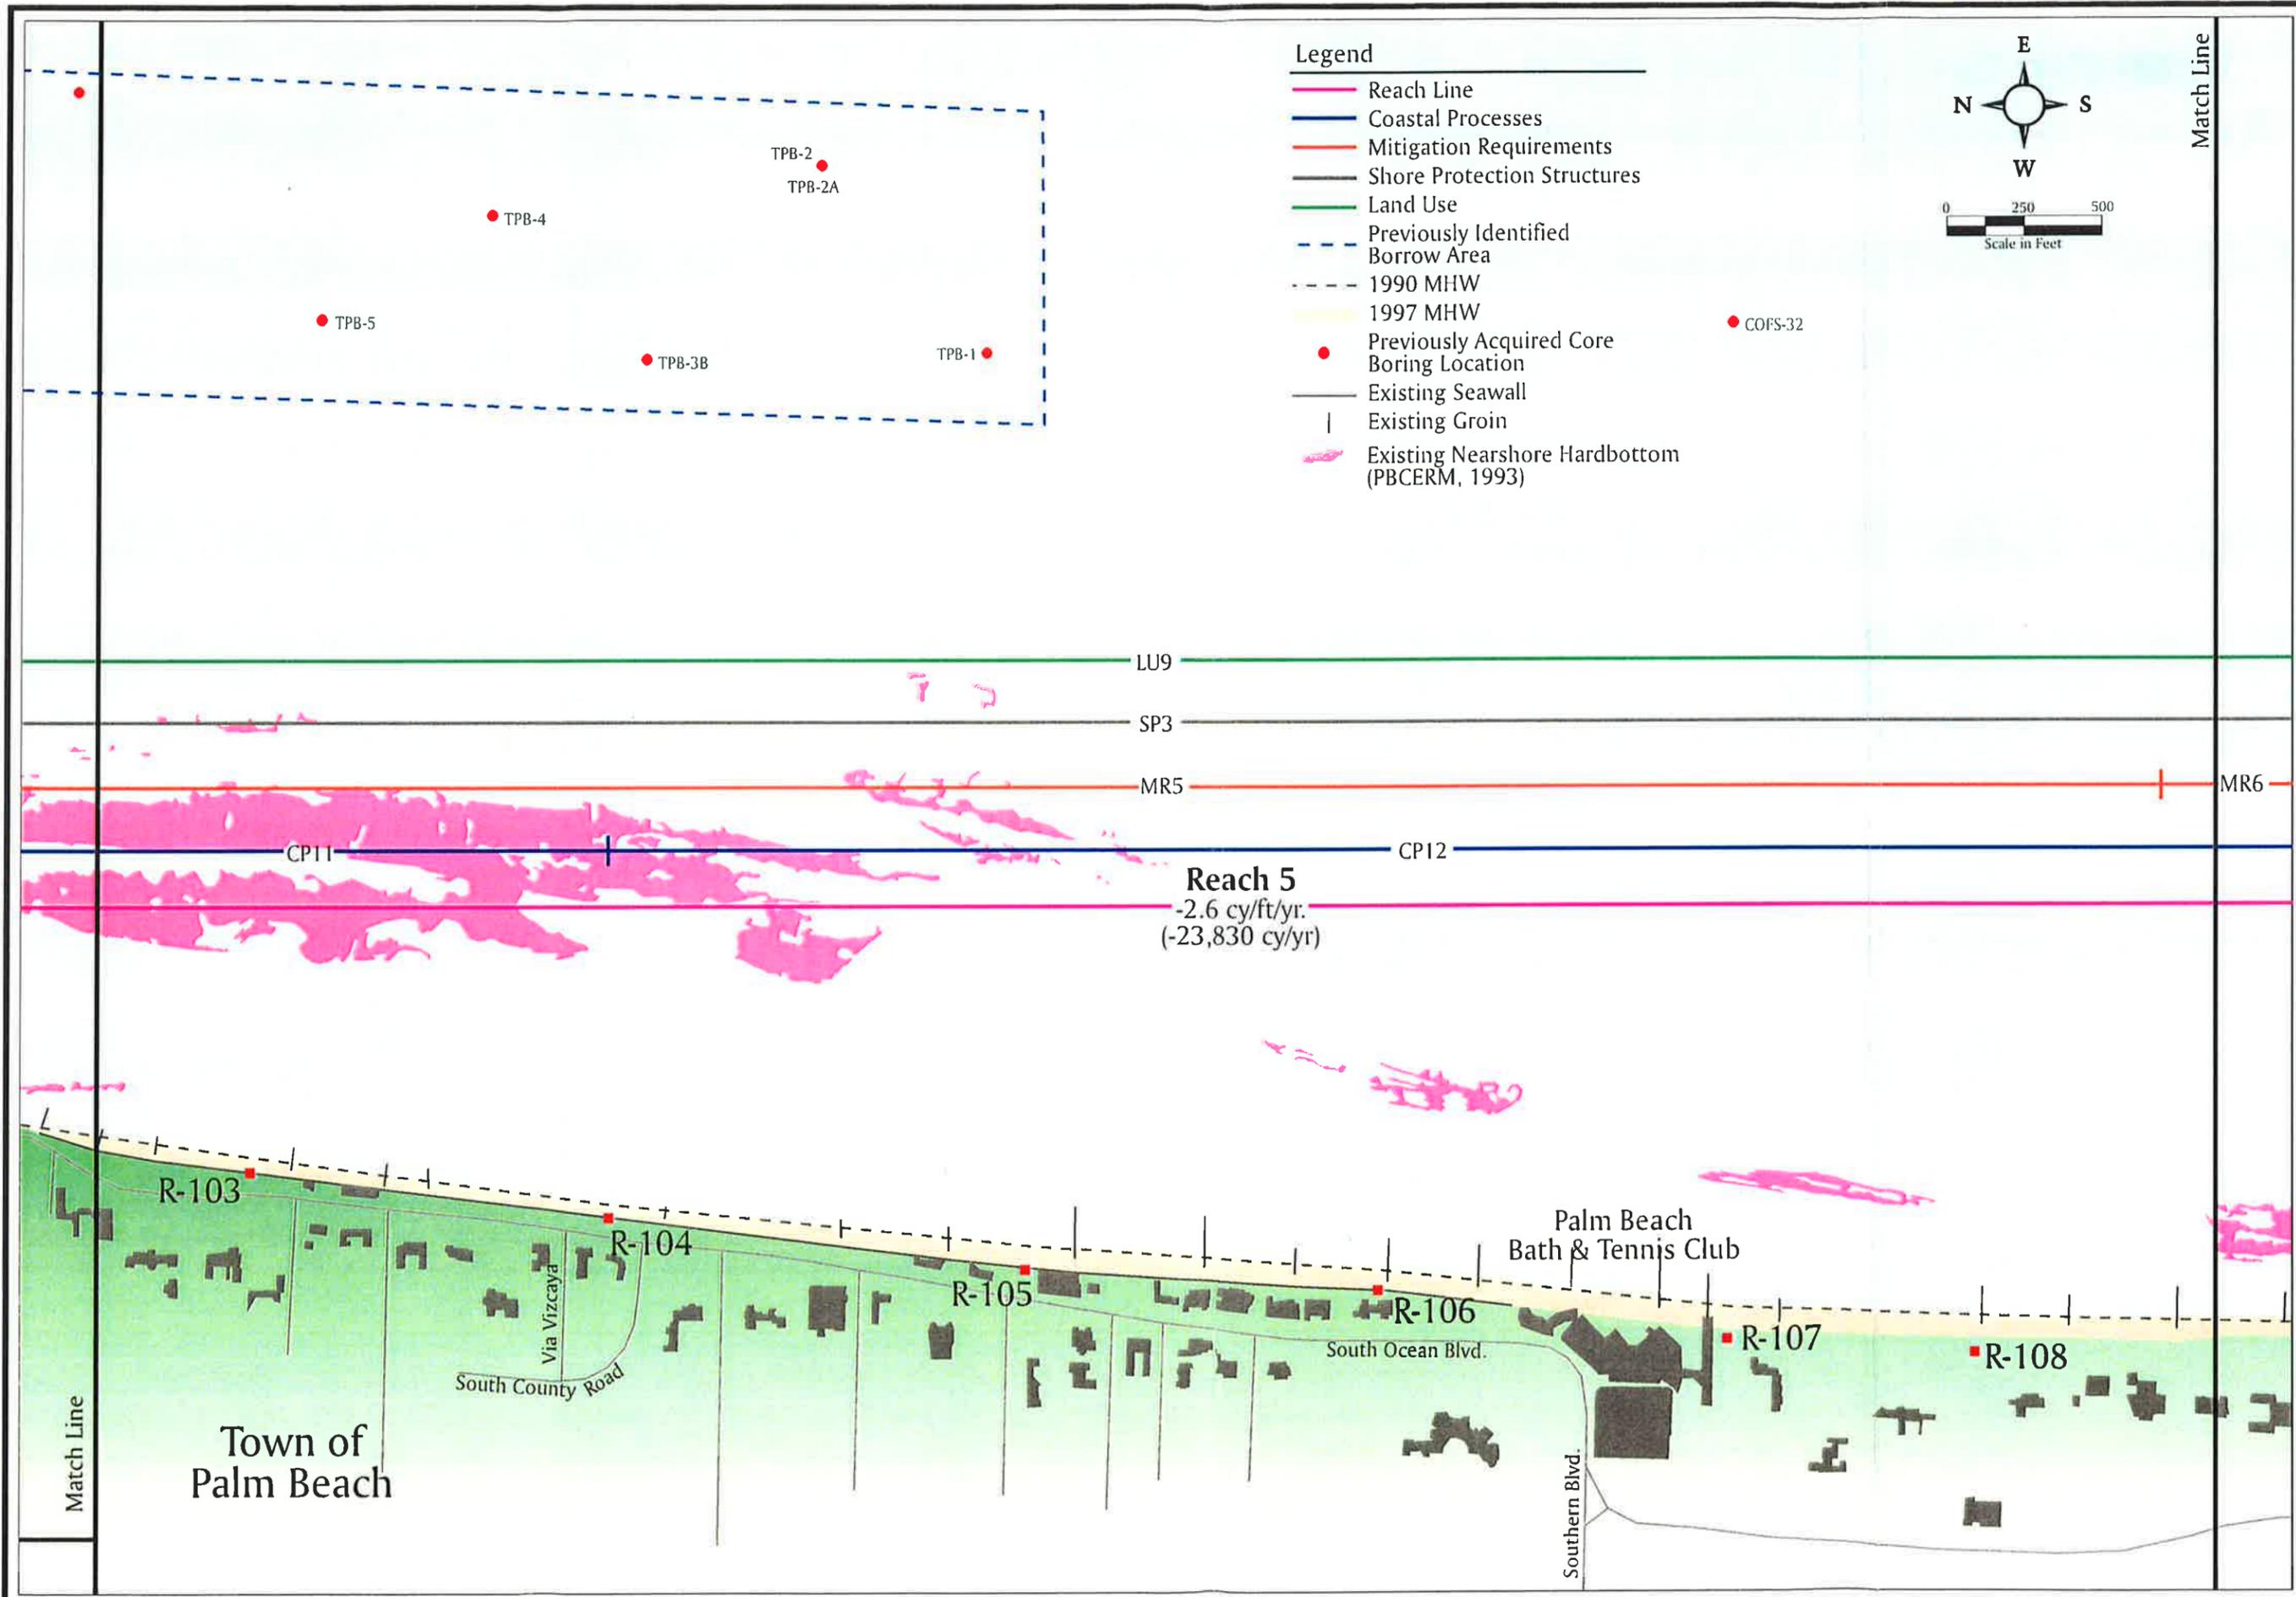
Figure 6-6
 Town of Palm Beach, Florida
 Comprehensive Coastal Management Plan
 Designation of Shoreline Zone and Reach Boundaries

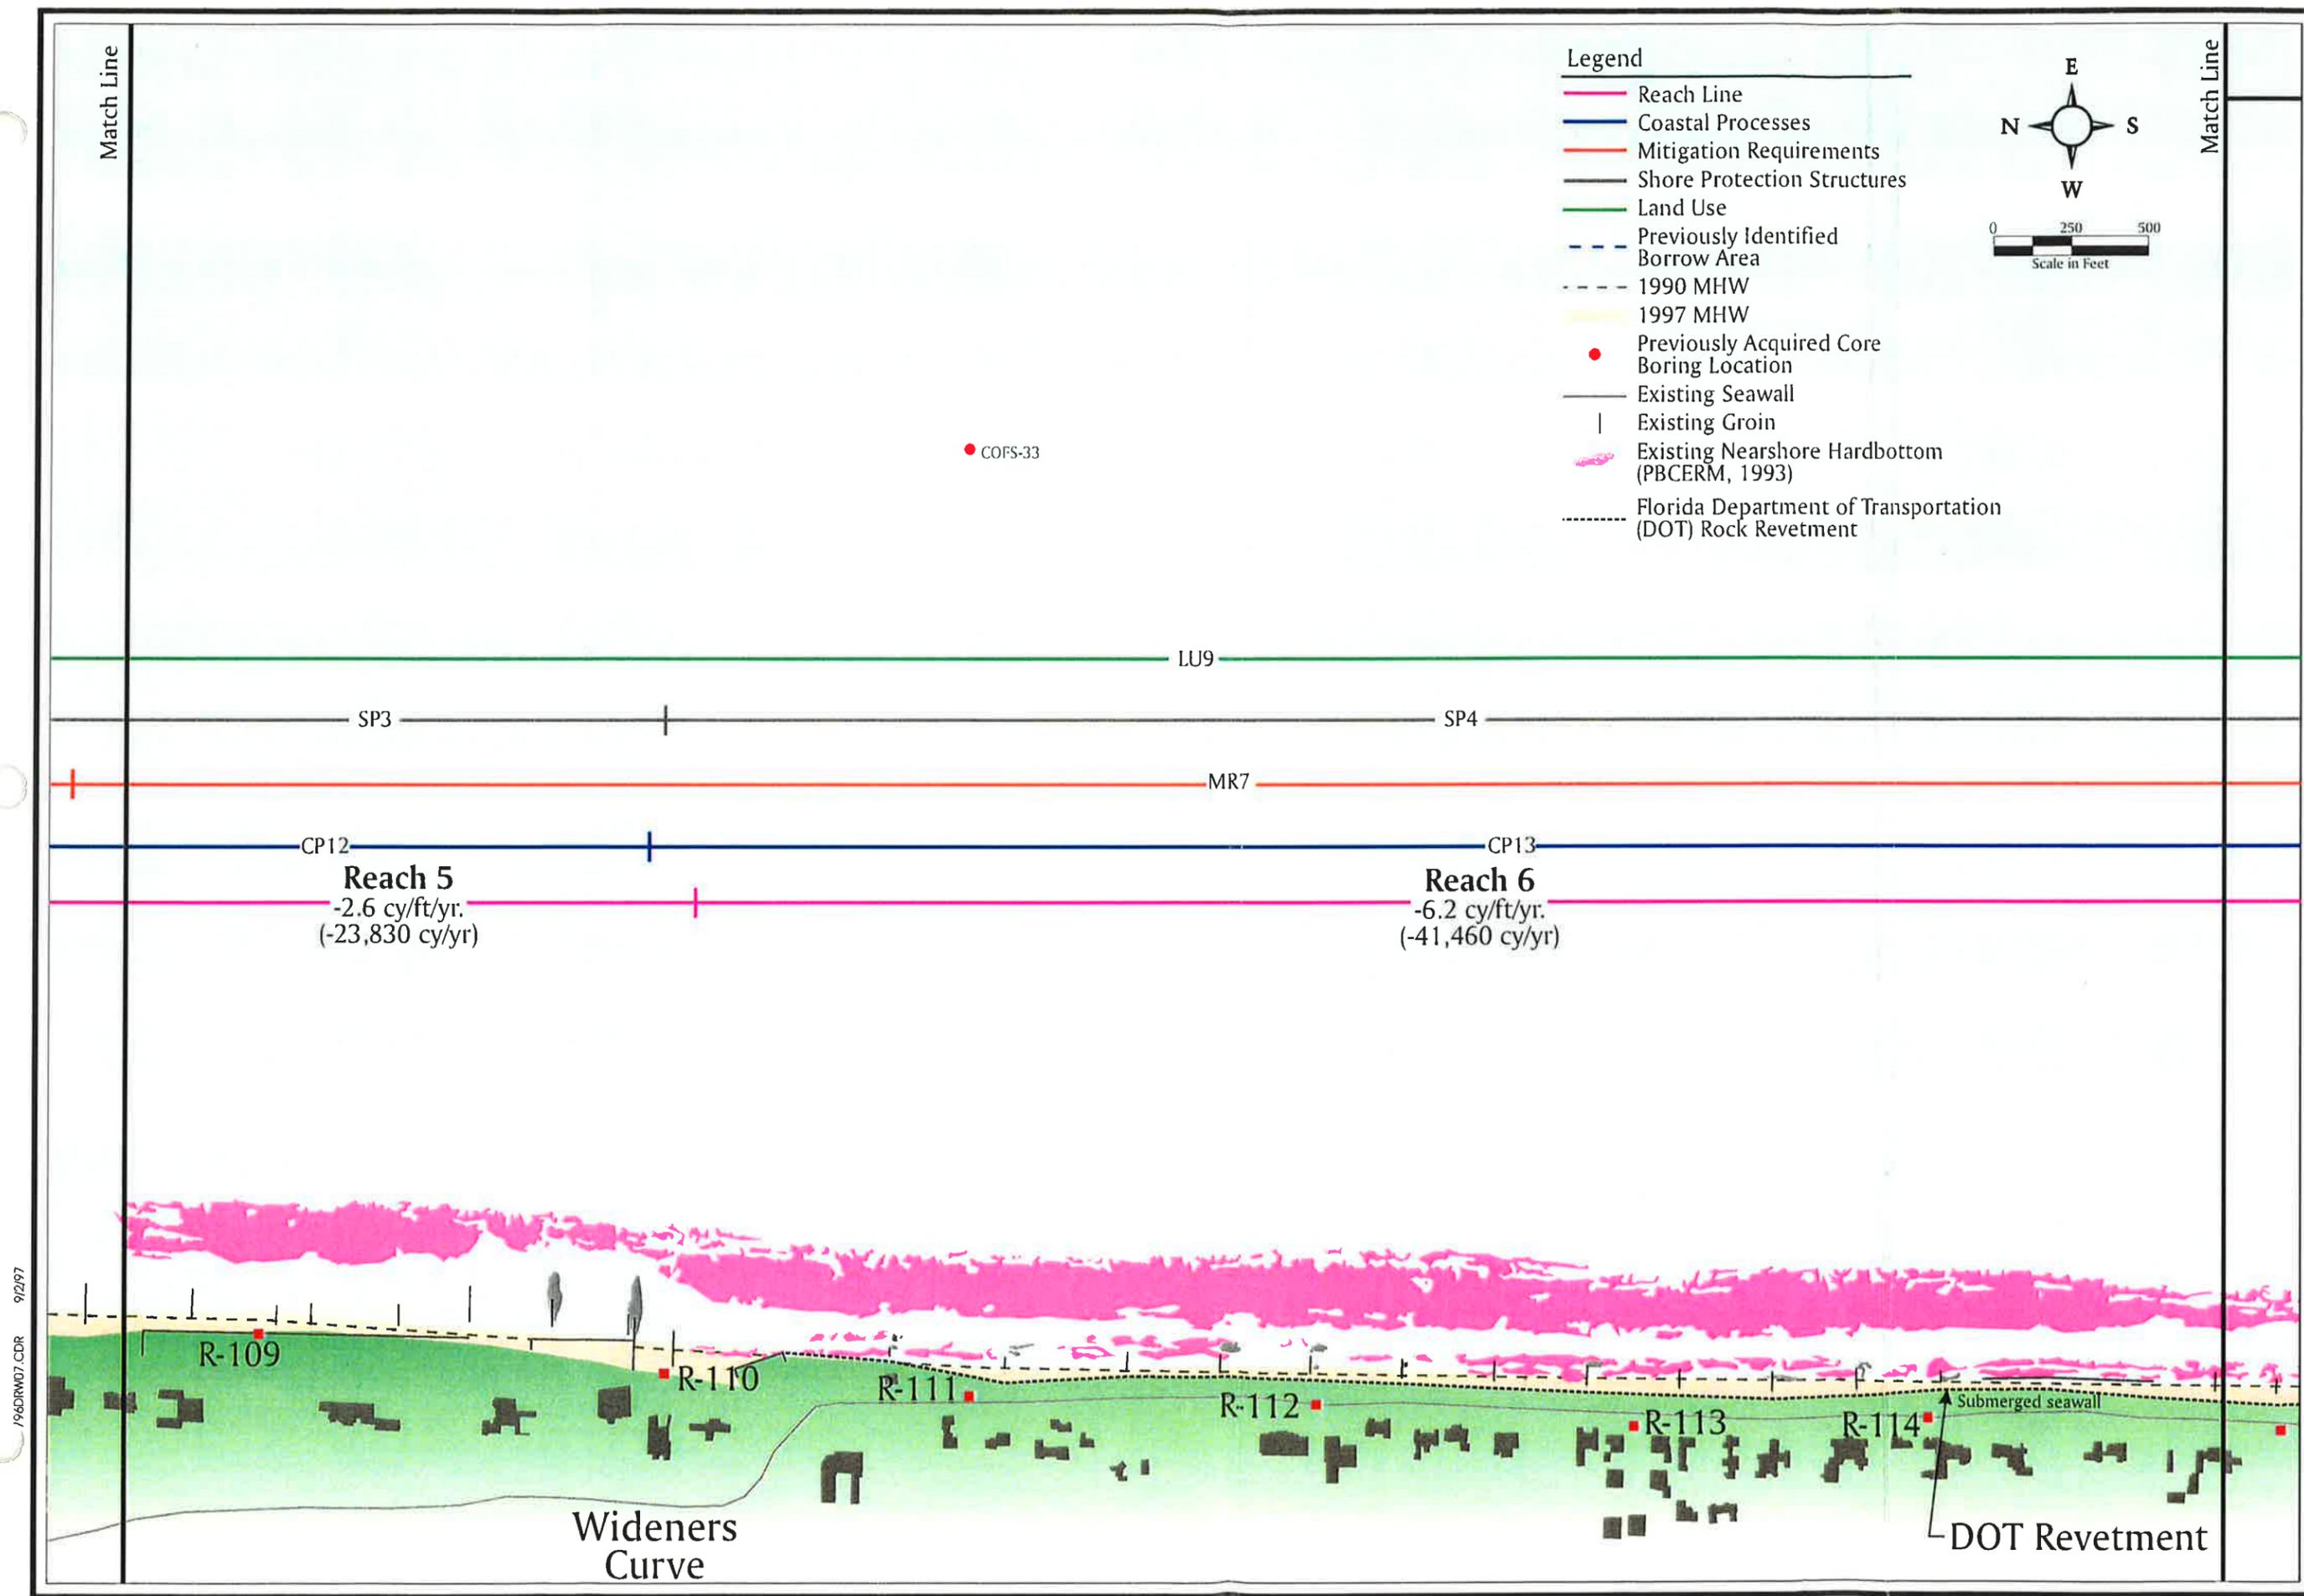
Figure 6-7
Town of Palm Beach, Florida
Comprehensive Coastal Management Plan
Designation of Shoreline Zone and Reach Boundaries

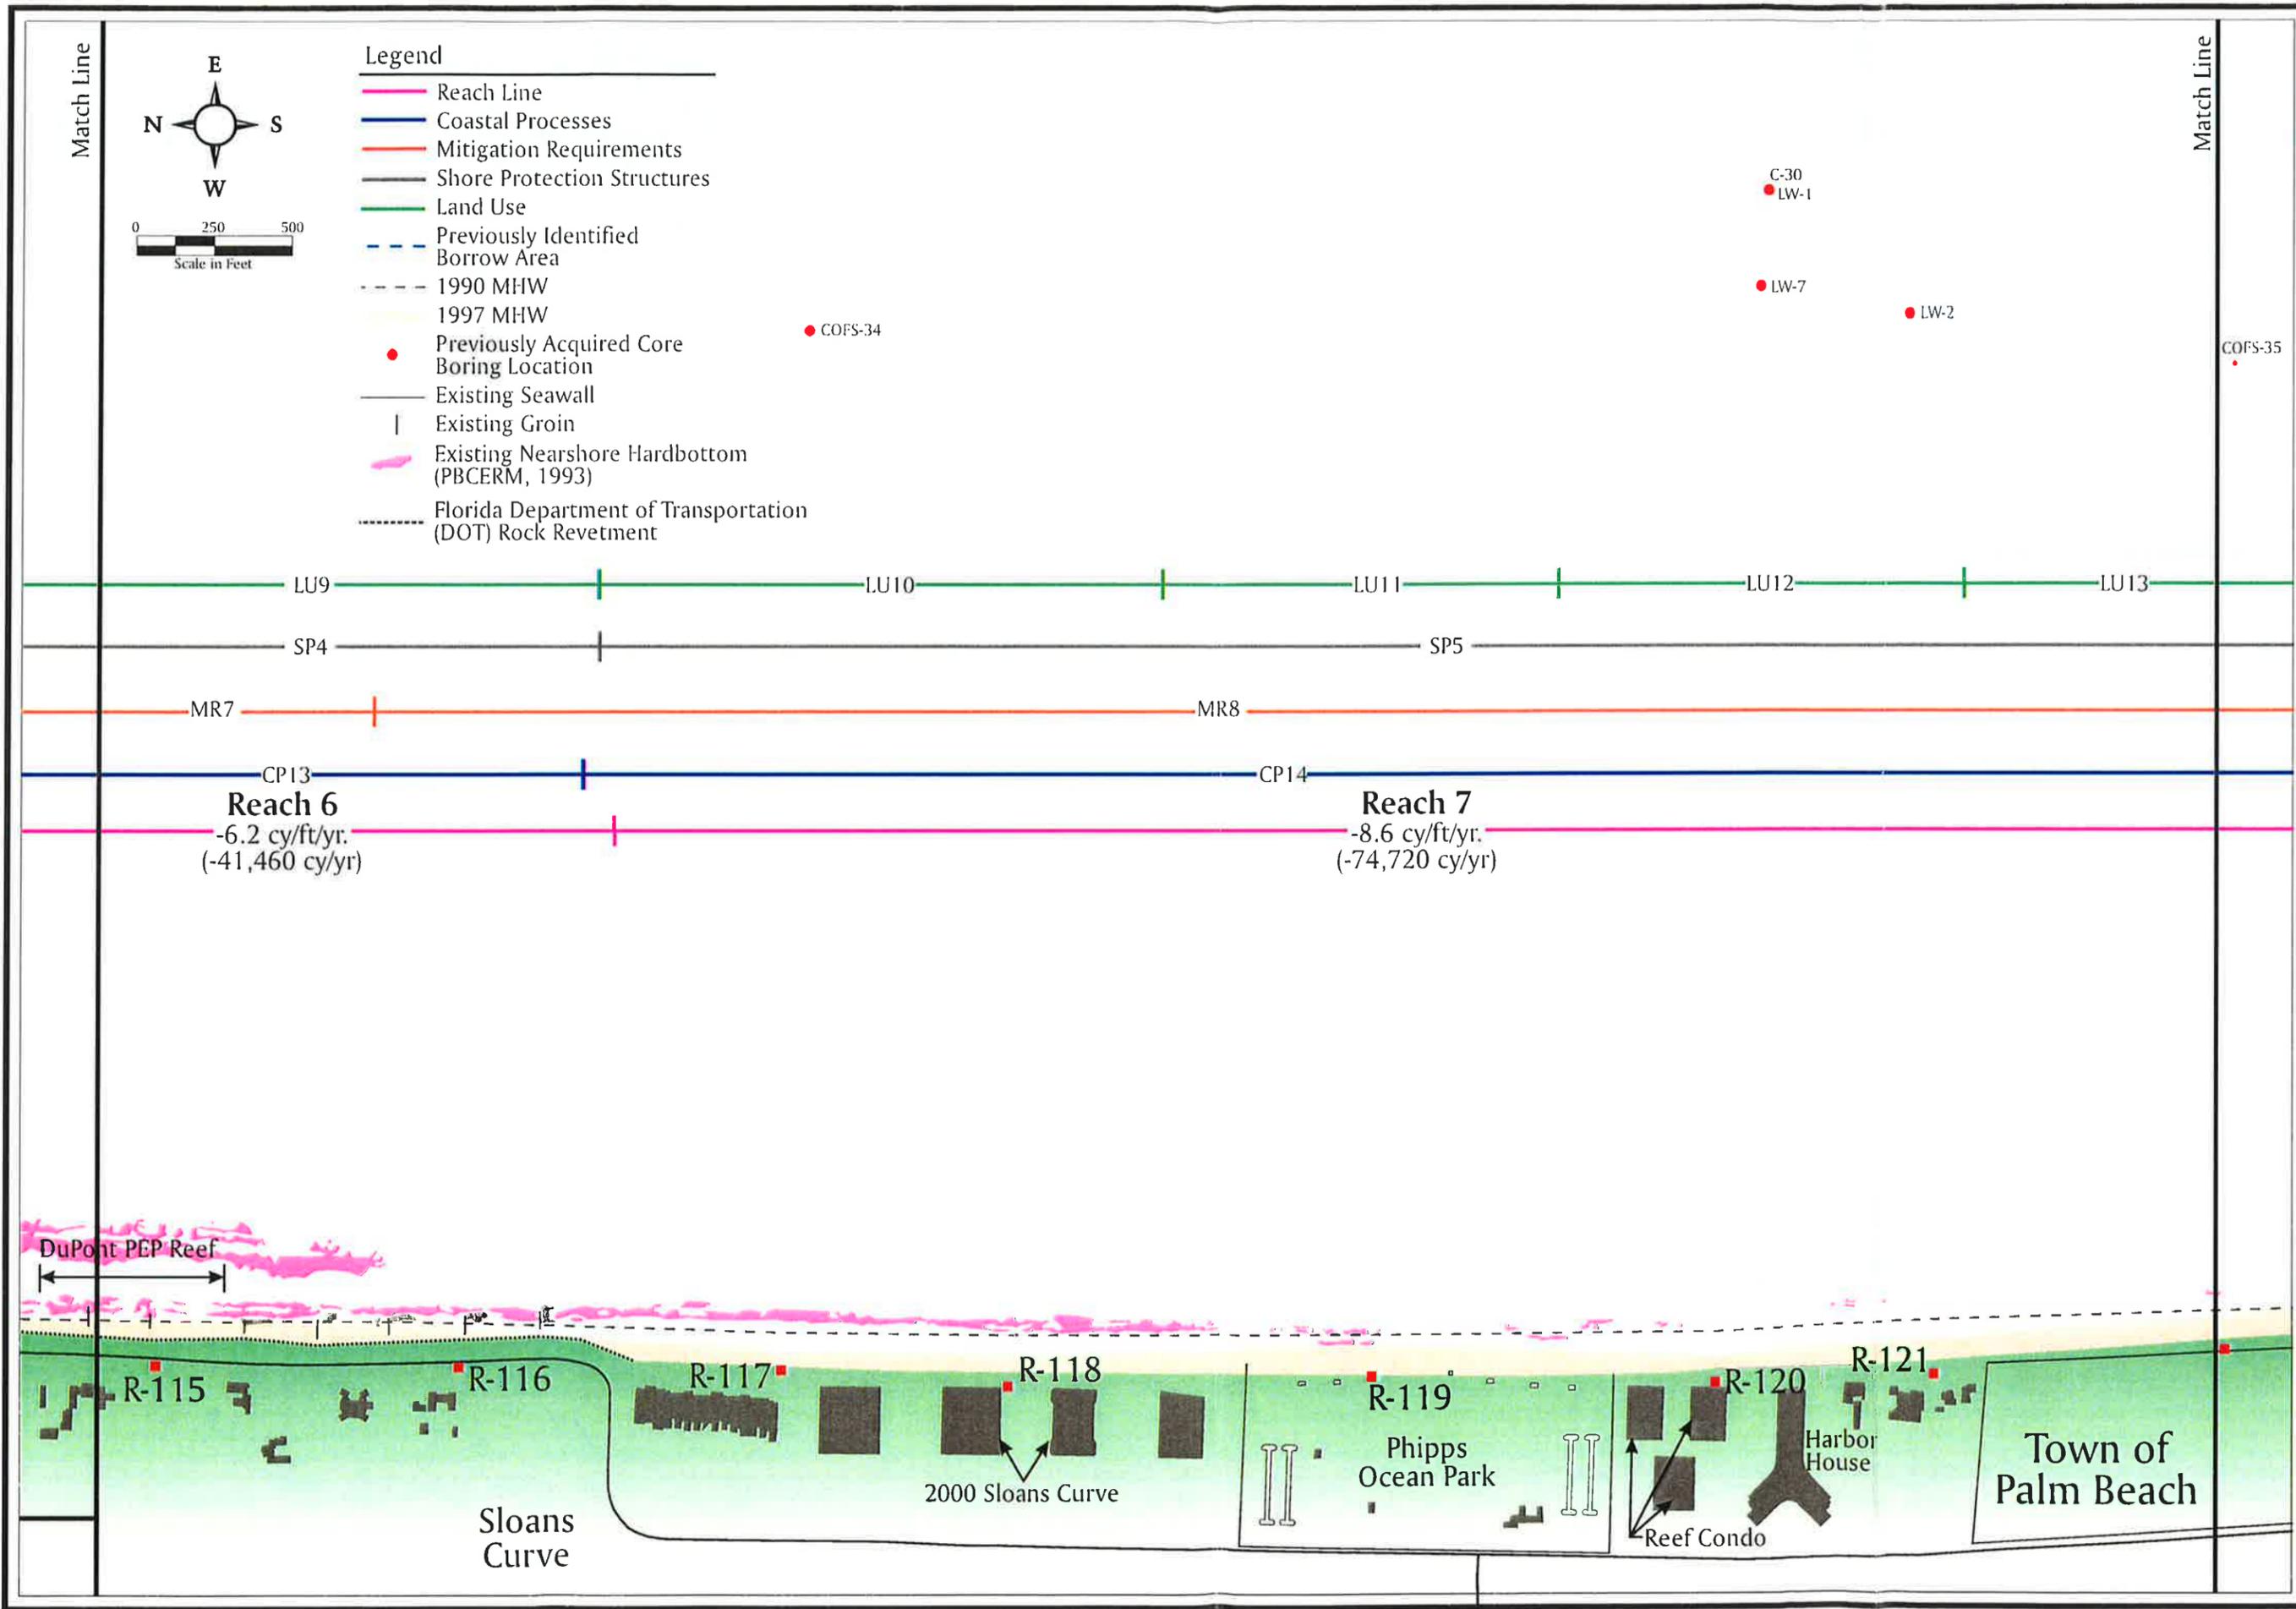
Figure 6-8
Town of Palm Beach, Florida
Comprehensive Coastal Management Plan
Designation of Shoreline Zone and Reach Boundaries

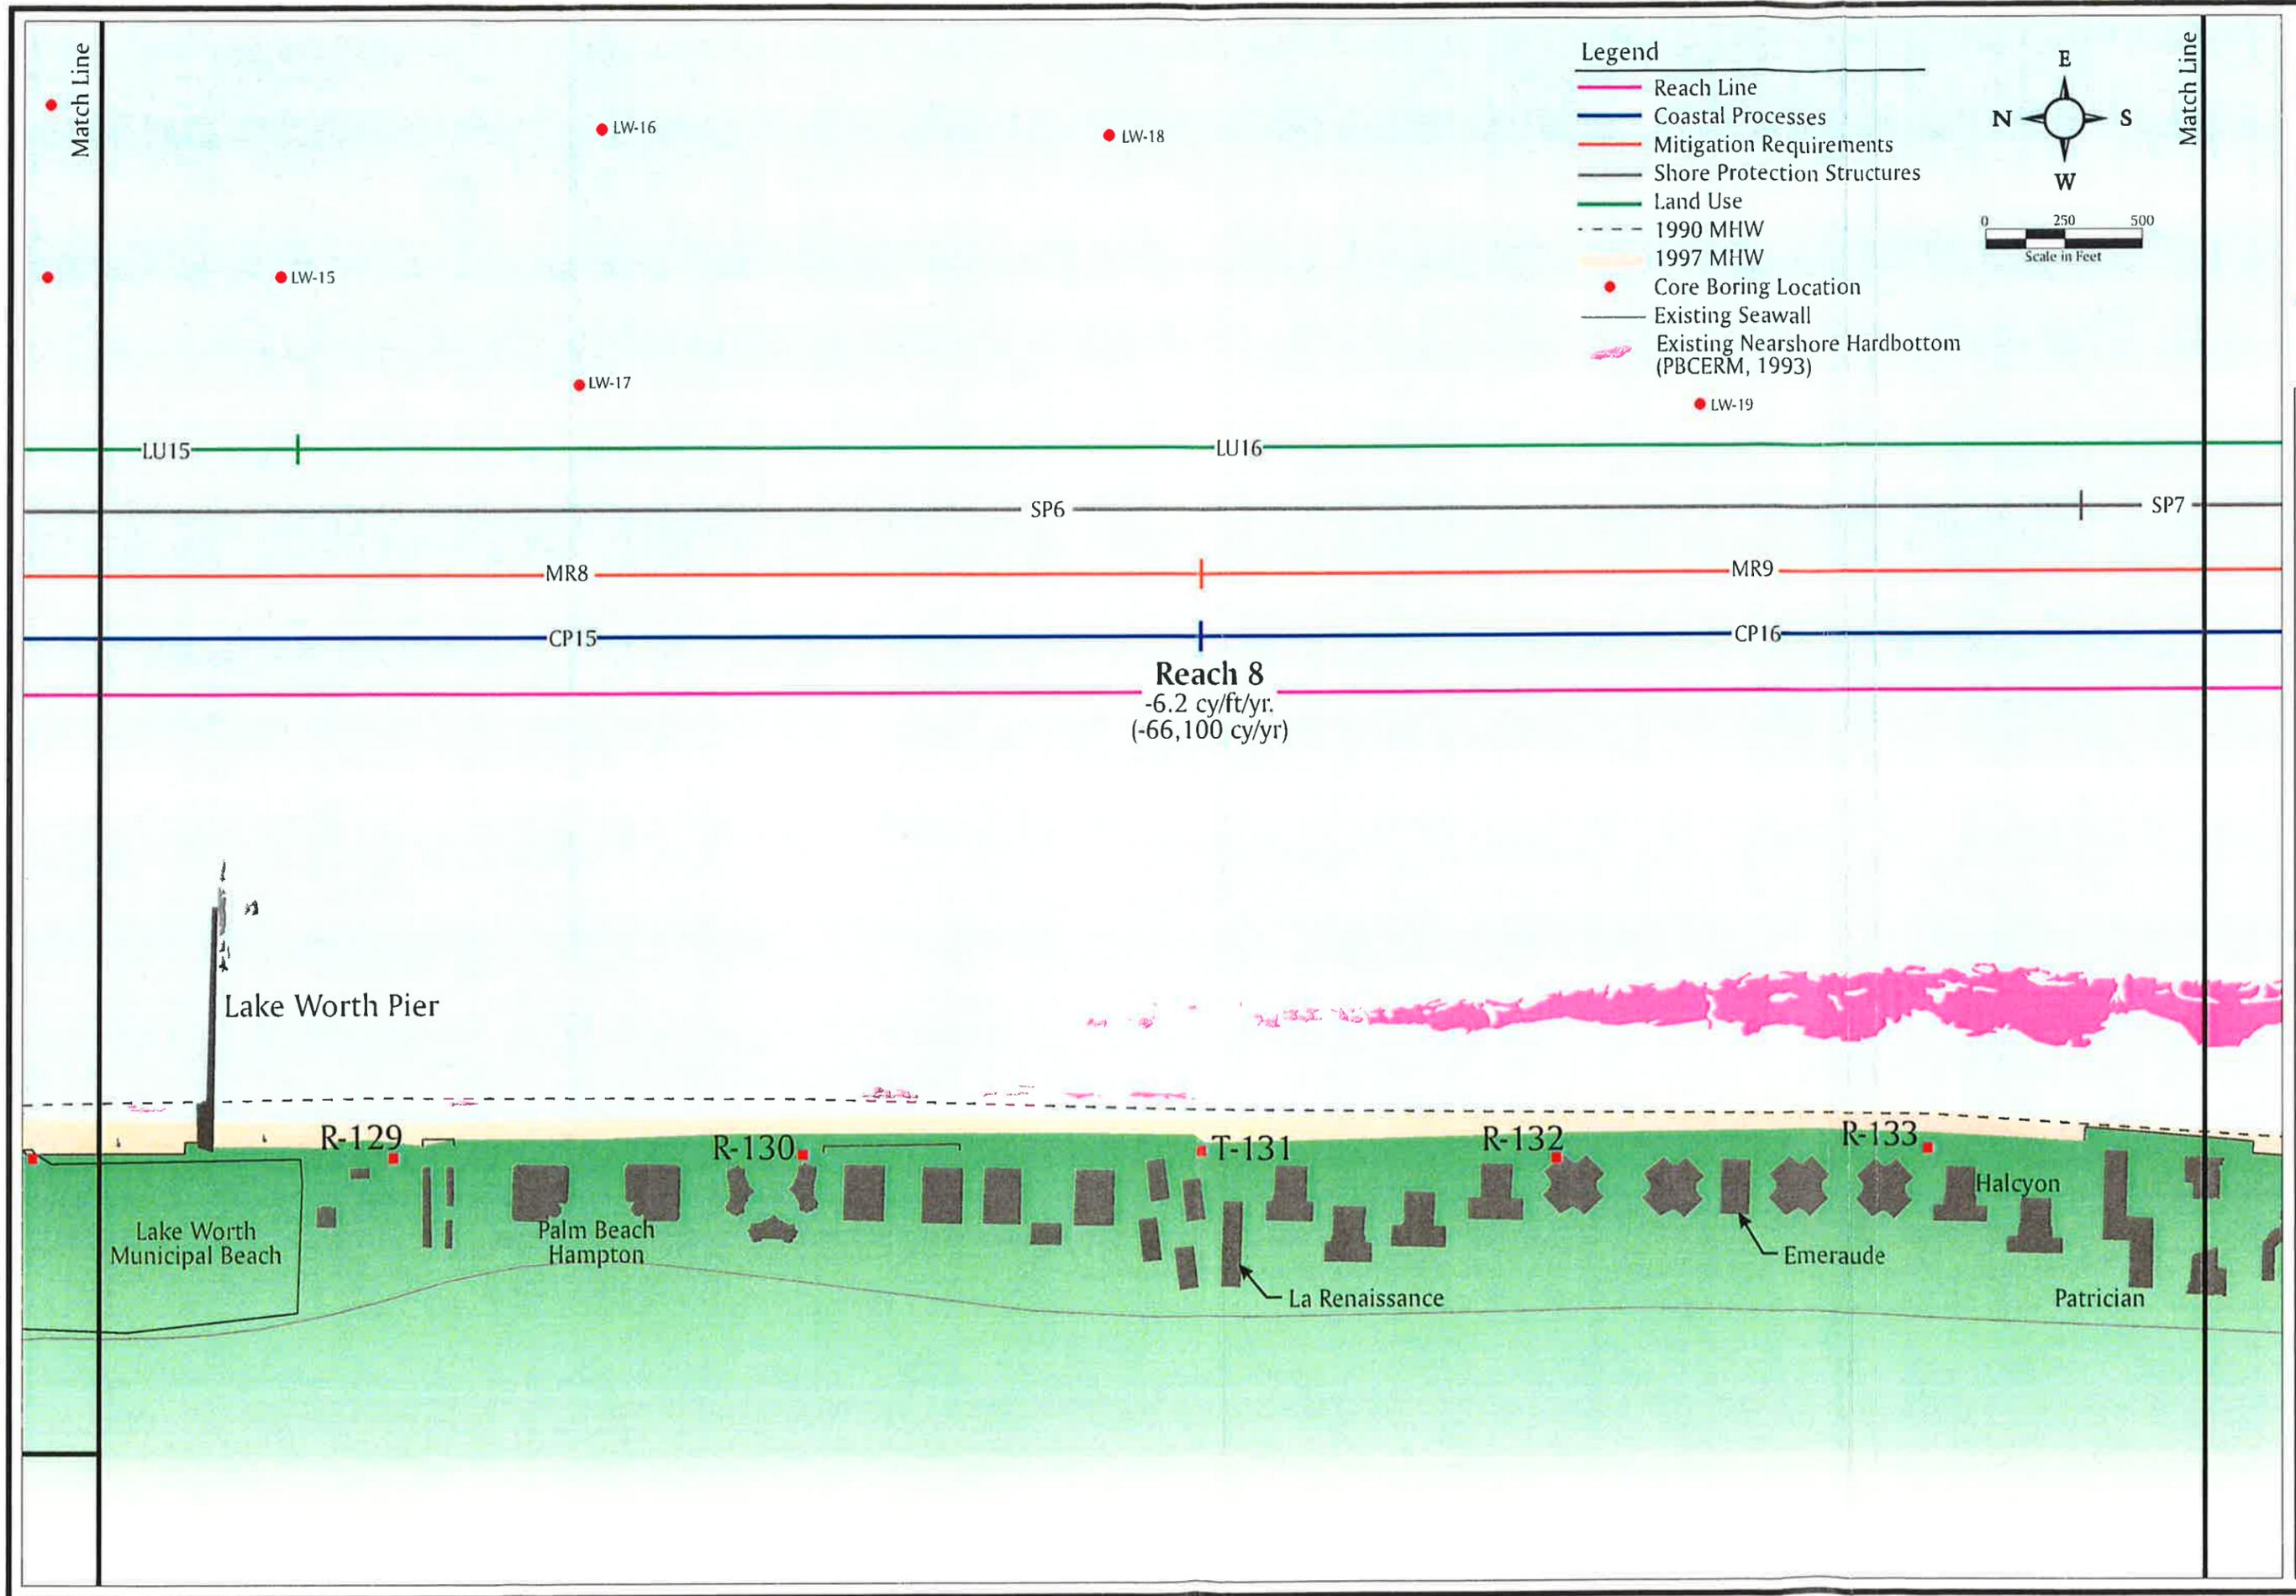
Figure 6-10
 Town of Palm Beach, Florida
 Comprehensive Coastal Management Plan
 Designation of Shoreline Zone and Reach Boundaries

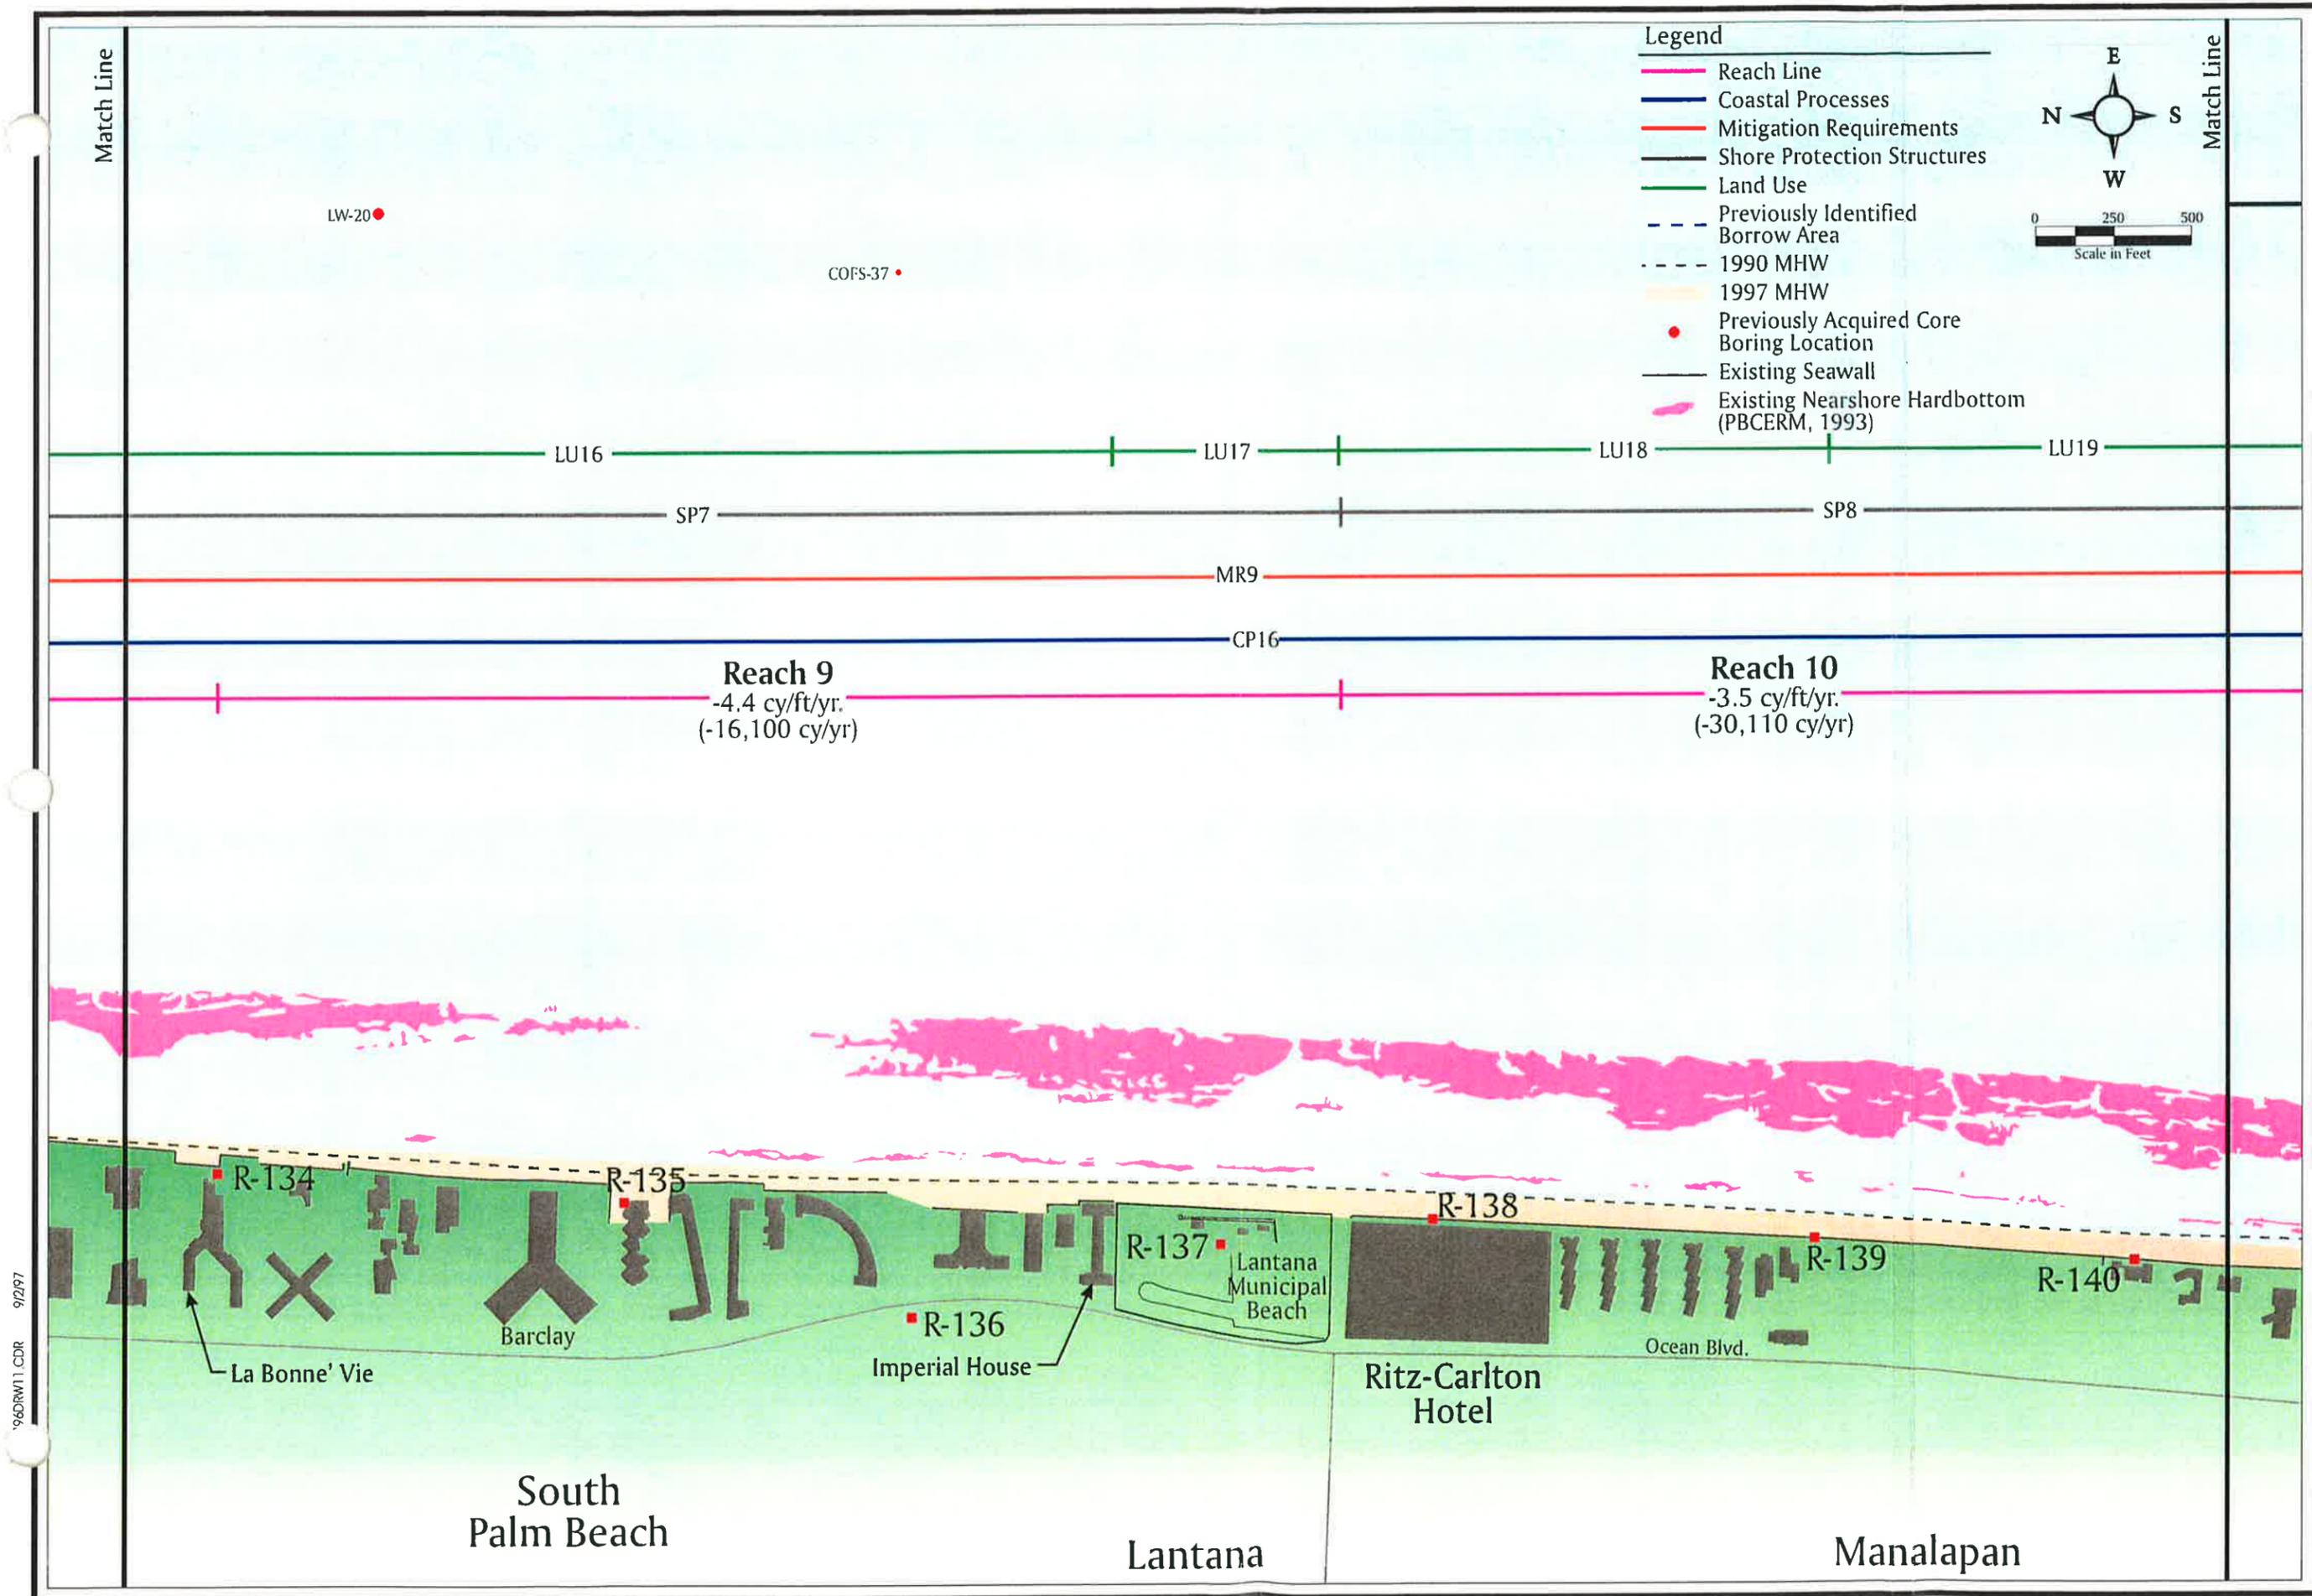
Figure 6-11
 Town of Palm Beach, Florida
 Comprehensive Coastal Management Plan
 Designation of Shoreline Zone and Reach Boundaries
