Comprehensive Coastal Management Plan Update

Palm Beach Island, Florida

June 1998

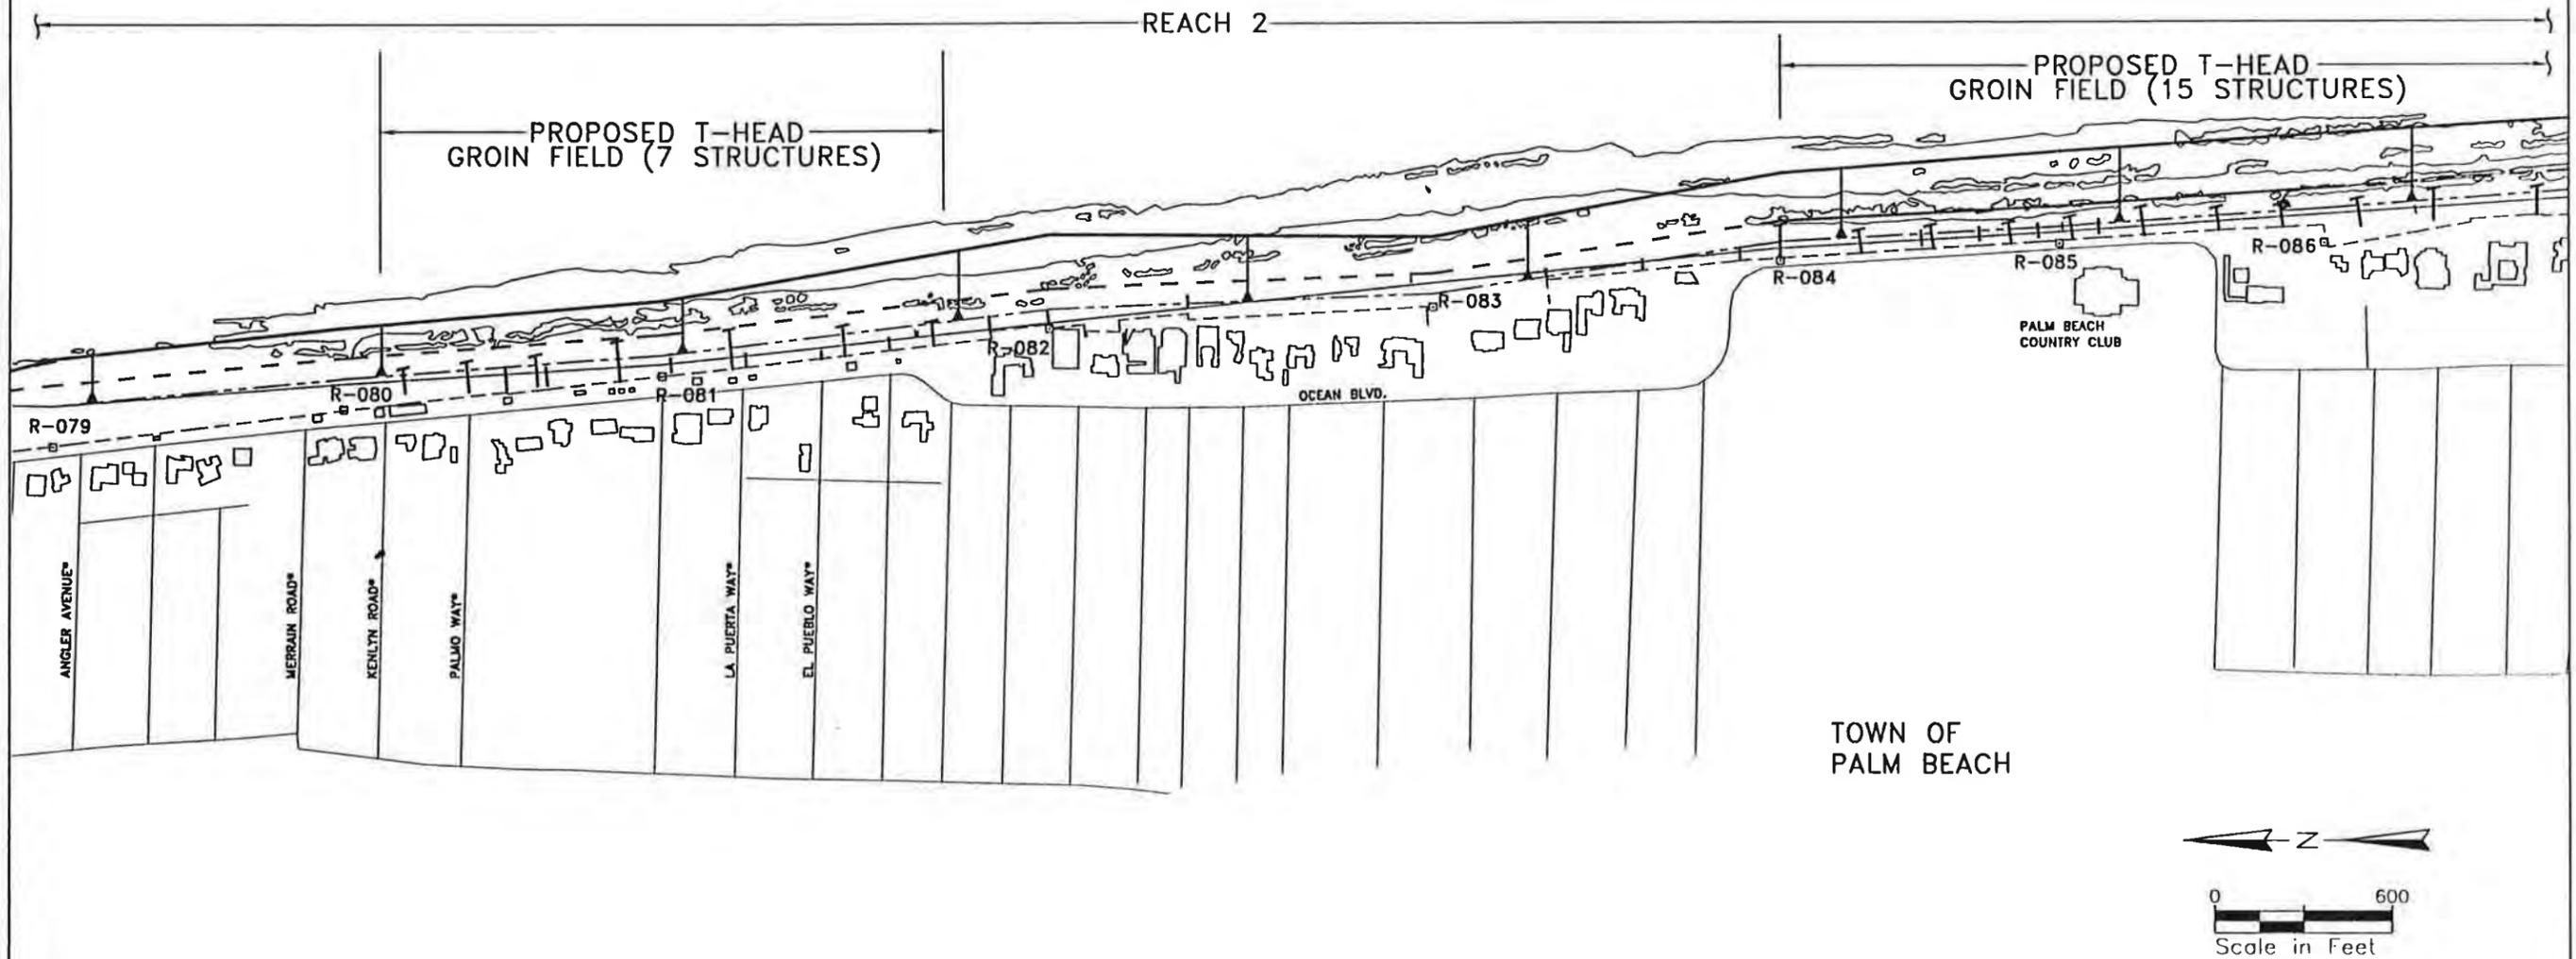
- REPAIR AND MAINTAIN ROADWAY AND PROPERTY PROTECTIVE SEAWALLS AS REQUIRED

FIGURE 7-2
RECOMMENDED ACTIONS FOR SHORELINE REACH 2

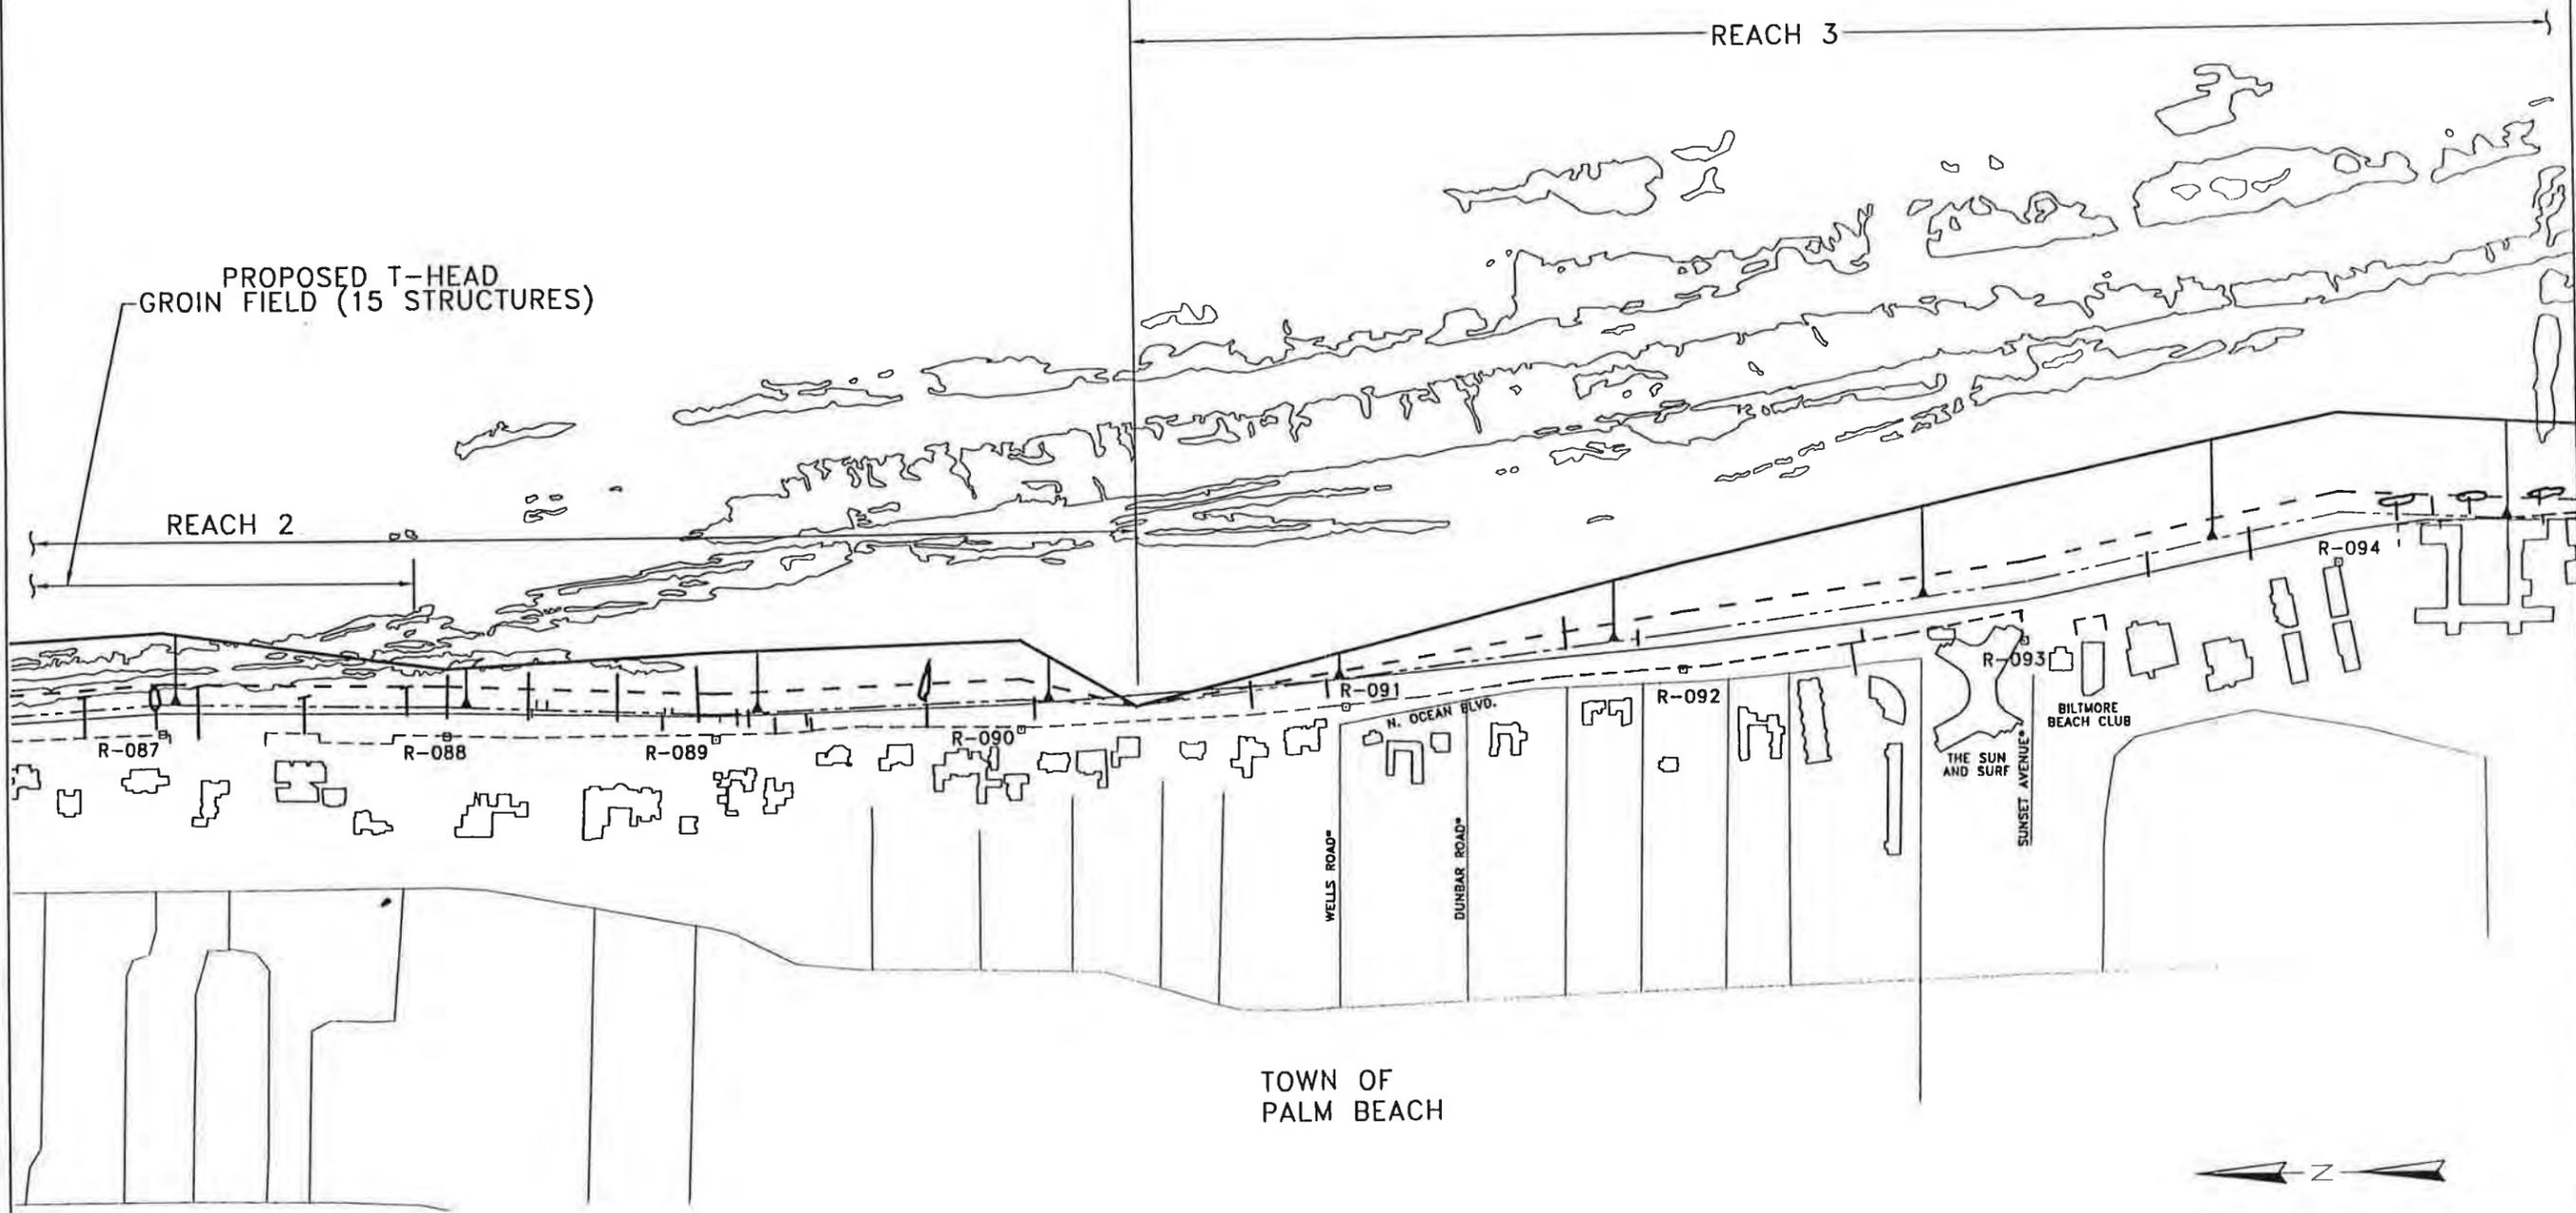
- RESTORE SHORELINE POSITION WITH BEACHFILL TO MODERATE WEAK EROSIONAL TREND IN REACH 3
- REHABILITATE AND MAINTAIN BREAKERS HOTEL AND MID-TOWN GROINS AS REQUIRED
- RENOURISH MID-TOWN TO COMPLY WITH 40% VOLUMETRIC LOSS PROVISION (FROM PROJECT AREA EXTEND MID-TOWN BEACHFILL SOUTH LIMIT 2,800 FT TO REACH BOUNDARY)
- EVALUATE CONDITION OF EXISTING GROINS AND REMOVE DERELICT STRUCTURES/RESTORE FUNCTIONAL GROINS
- MONITOR FILL SPREADING INTO REACHES 2 AND 5
- STRUCTURES (GROINS) NOT NEEDED IN REACH 3 DUE TO HARDBOTTOM 500+ FT FROM 1997 MHWL
- REPAIR AND MAINTAIN ROADWAY AND PROPERTY PROTECTIVE SEAWALLS AS REQUIRED

FIGURE 7-3
 RECOMMENDED ACTIONS FOR SHORELINE REACH 2 (CONTINUED)
 AND REACH 3

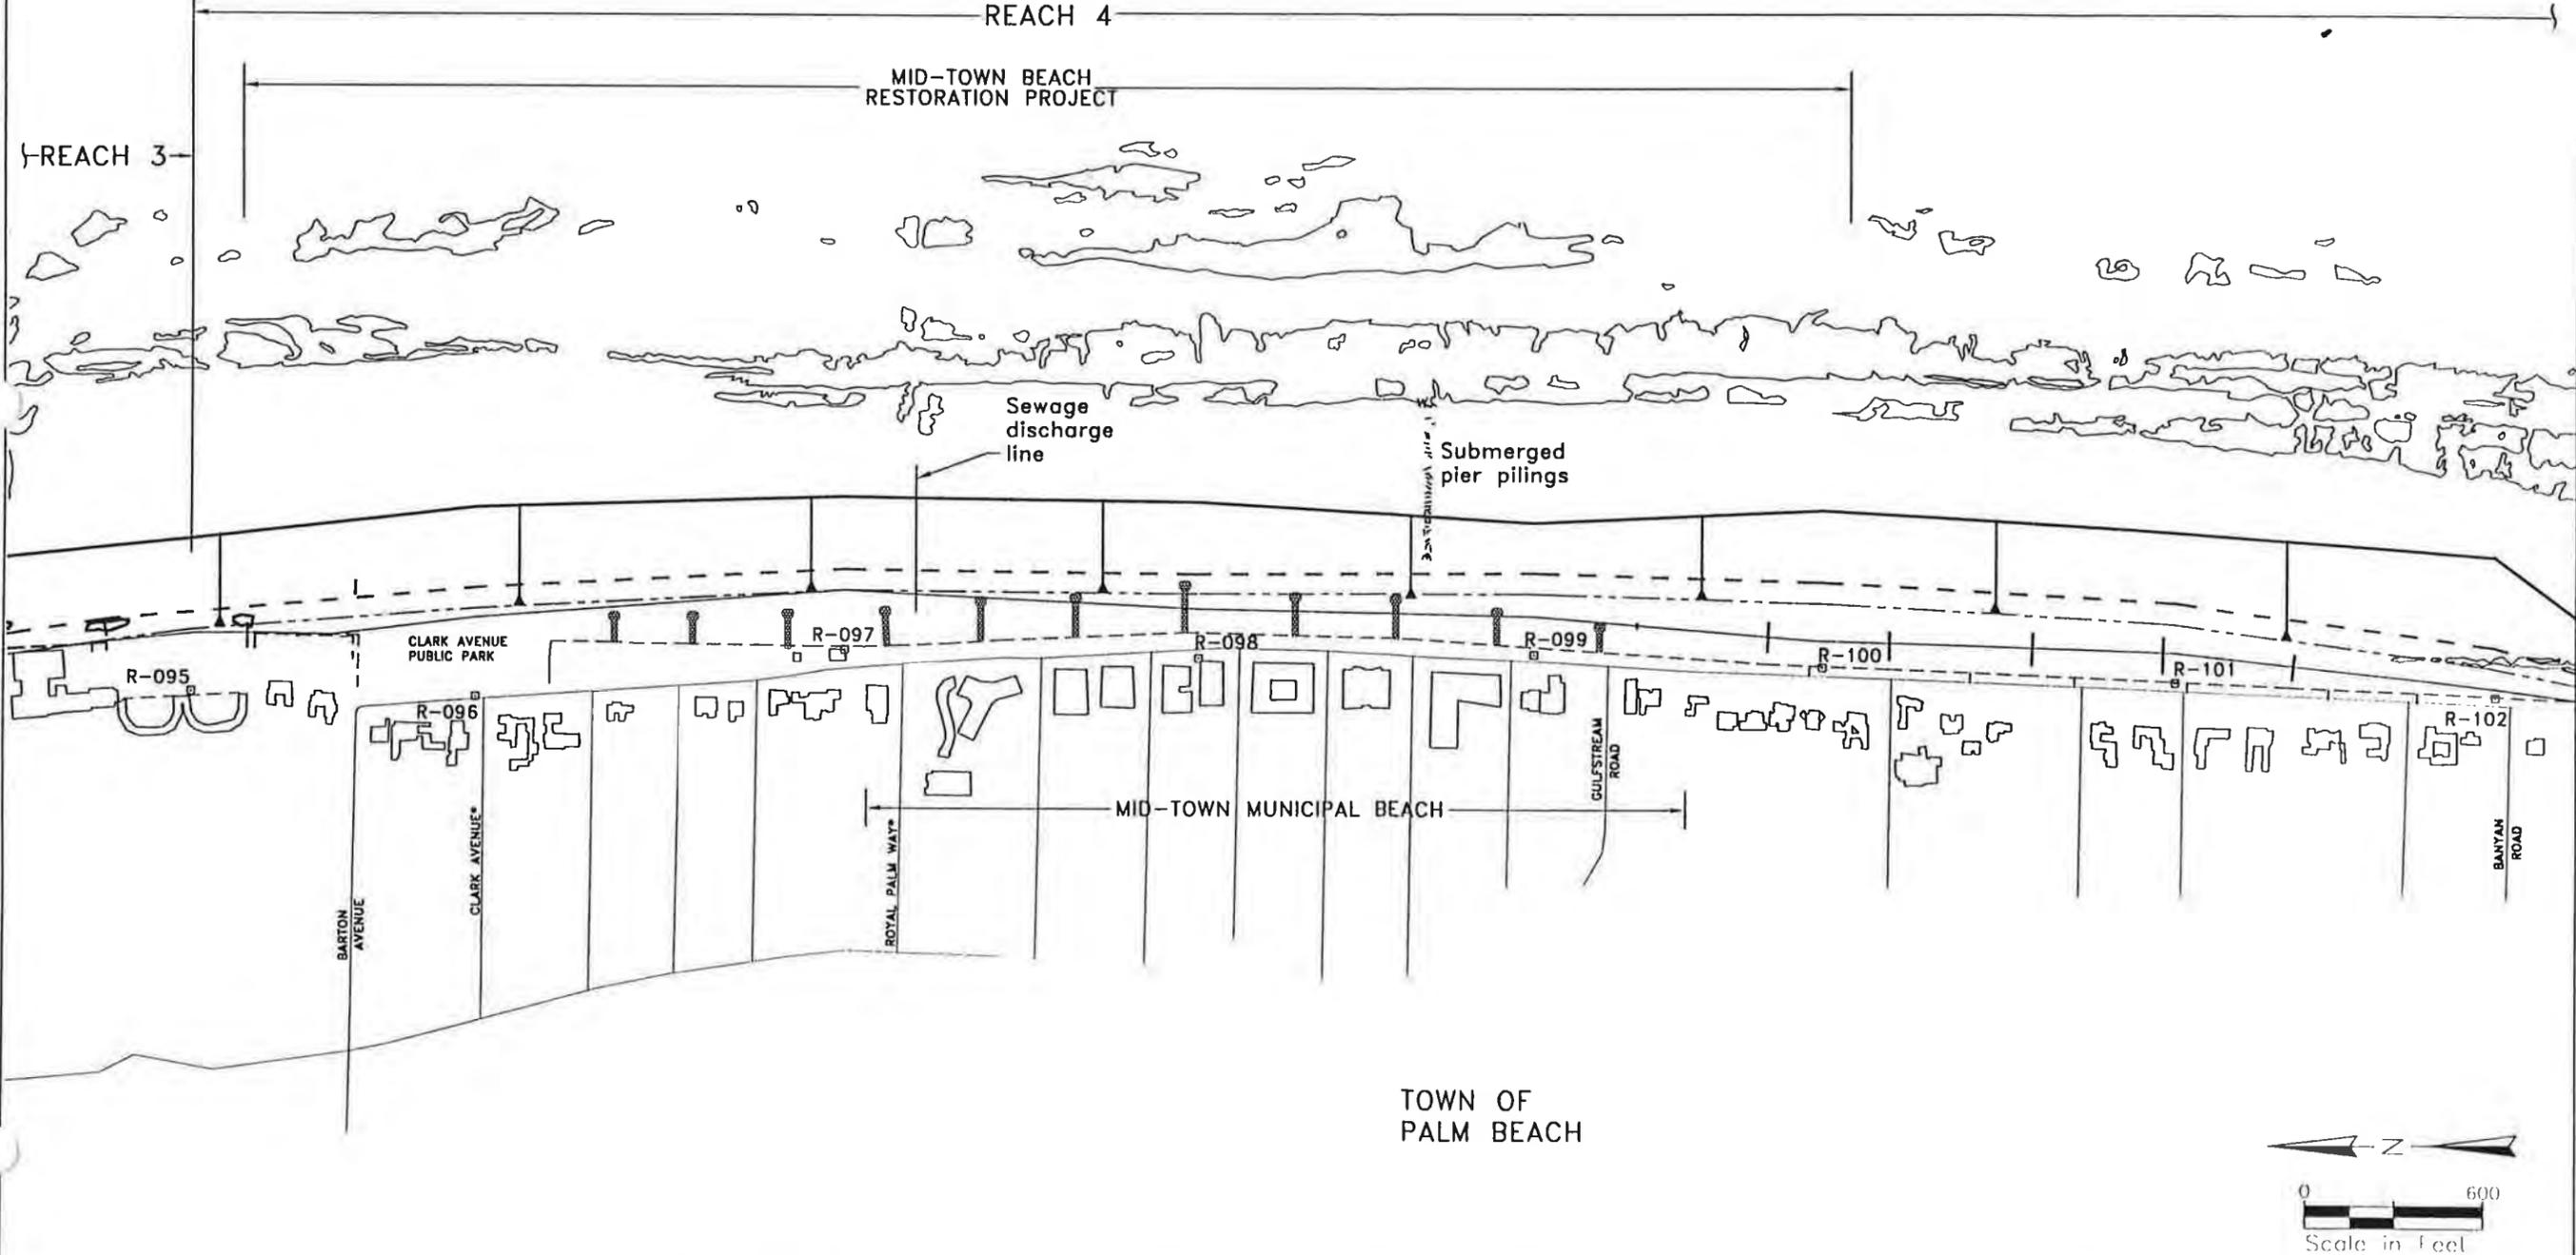
- REHABILITATE AND MAINTAIN BREAKERS HOTEL AND MID-TOWN GROINS AS REQUIRED
- RENOURISH MID-TOWN TO COMPLY WITH 40% VOLUMETRIC LOSS PROVISION (FROM PROJECT AREA EXTEND MID-TOWN BEACHFILL SOUTH LIMIT 2,800 FT TO REACH BOUNDARY)
- EVALUATE CONDITION OF EXISTING GROINS AND REMOVE DERELICT STRUCTURES/RESTORE FUNCTIONAL GROINS
- MONITOR FILL SPREADING INTO REACHES 2 AND 5
- STRUCTURES (GROINS) NOT NEEDED IN REACH 3 DUE TO HARDBOTTOM 500+ FT FROM 1997 MHWL
- REPAIR AND MAINTAIN ROADWAY AND PROPERTY PROTECTIVE SEAWALLS AS REQUIRED

FIGURE 7-4
 RECOMMENDED ACTIONS FOR SHORELINE REACH 4

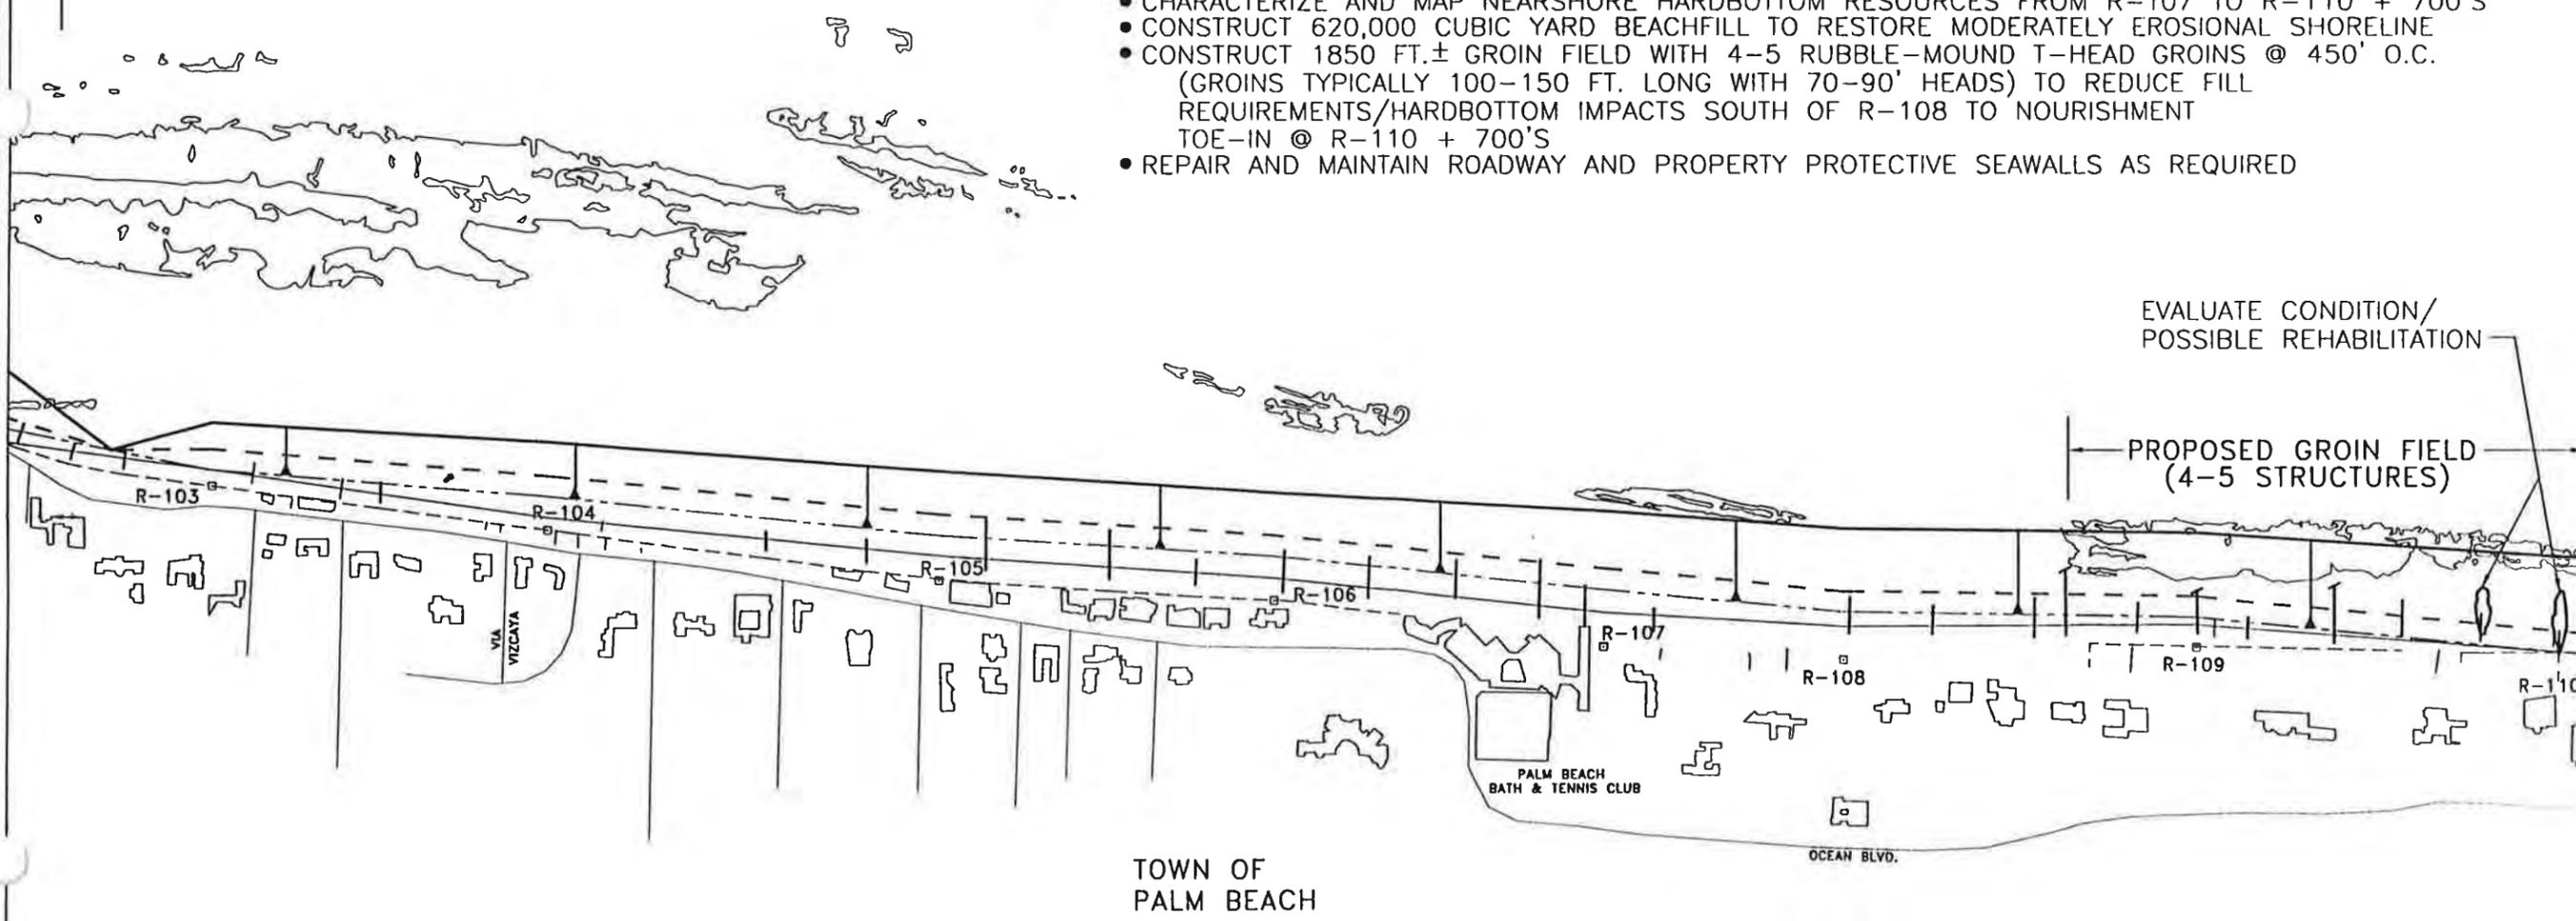
- CHARACTERIZE AND MAP NEARSHORE HARDBOTTOM RESOURCES FROM R-107 TO R-110 + 700'S
- CONSTRUCT 620,000 CUBIC YARD BEACHFILL TO RESTORE MODERATELY EROSIONAL SHORELINE
- CONSTRUCT 1850 FT. ± GROIN FIELD WITH 4-5 RUBBLE-MOUND T-HEAD GROINS @ 450' O.C. (GROINS TYPICALLY 100-150 FT. LONG WITH 70-90' HEADS) TO REDUCE FILL REQUIREMENTS/HARDBOTTOM IMPACTS SOUTH OF R-108 TO NOURISHMENT TOE-IN @ R-110 + 700'S
- REPAIR AND MAINTAIN ROADWAY AND PROPERTY PROTECTIVE SEAWALLS AS REQUIRED

FIGURE 7-5
 RECOMMENDED ACTIONS FOR SHORELINE REACH 5

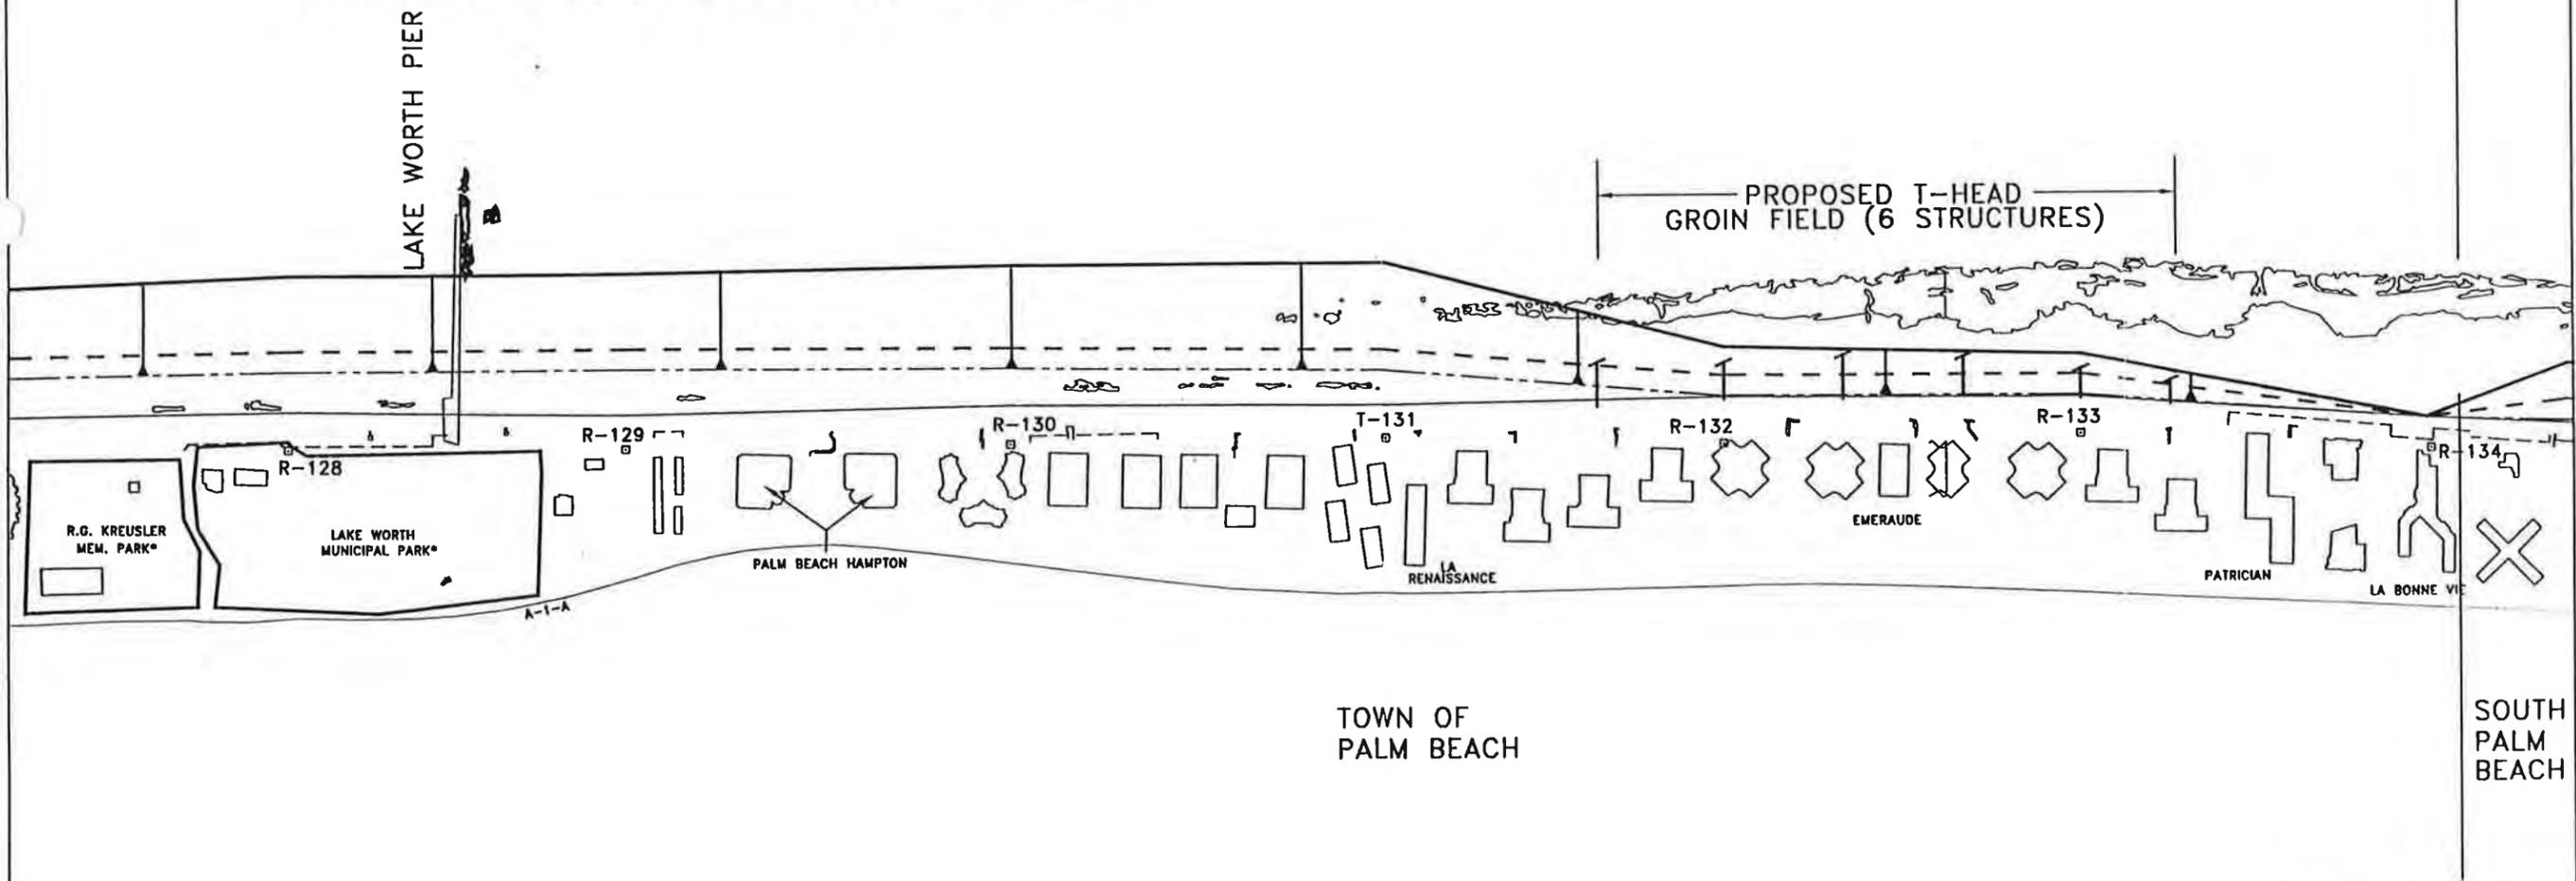
FIGURE 7-8
RECOMMENDED ACTIONS FOR SHORELINE REACH 8

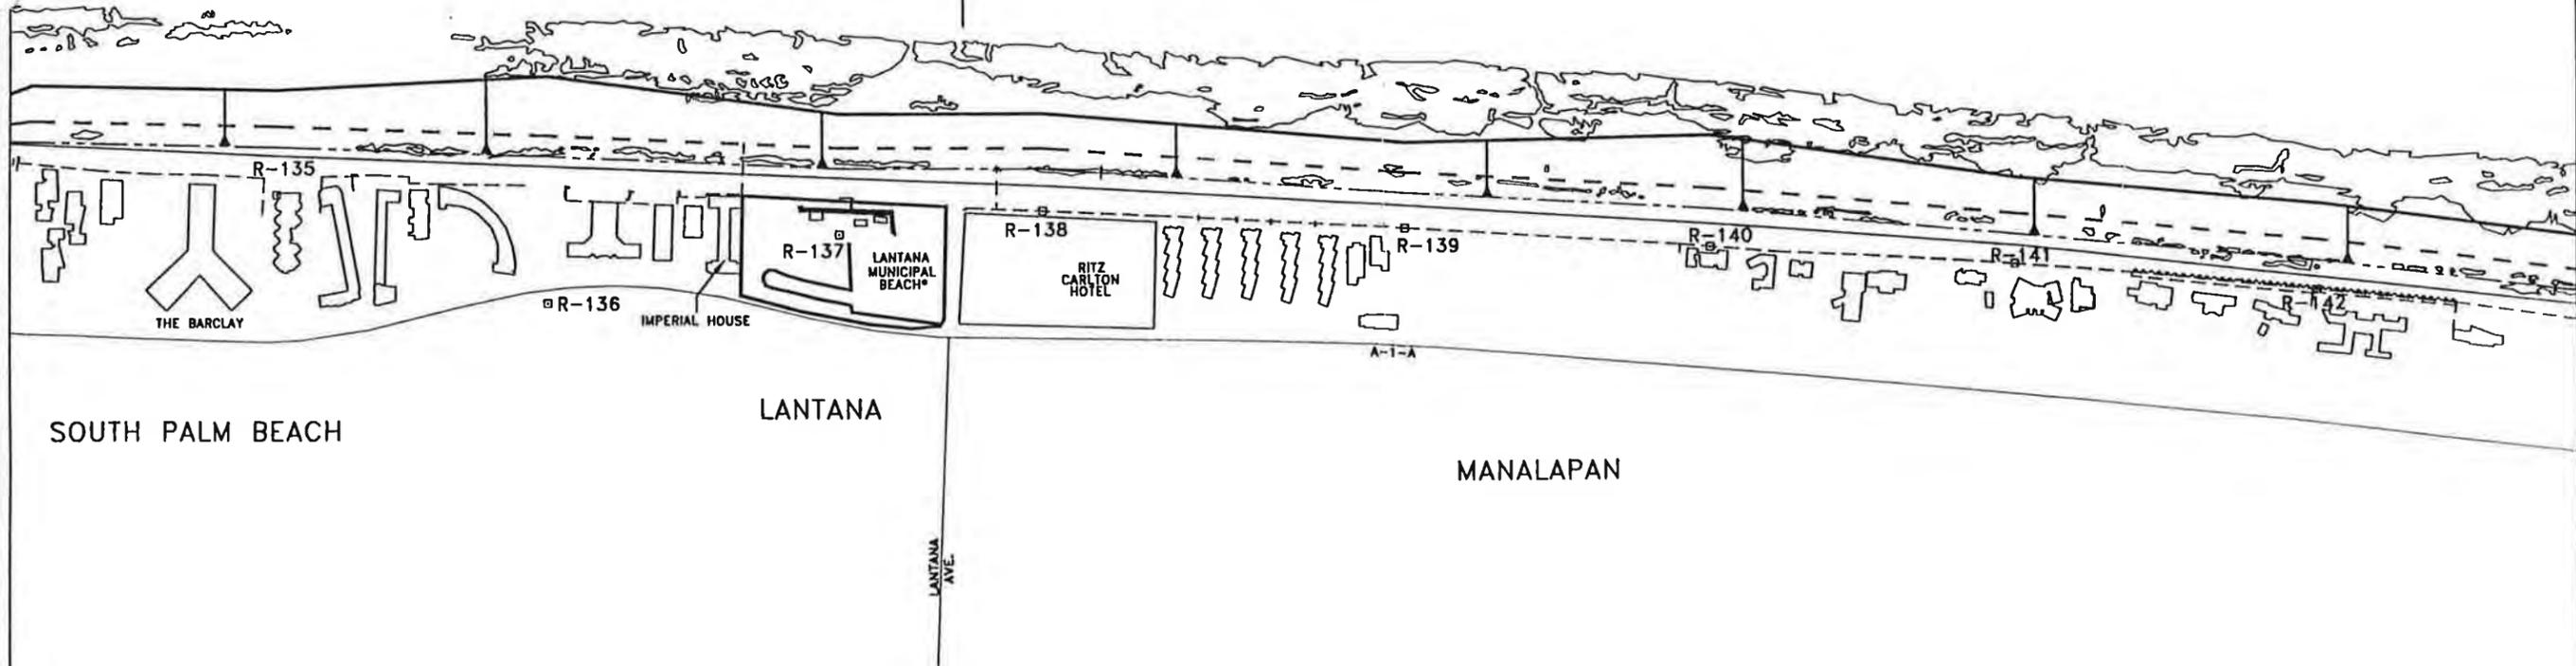
- CHARACTERIZE AND MAP NEARSHORE HARDBOTTOM OVER ENTIRE REACH BOUNDARY TO SUPPLEMENT PBCERM 1993 STUDY
- CONSTRUCT BEACHFILL TO RESTORE MODERATE SHORELINE EROSION LOSSES
- EVALUATE POSSIBLE 6-7 STRUCTURE T-HEAD GROIN FIELD BETWEEN R-141 AND R-142 TO MINIMIZE CROSS-SHORE LOSSES/SECONDARY IMPACTS TO EXISTING NEARSHORE HARDBOTTOM

FIGURE 7-9
 RECOMMENDED ACTIONS FOR SHORELINE REACHES 9 AND 10

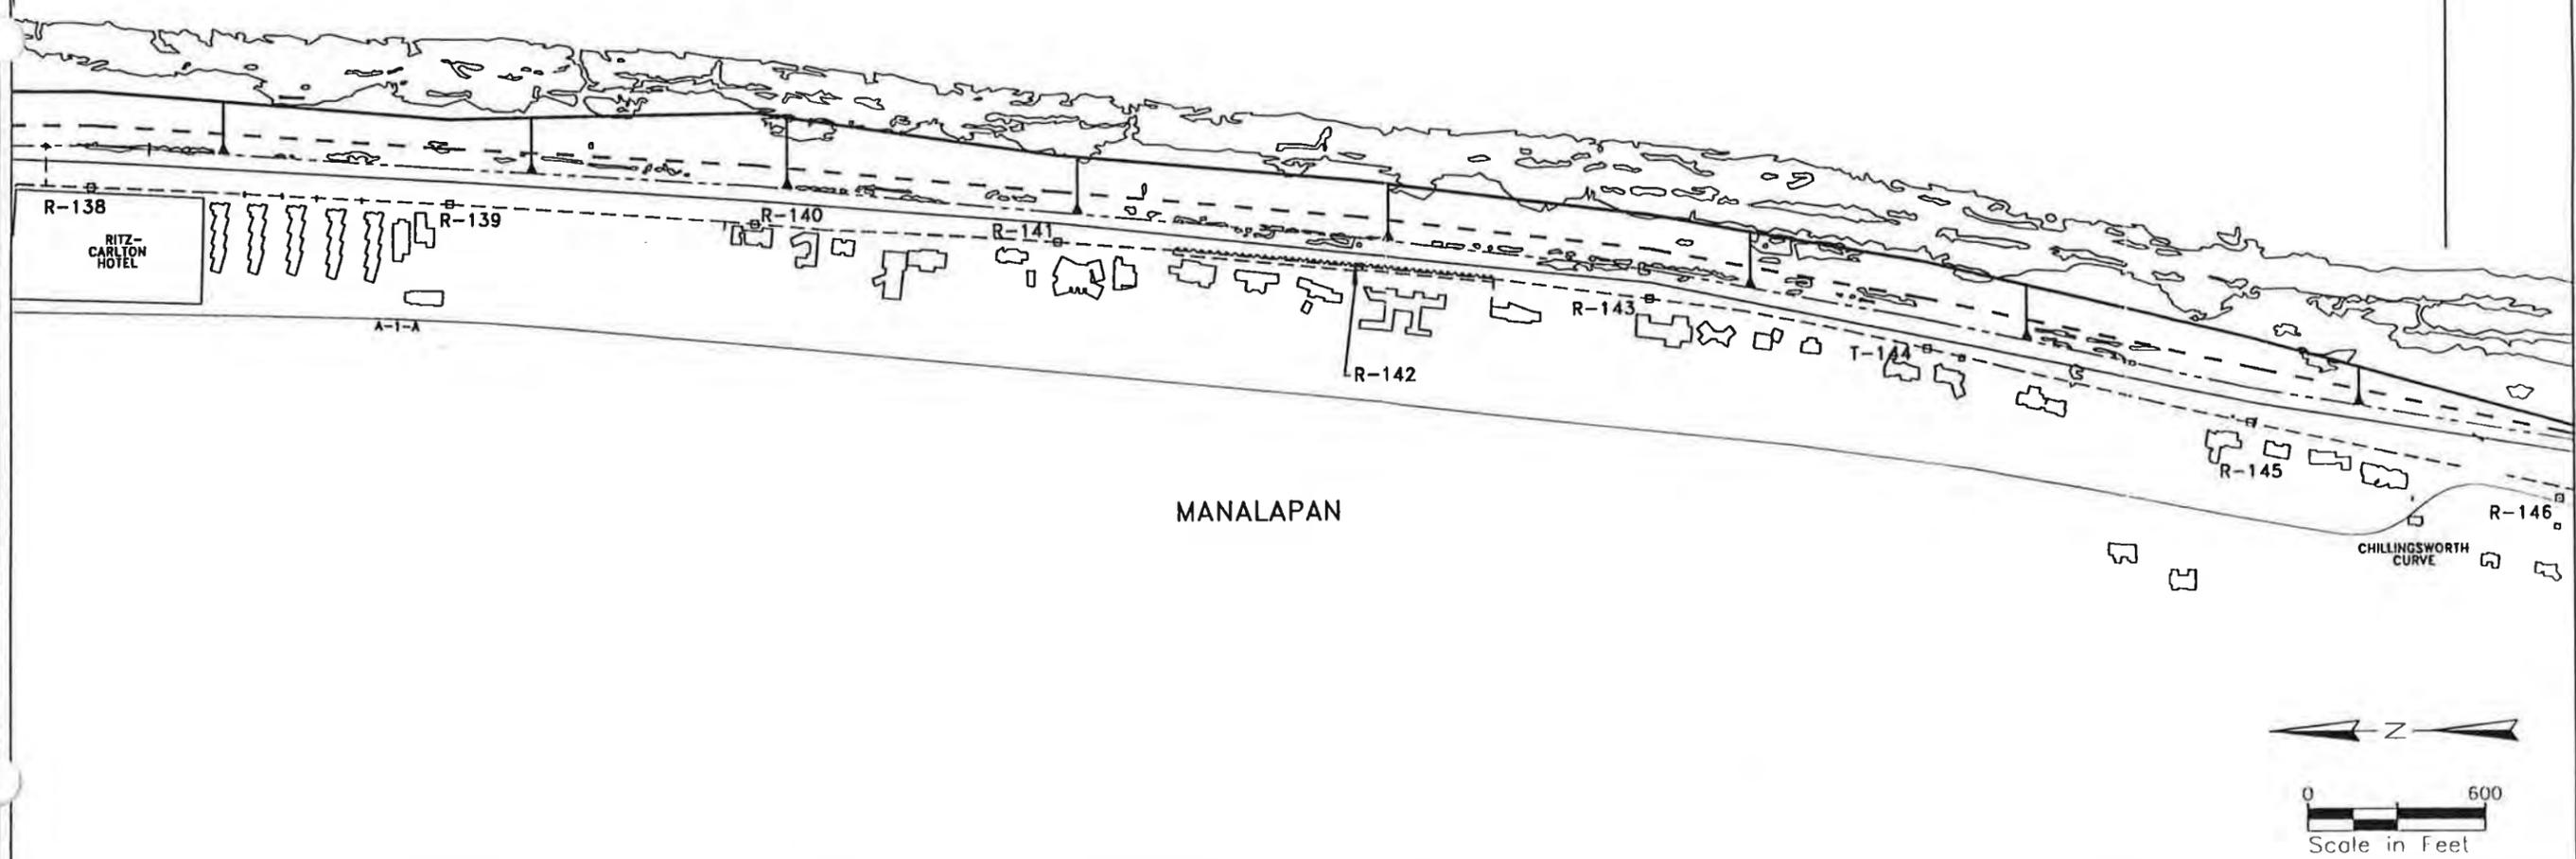
FIGURE 7-10
 RECOMMENDED ACTIONS FOR SHORELINE REACH 10

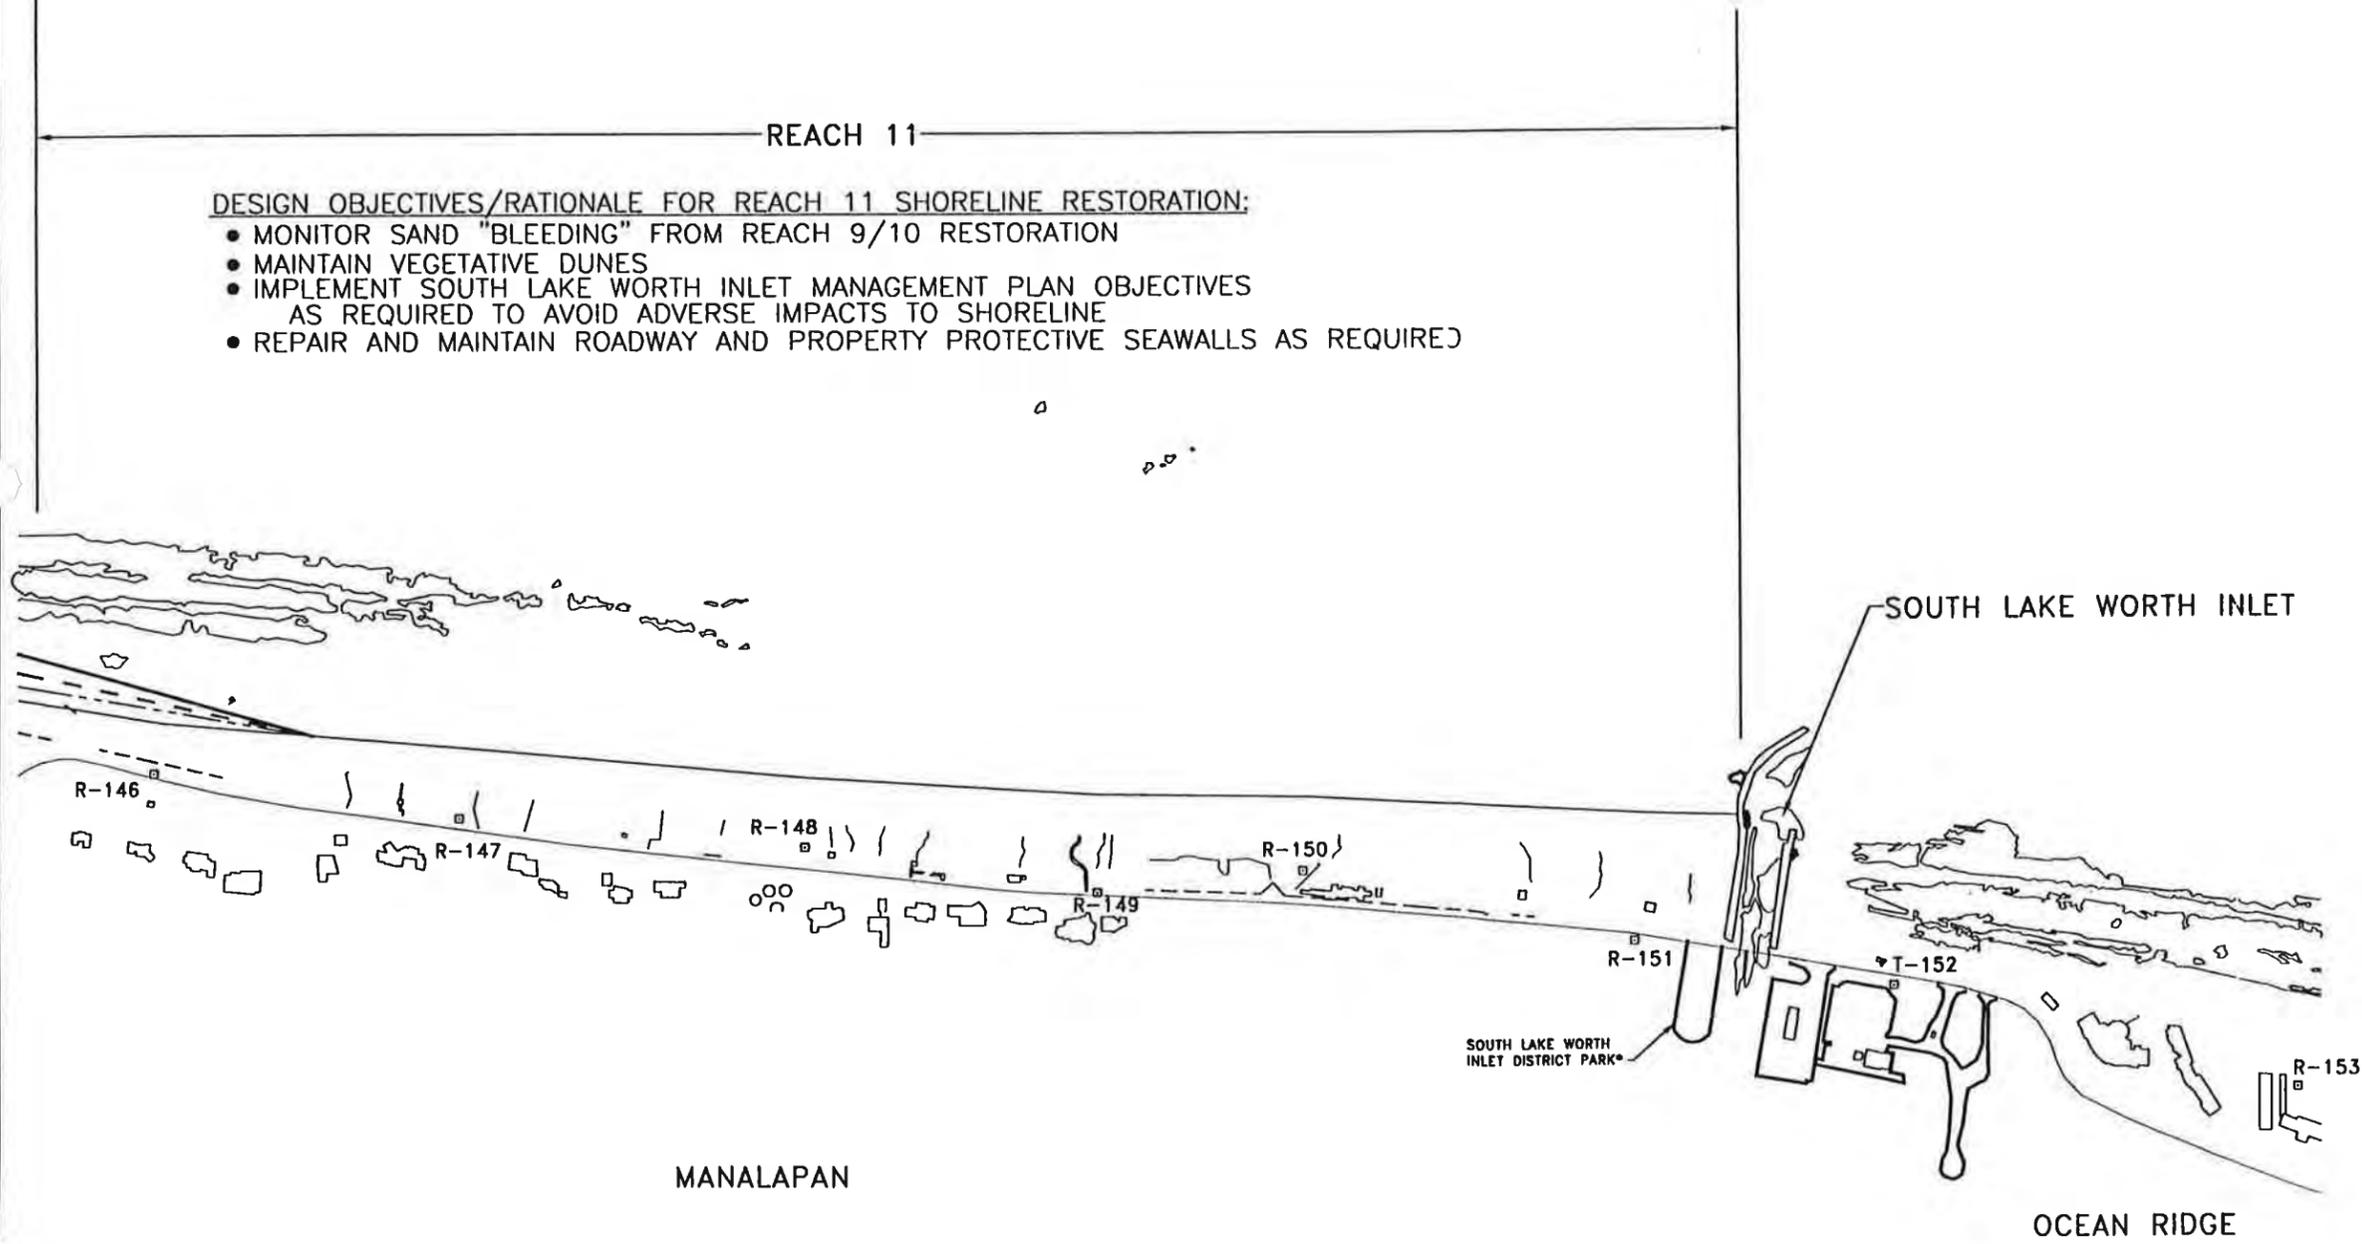
- MONITOR SAND "BLEEDING" FROM REACH 9/10 RESTORATION
- MAINTAIN VEGETATIVE DUNES
- IMPLEMENT SOUTH LAKE WORTH INLET MANAGEMENT PLAN OBJECTIVES AS REQUIRED TO AVOID ADVERSE IMPACTS TO SHORELINE
- REPAIR AND MAINTAIN ROADWAY AND PROPERTY PROTECTIVE SEAWALLS AS REQUIRED

FIGURE 7-11
RECOMMENDED ACTIONS FOR SHORELINE REACH 11
