Comprehensive Coastal Management Plan Update

Palm Beach Island, Florida

June 1998

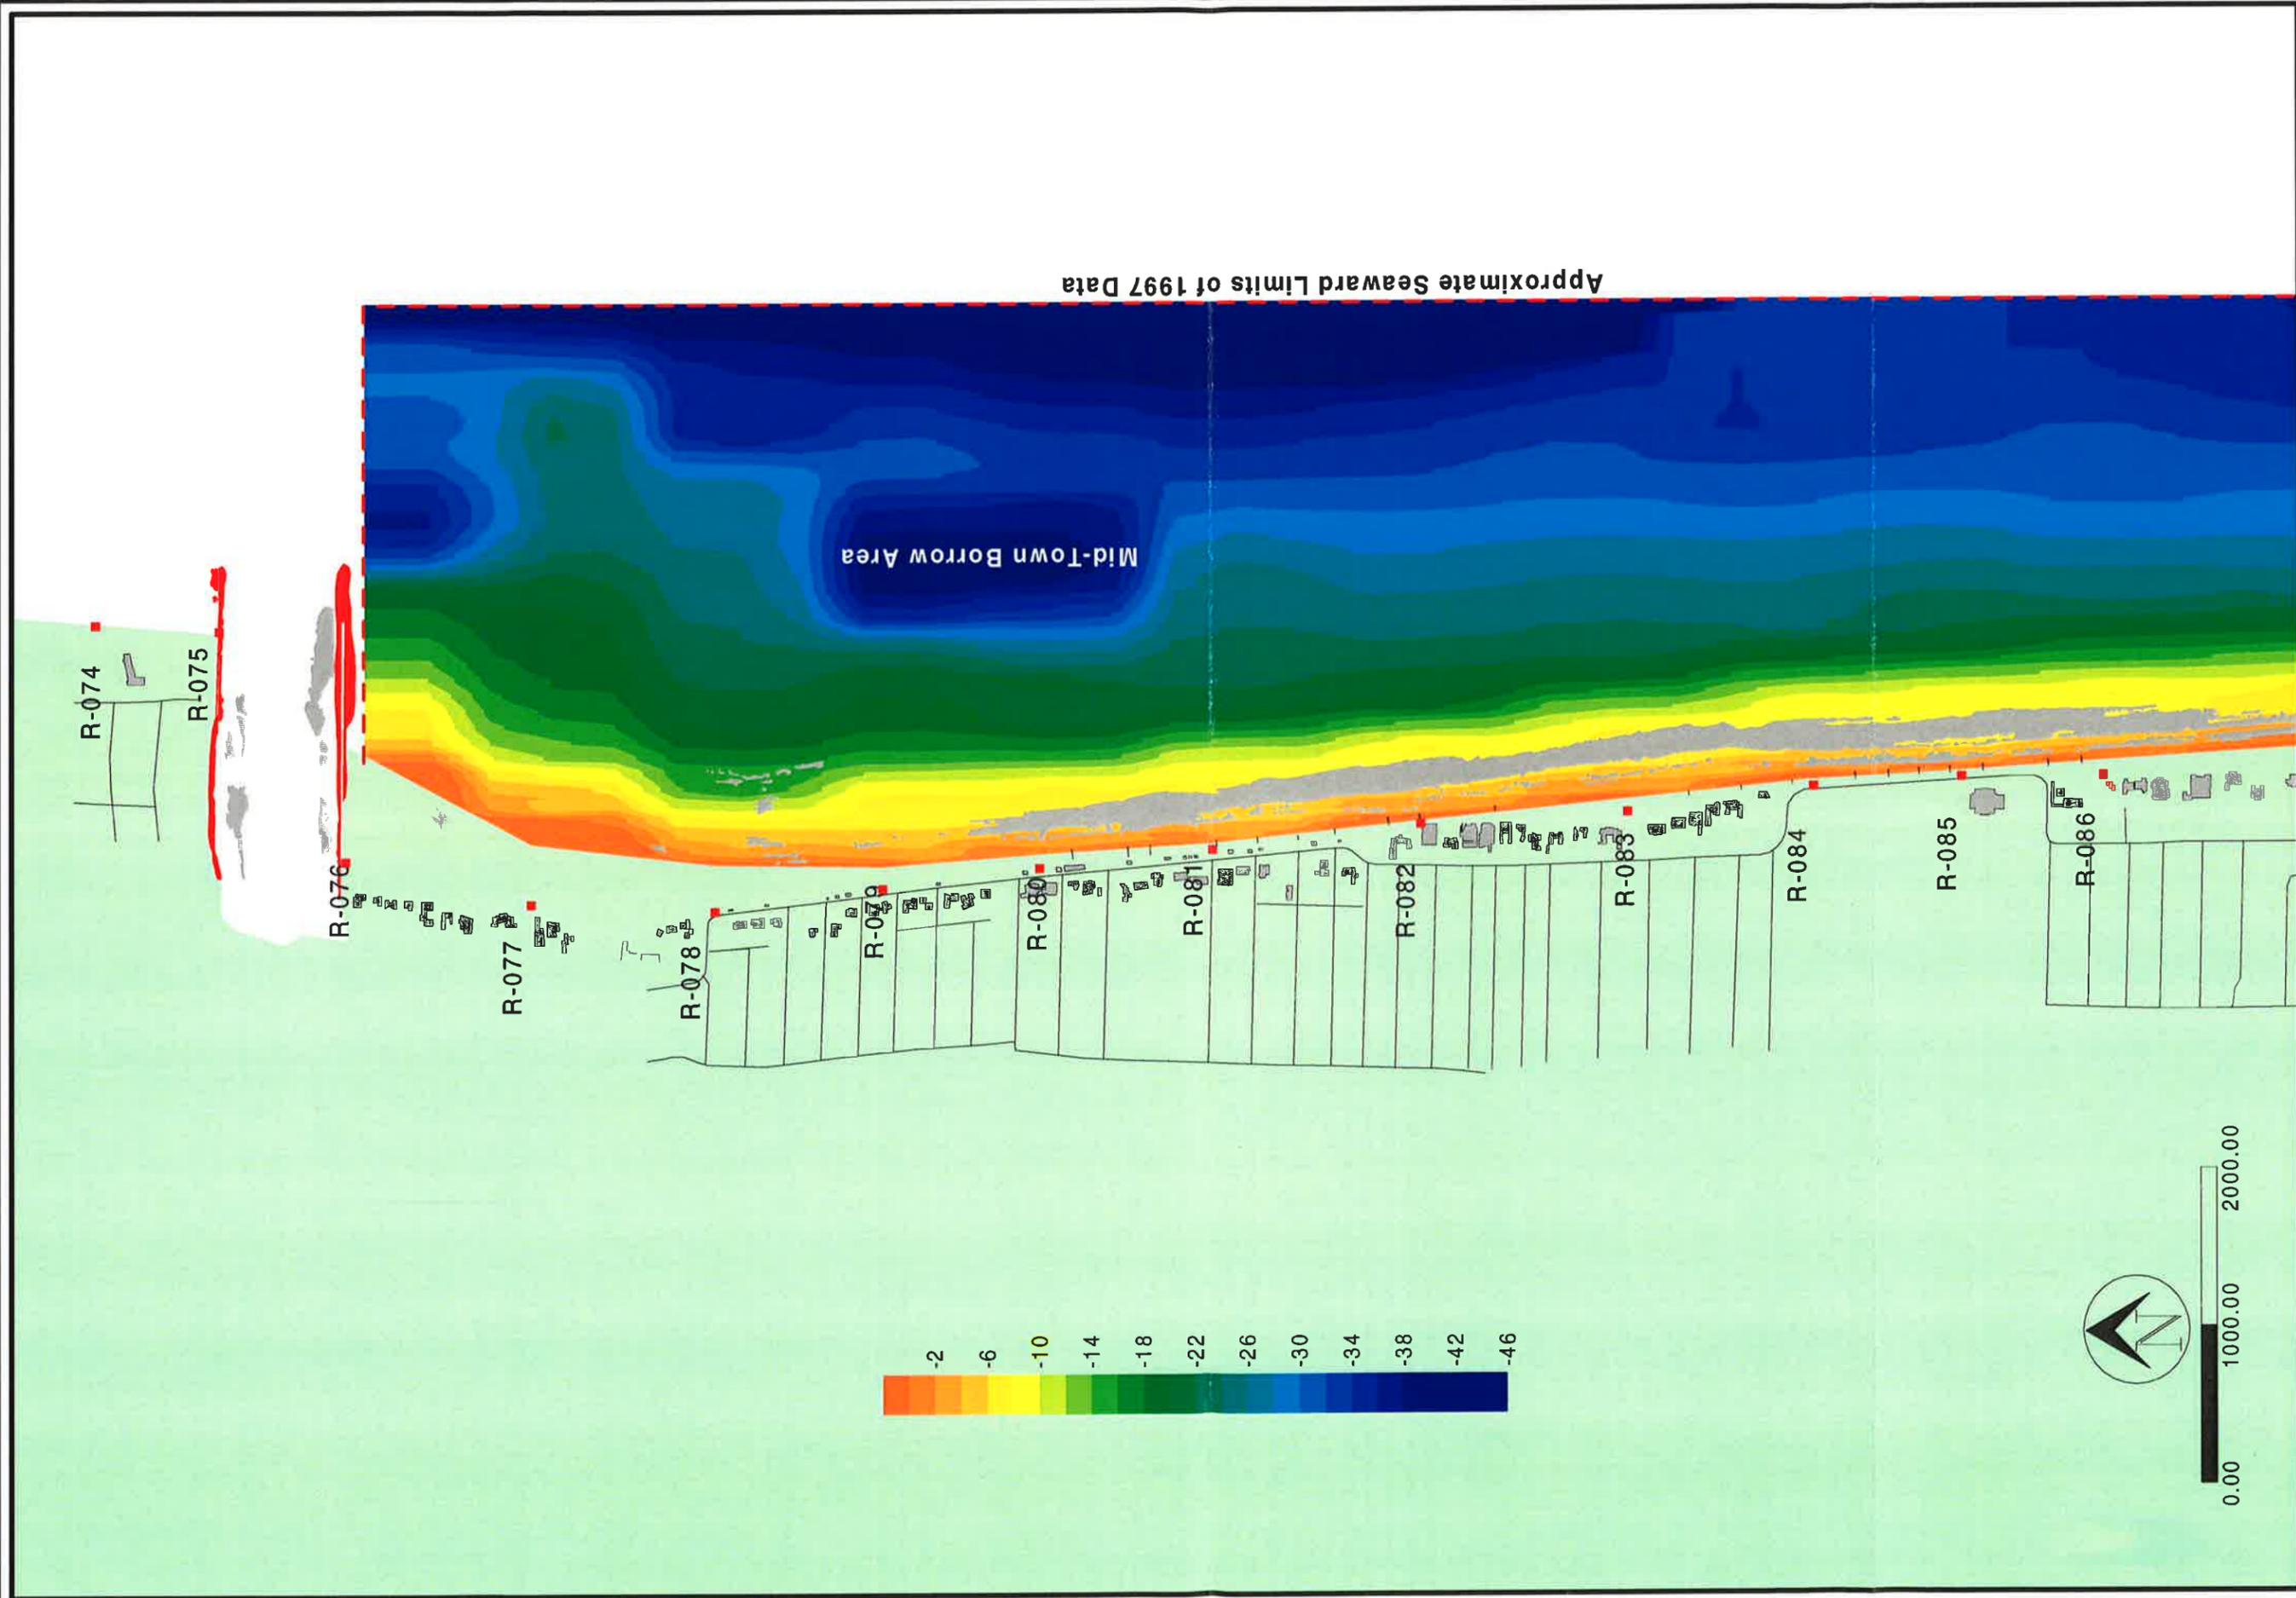
Figure 1
Palm Beach Island Bathymetry (April/May 1997)

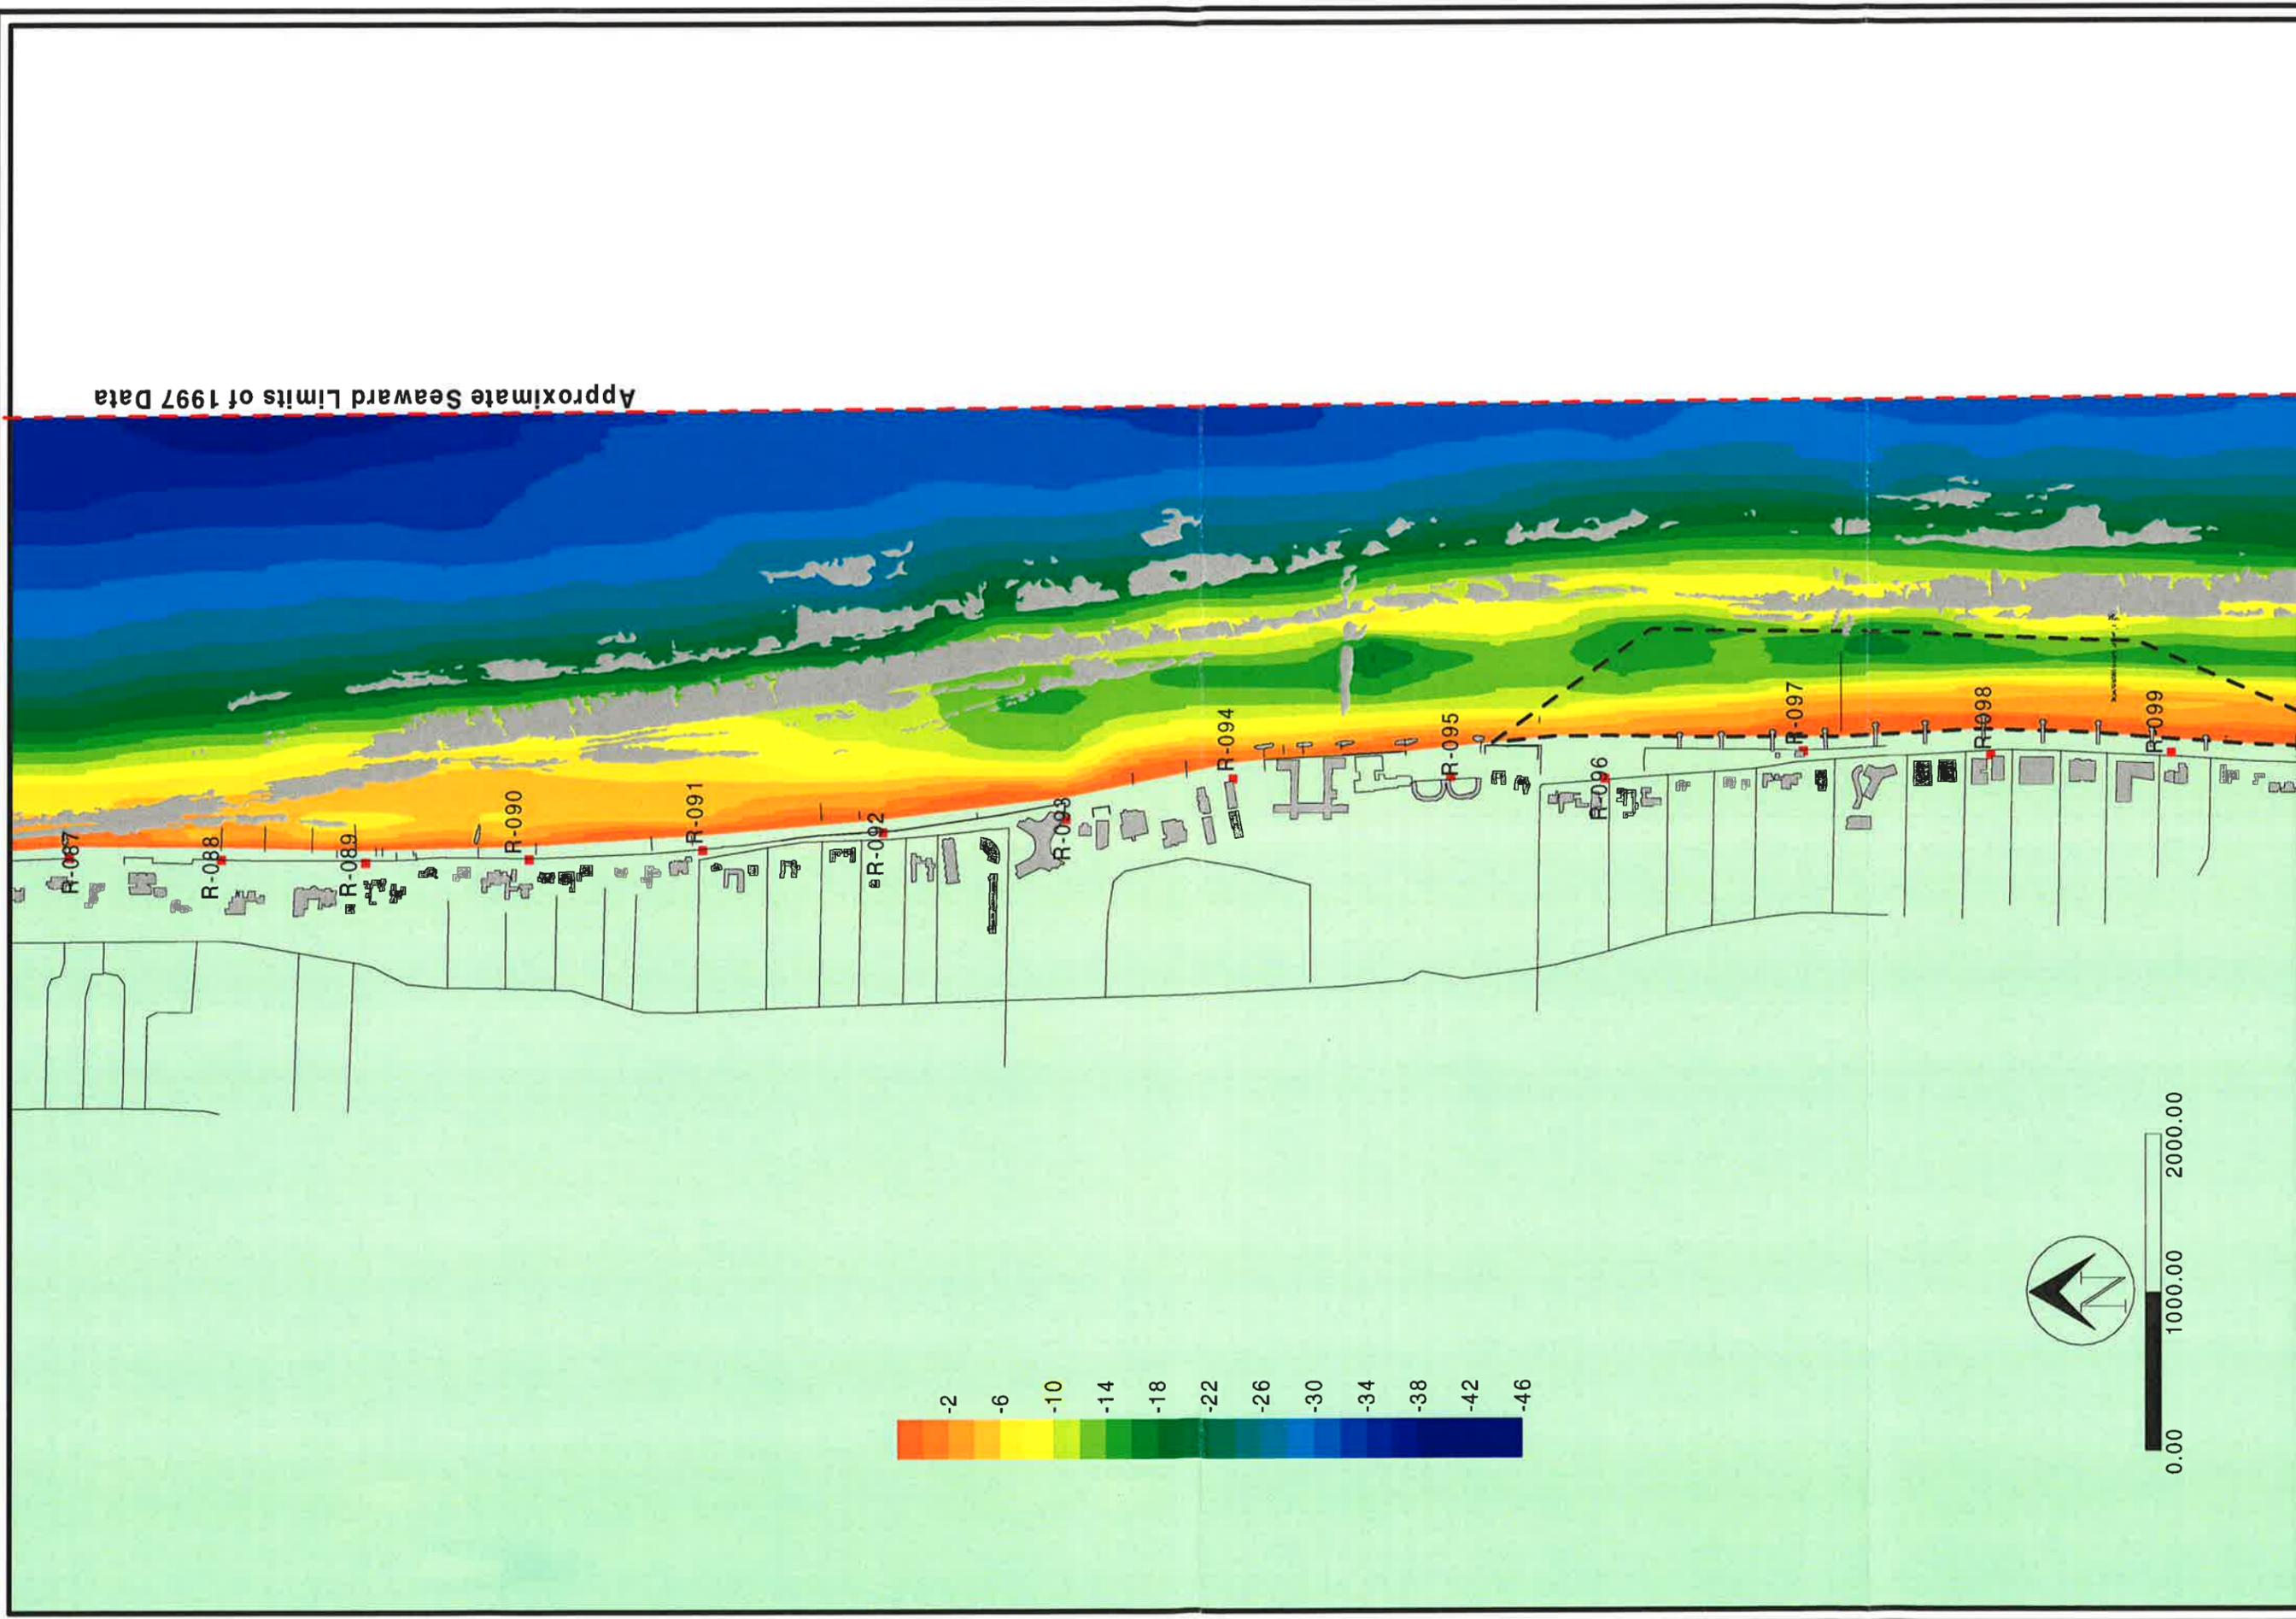
Figure 2
Palm Beach Island Bathymetry (April/May 1997)

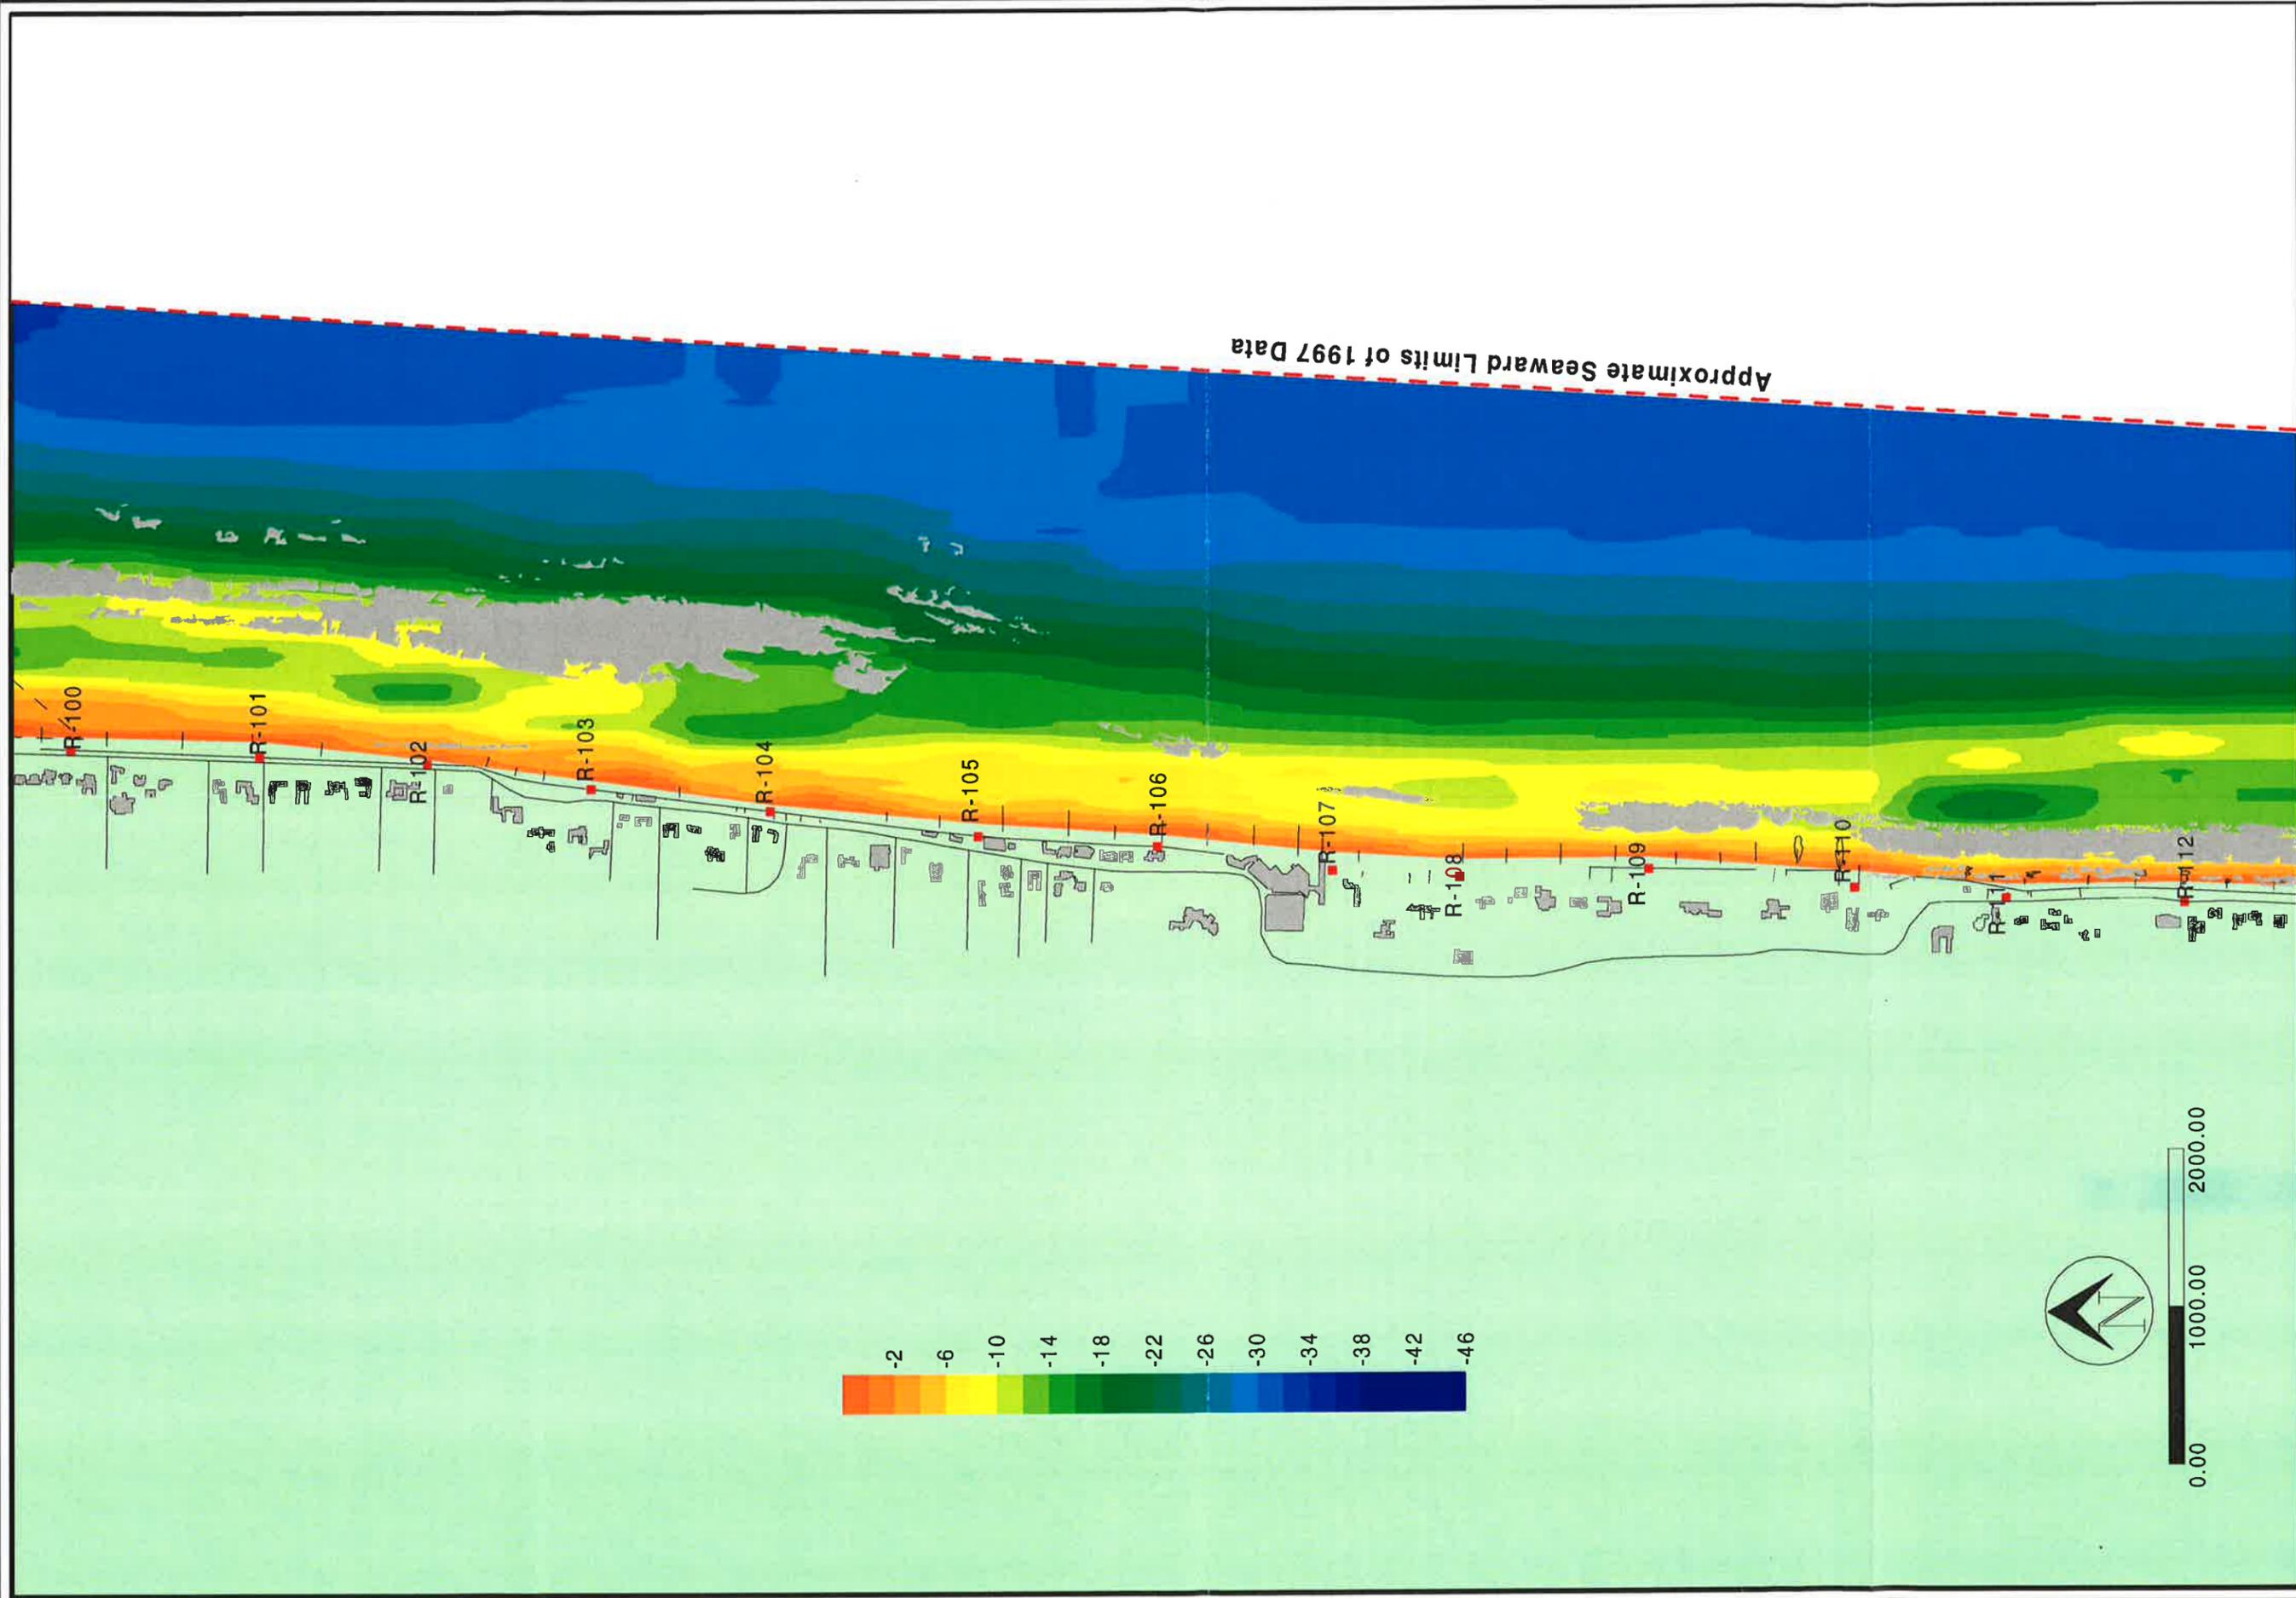
Figure 3
Palm Beach Island Bathymetry (April/May 1997)

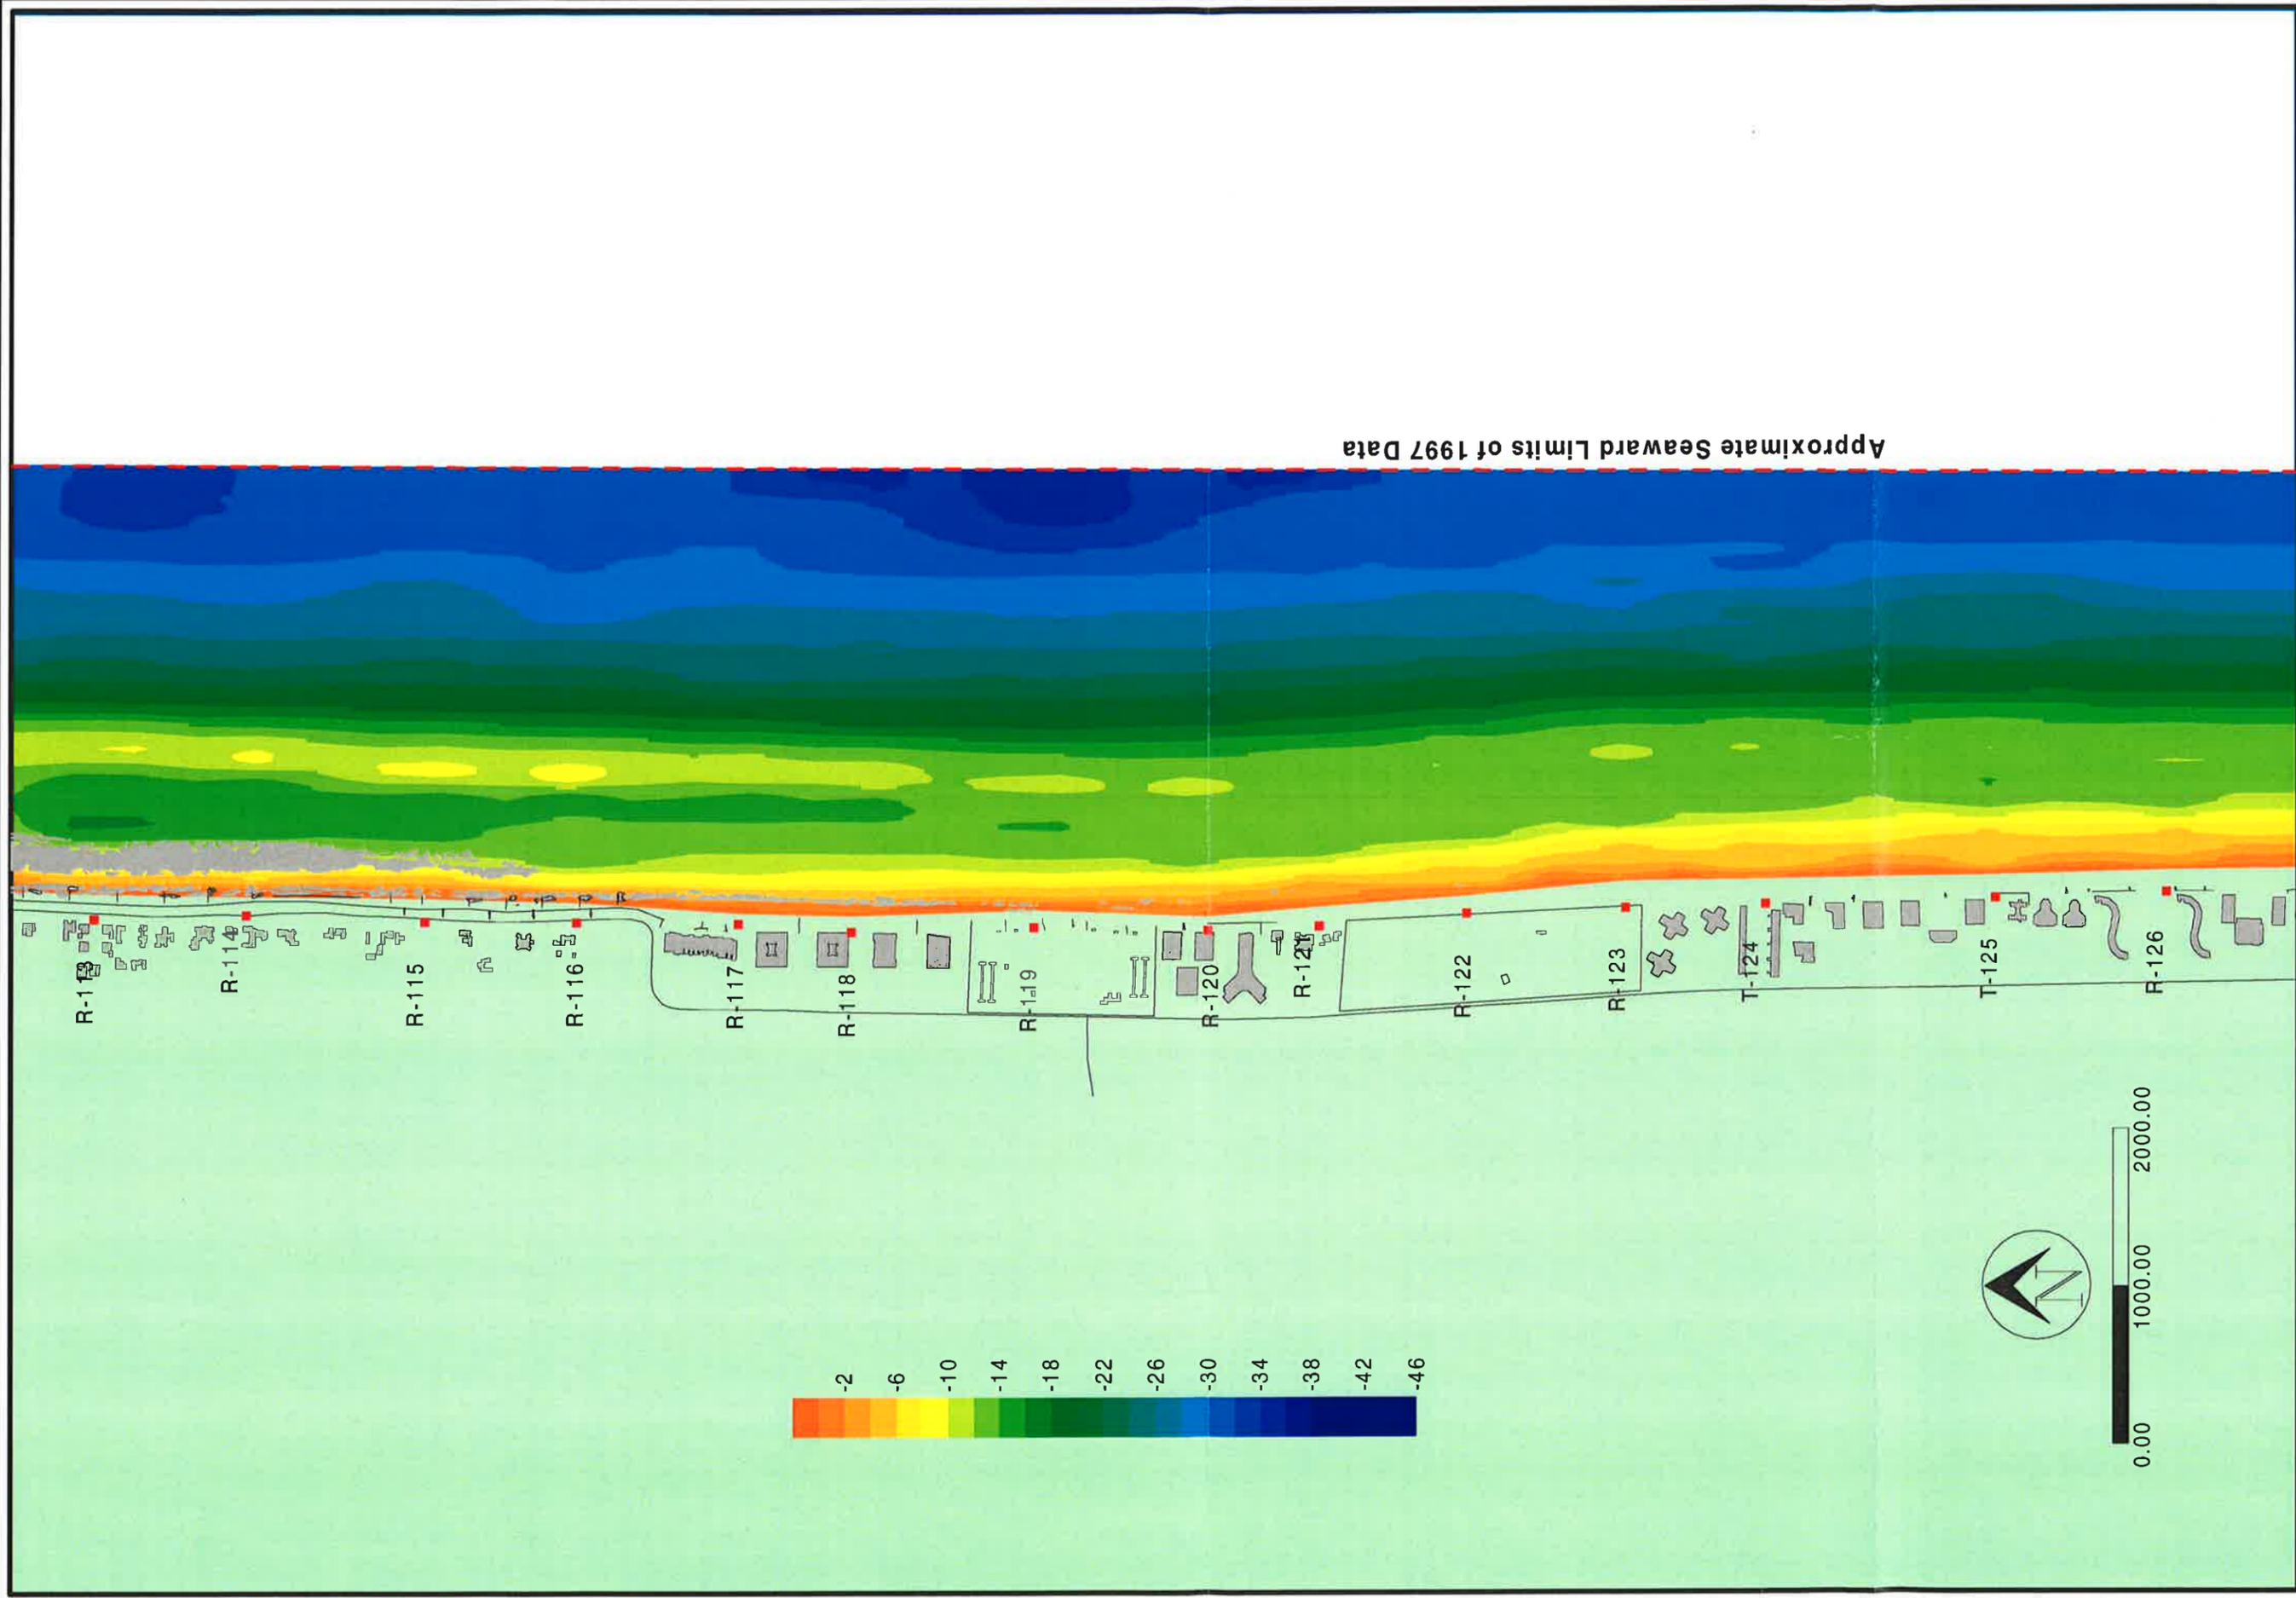
Figure 4
Palm Beach Island Bathymetry (April/May 1997)

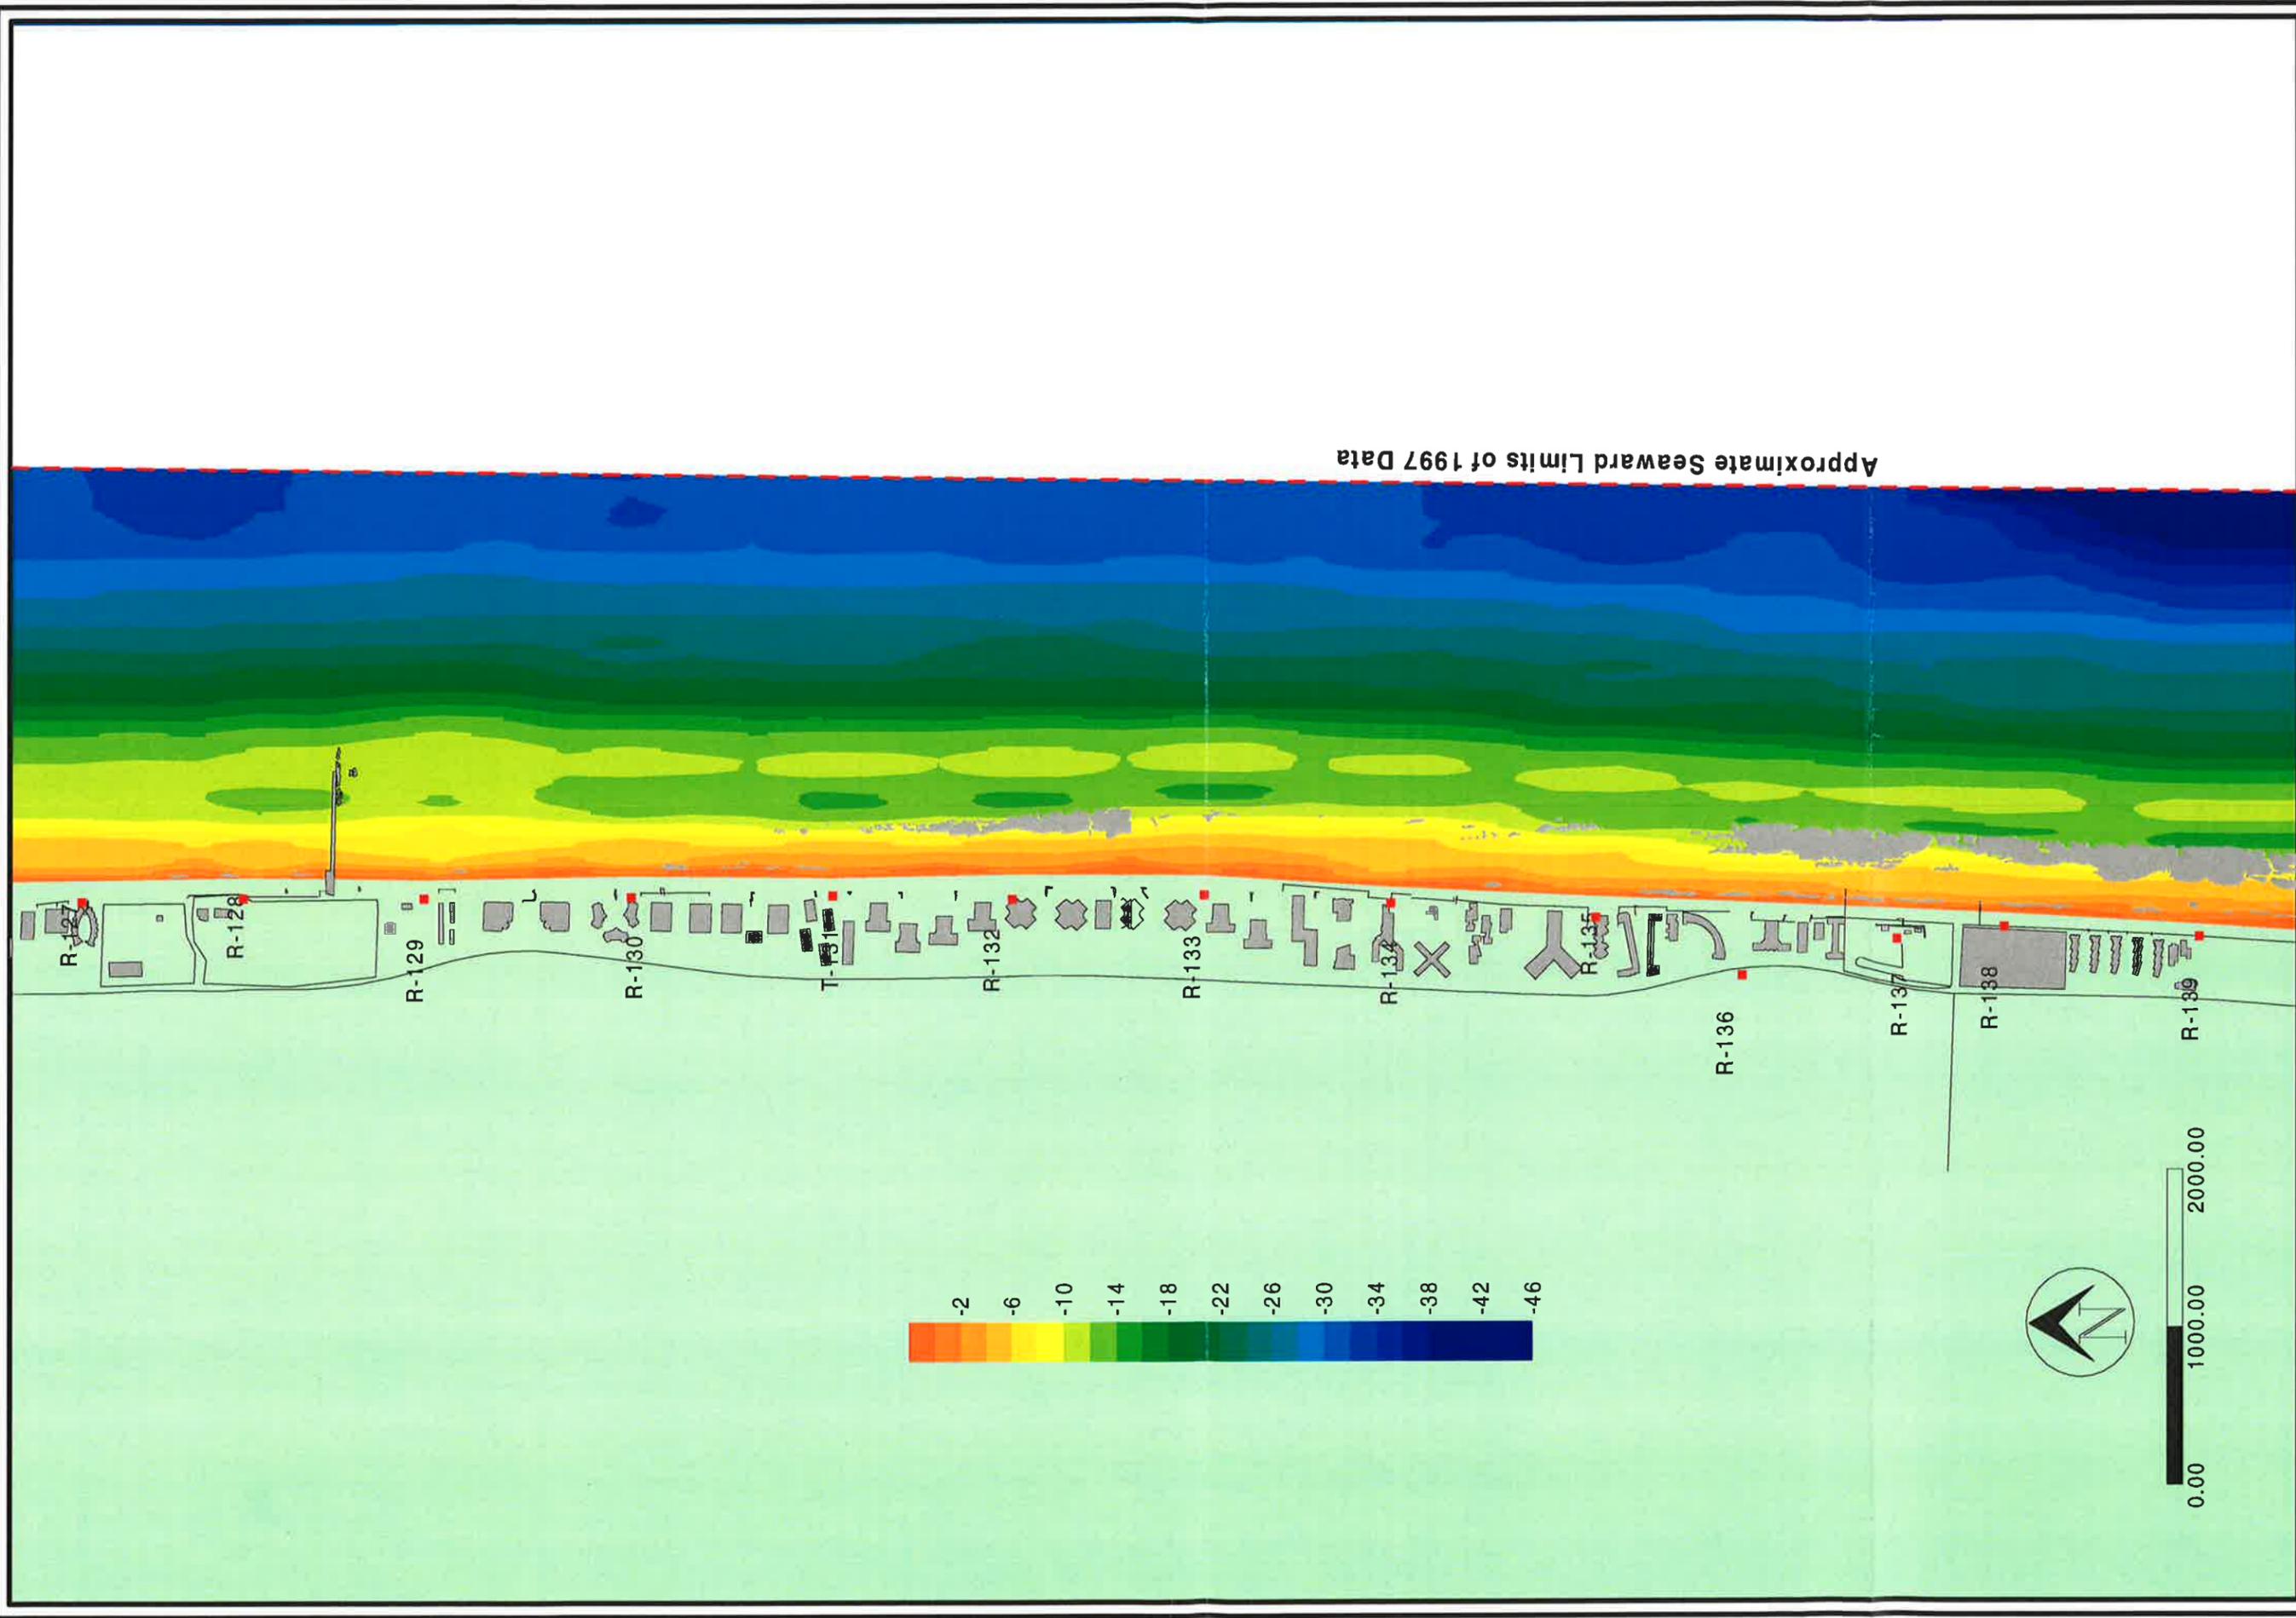
Figure 5
Palm Beach Island Bathymetry (April/May 1997)

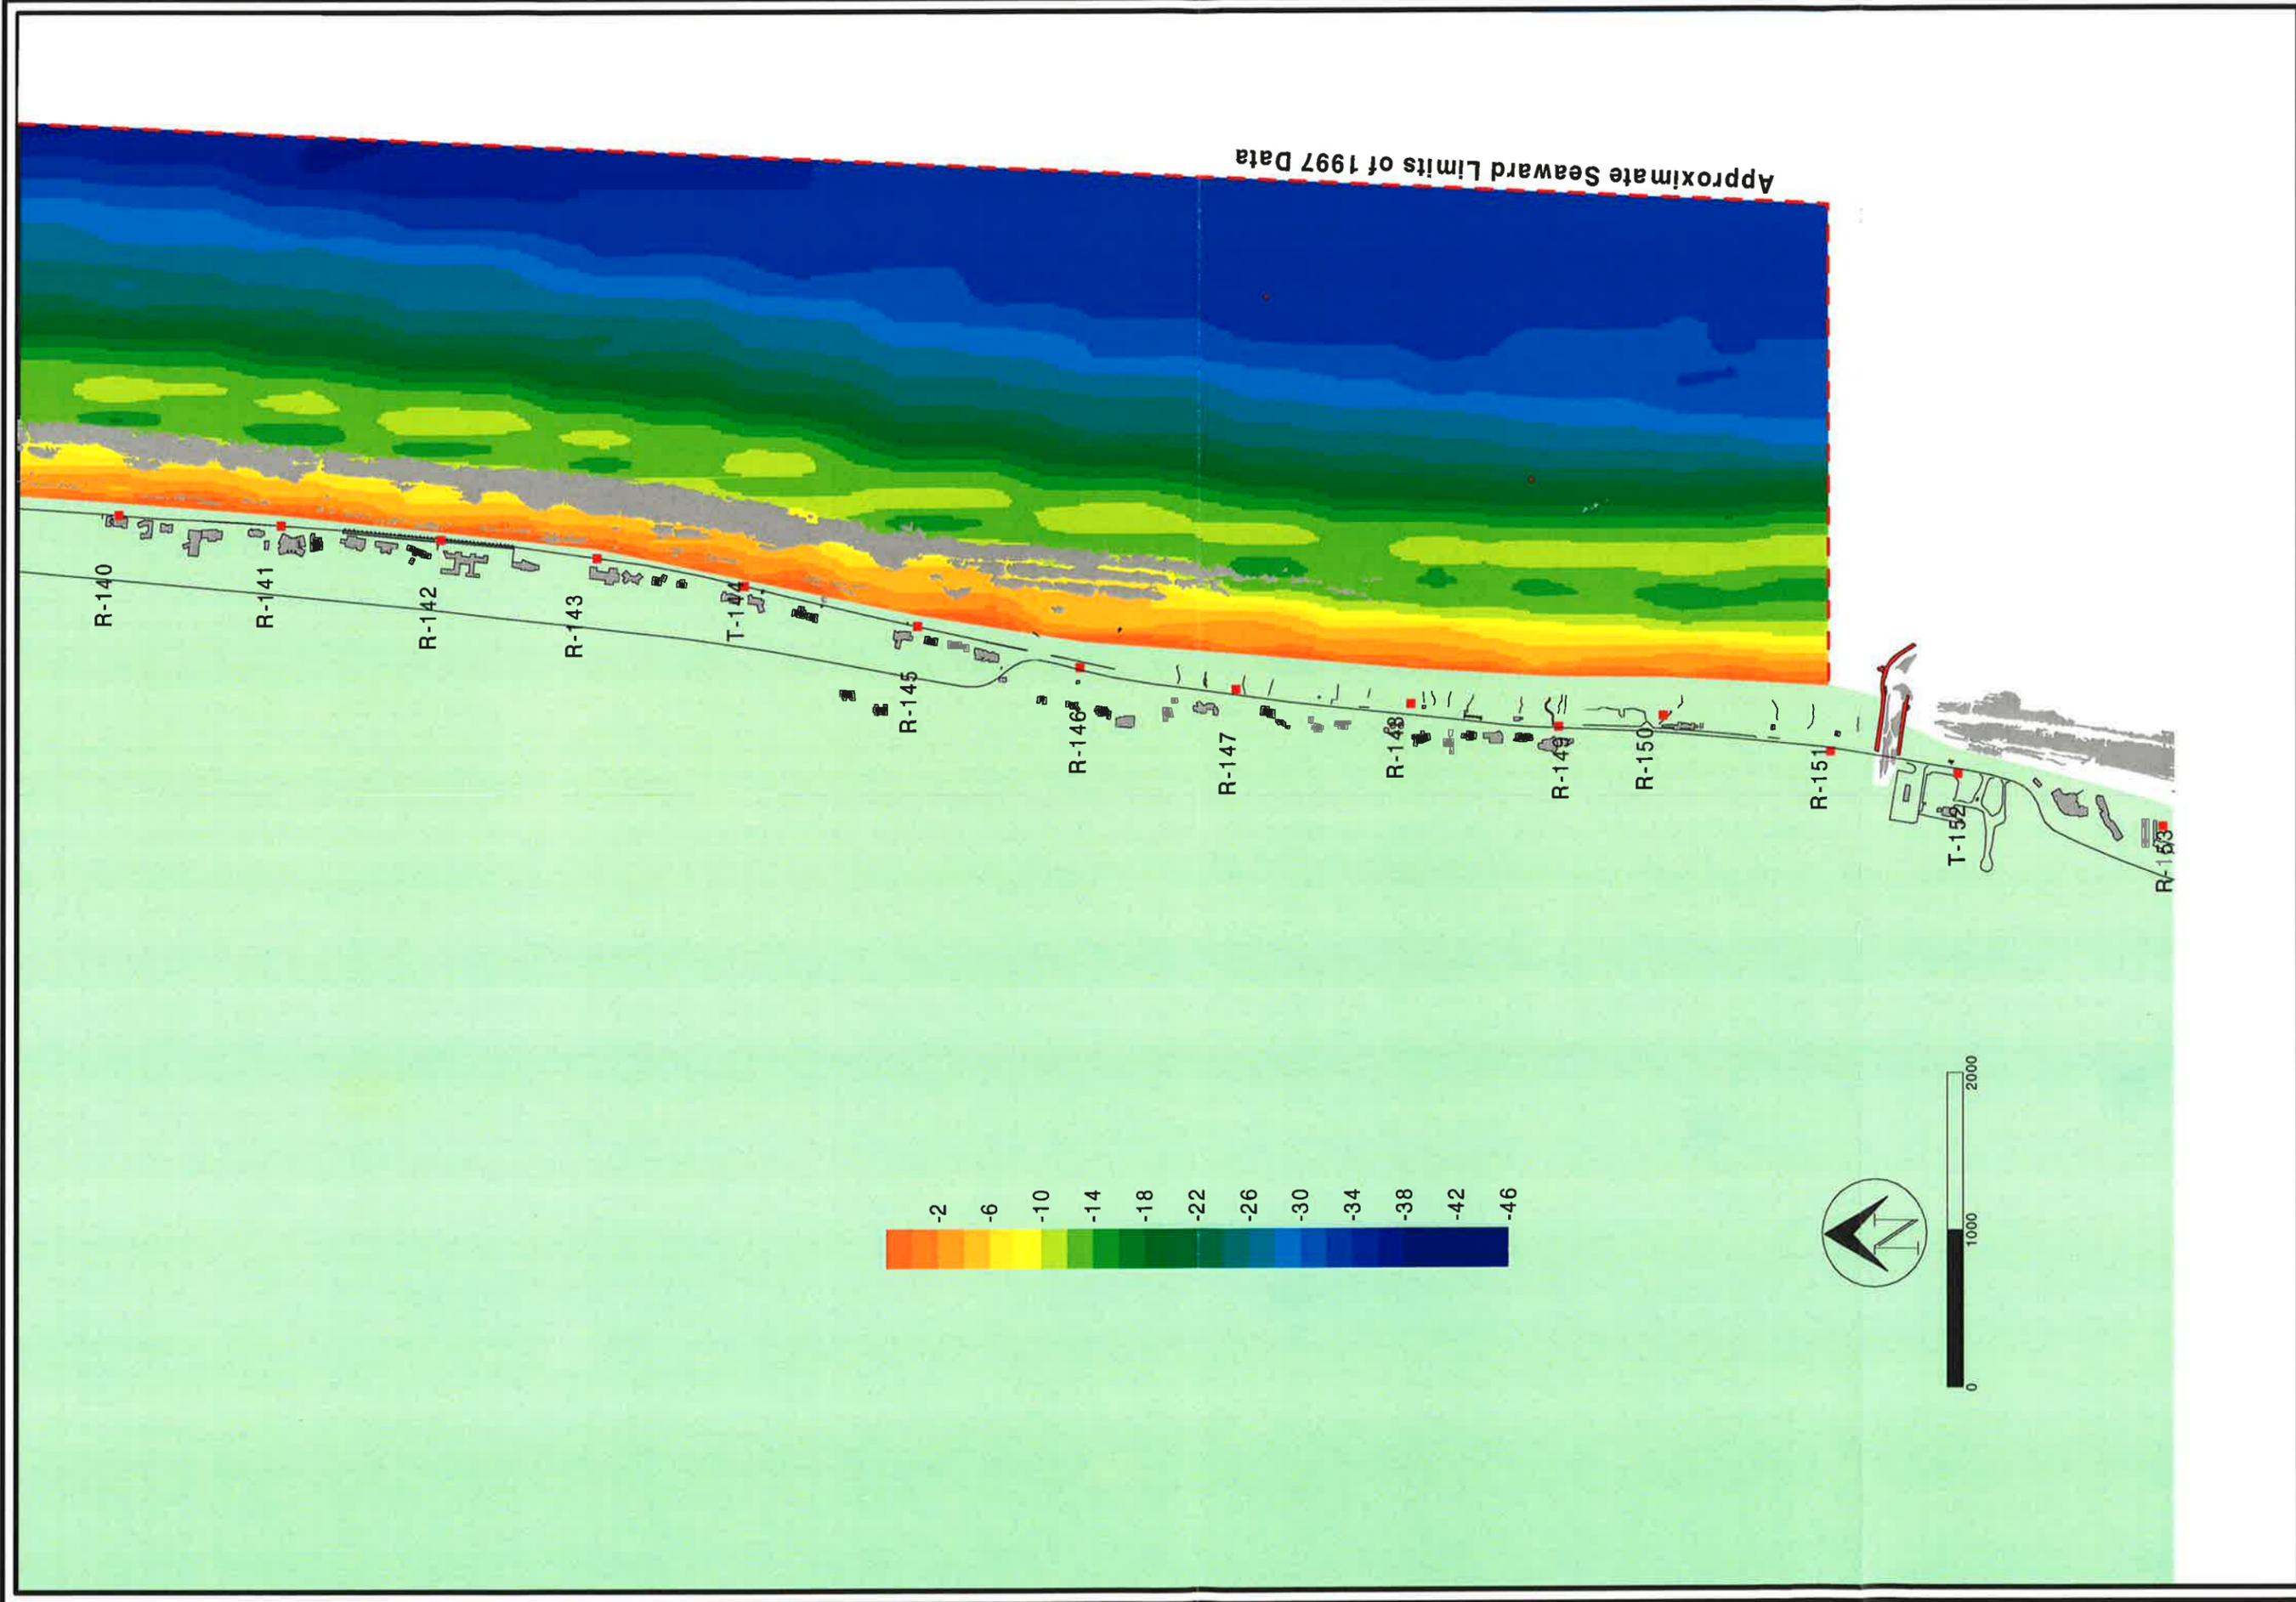
Figure 6
Palm Beach Island Bathymetry (April/May 1997)
