Comprehensive Coastal Management Plan Update

Palm Beach Island, Florida

June 1998

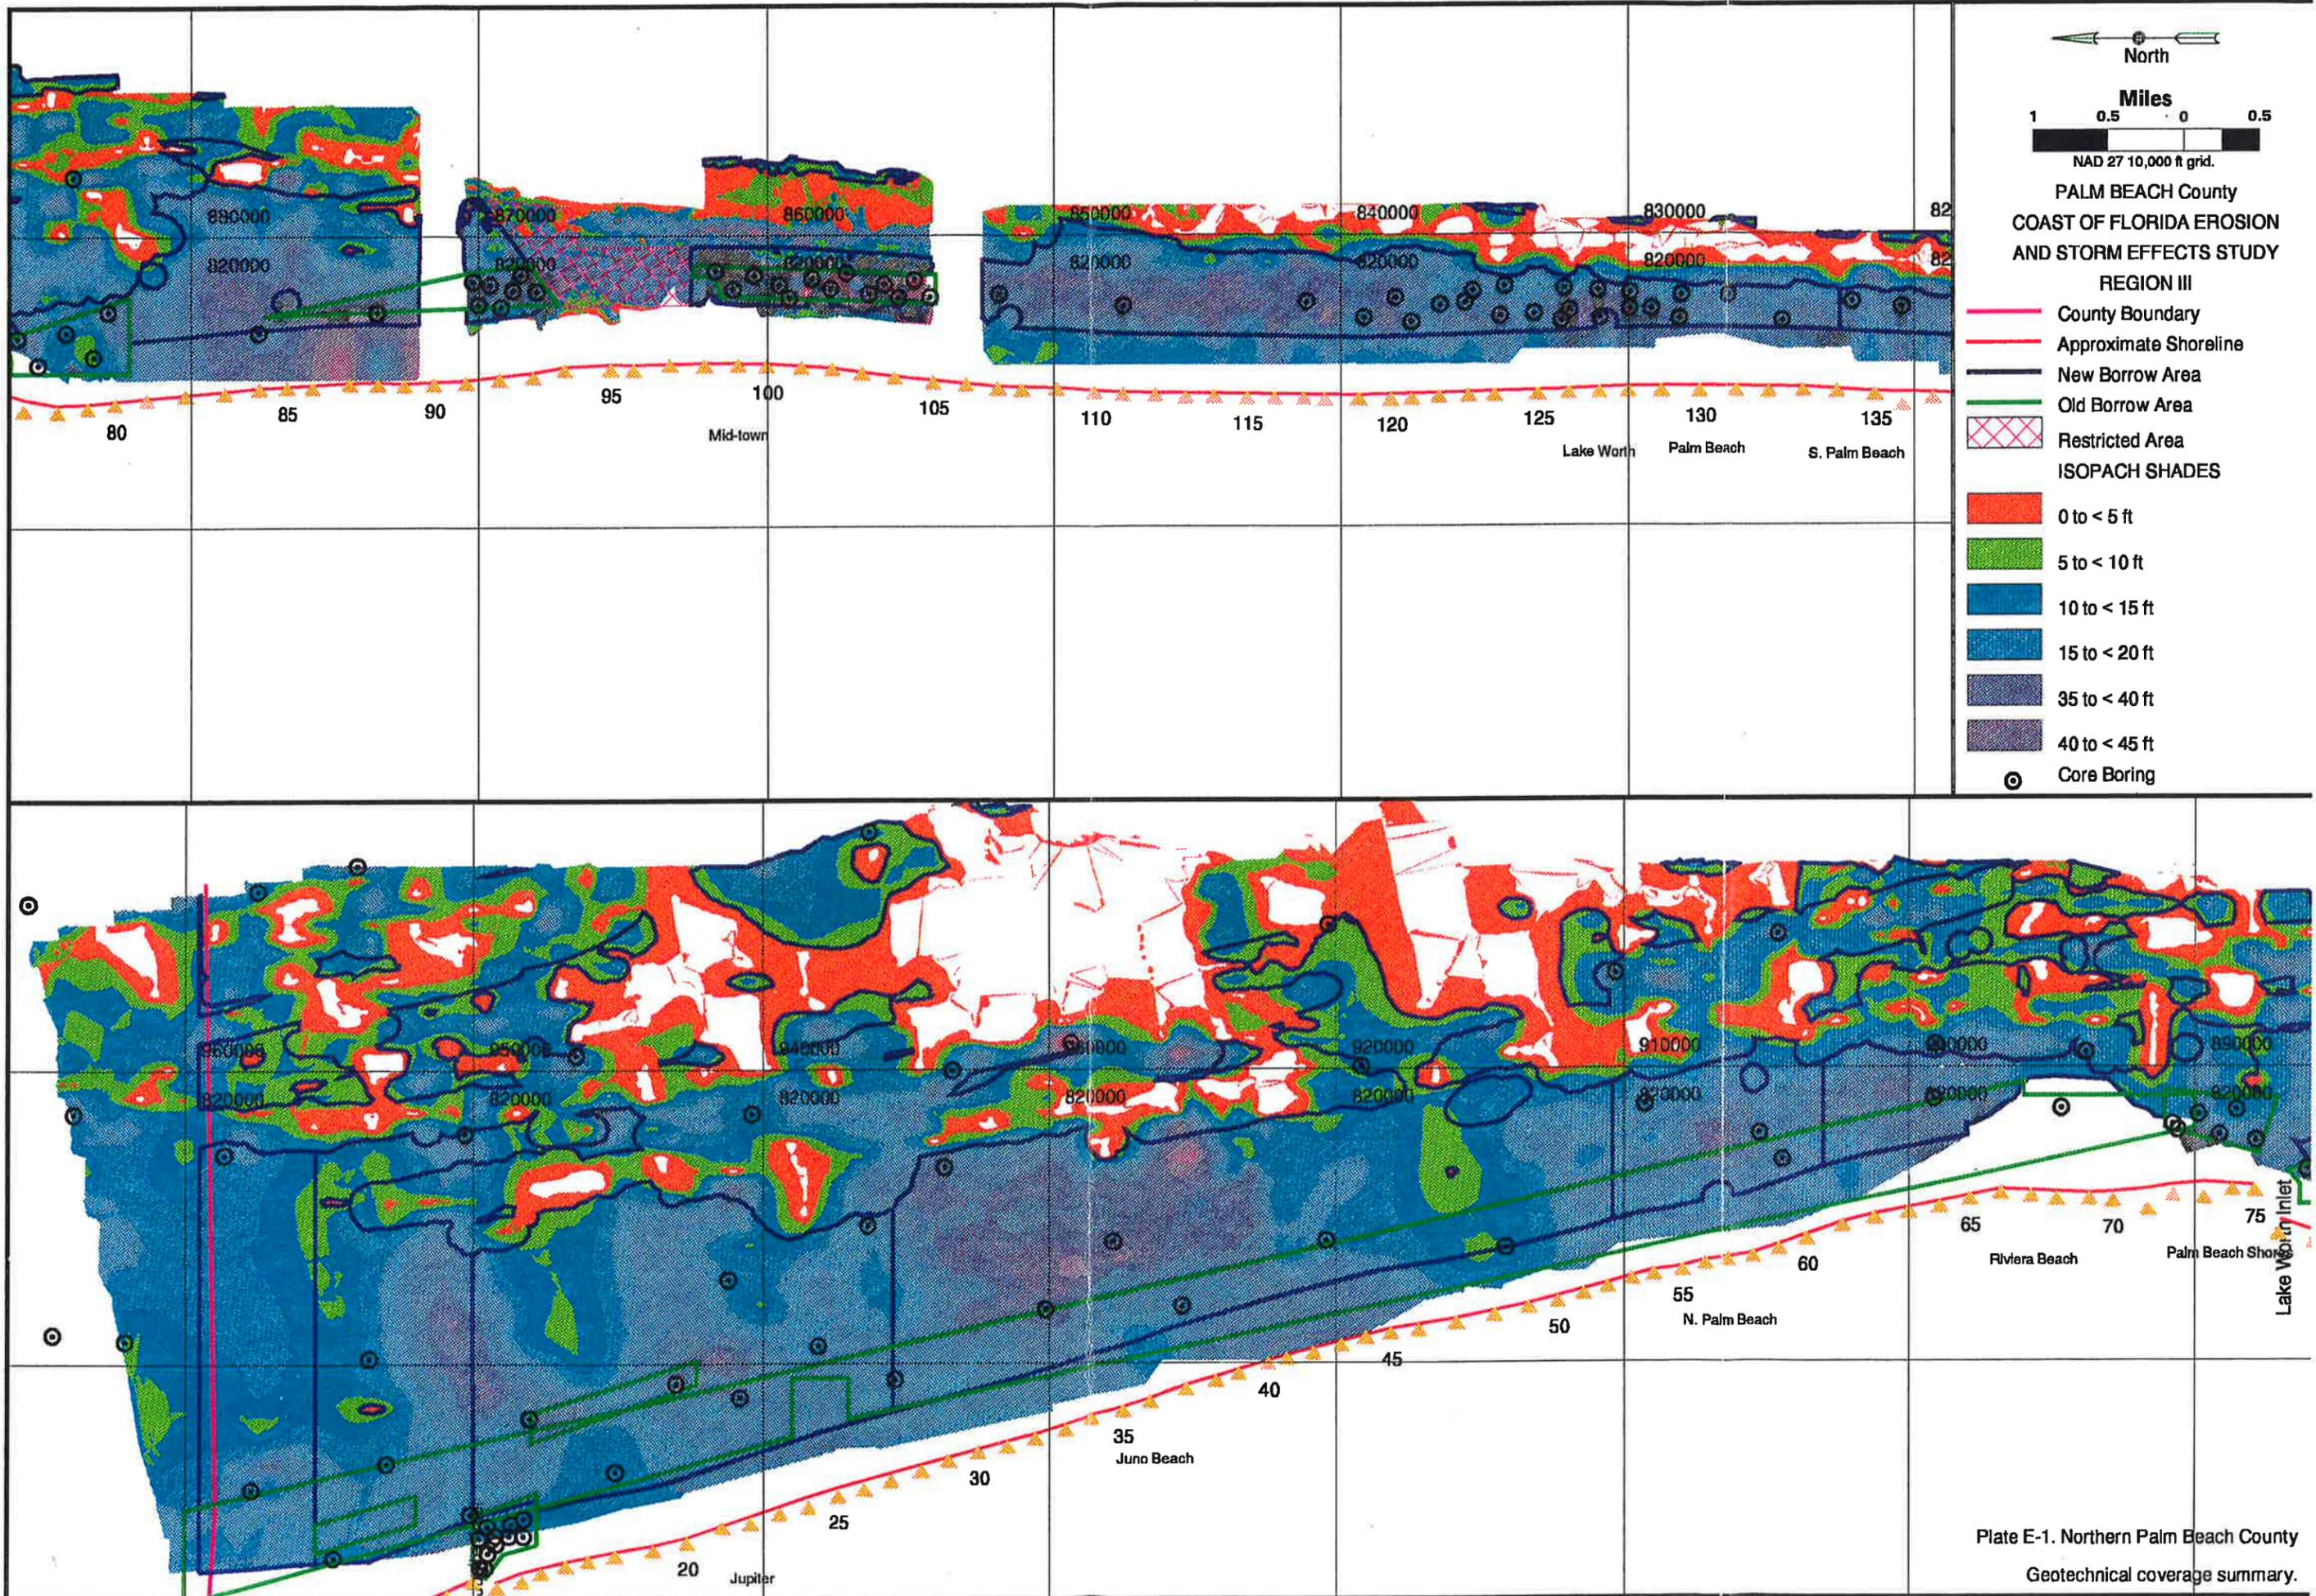
Plate E-1. Northern Palm Beach County
 Geotechnical coverage summary.

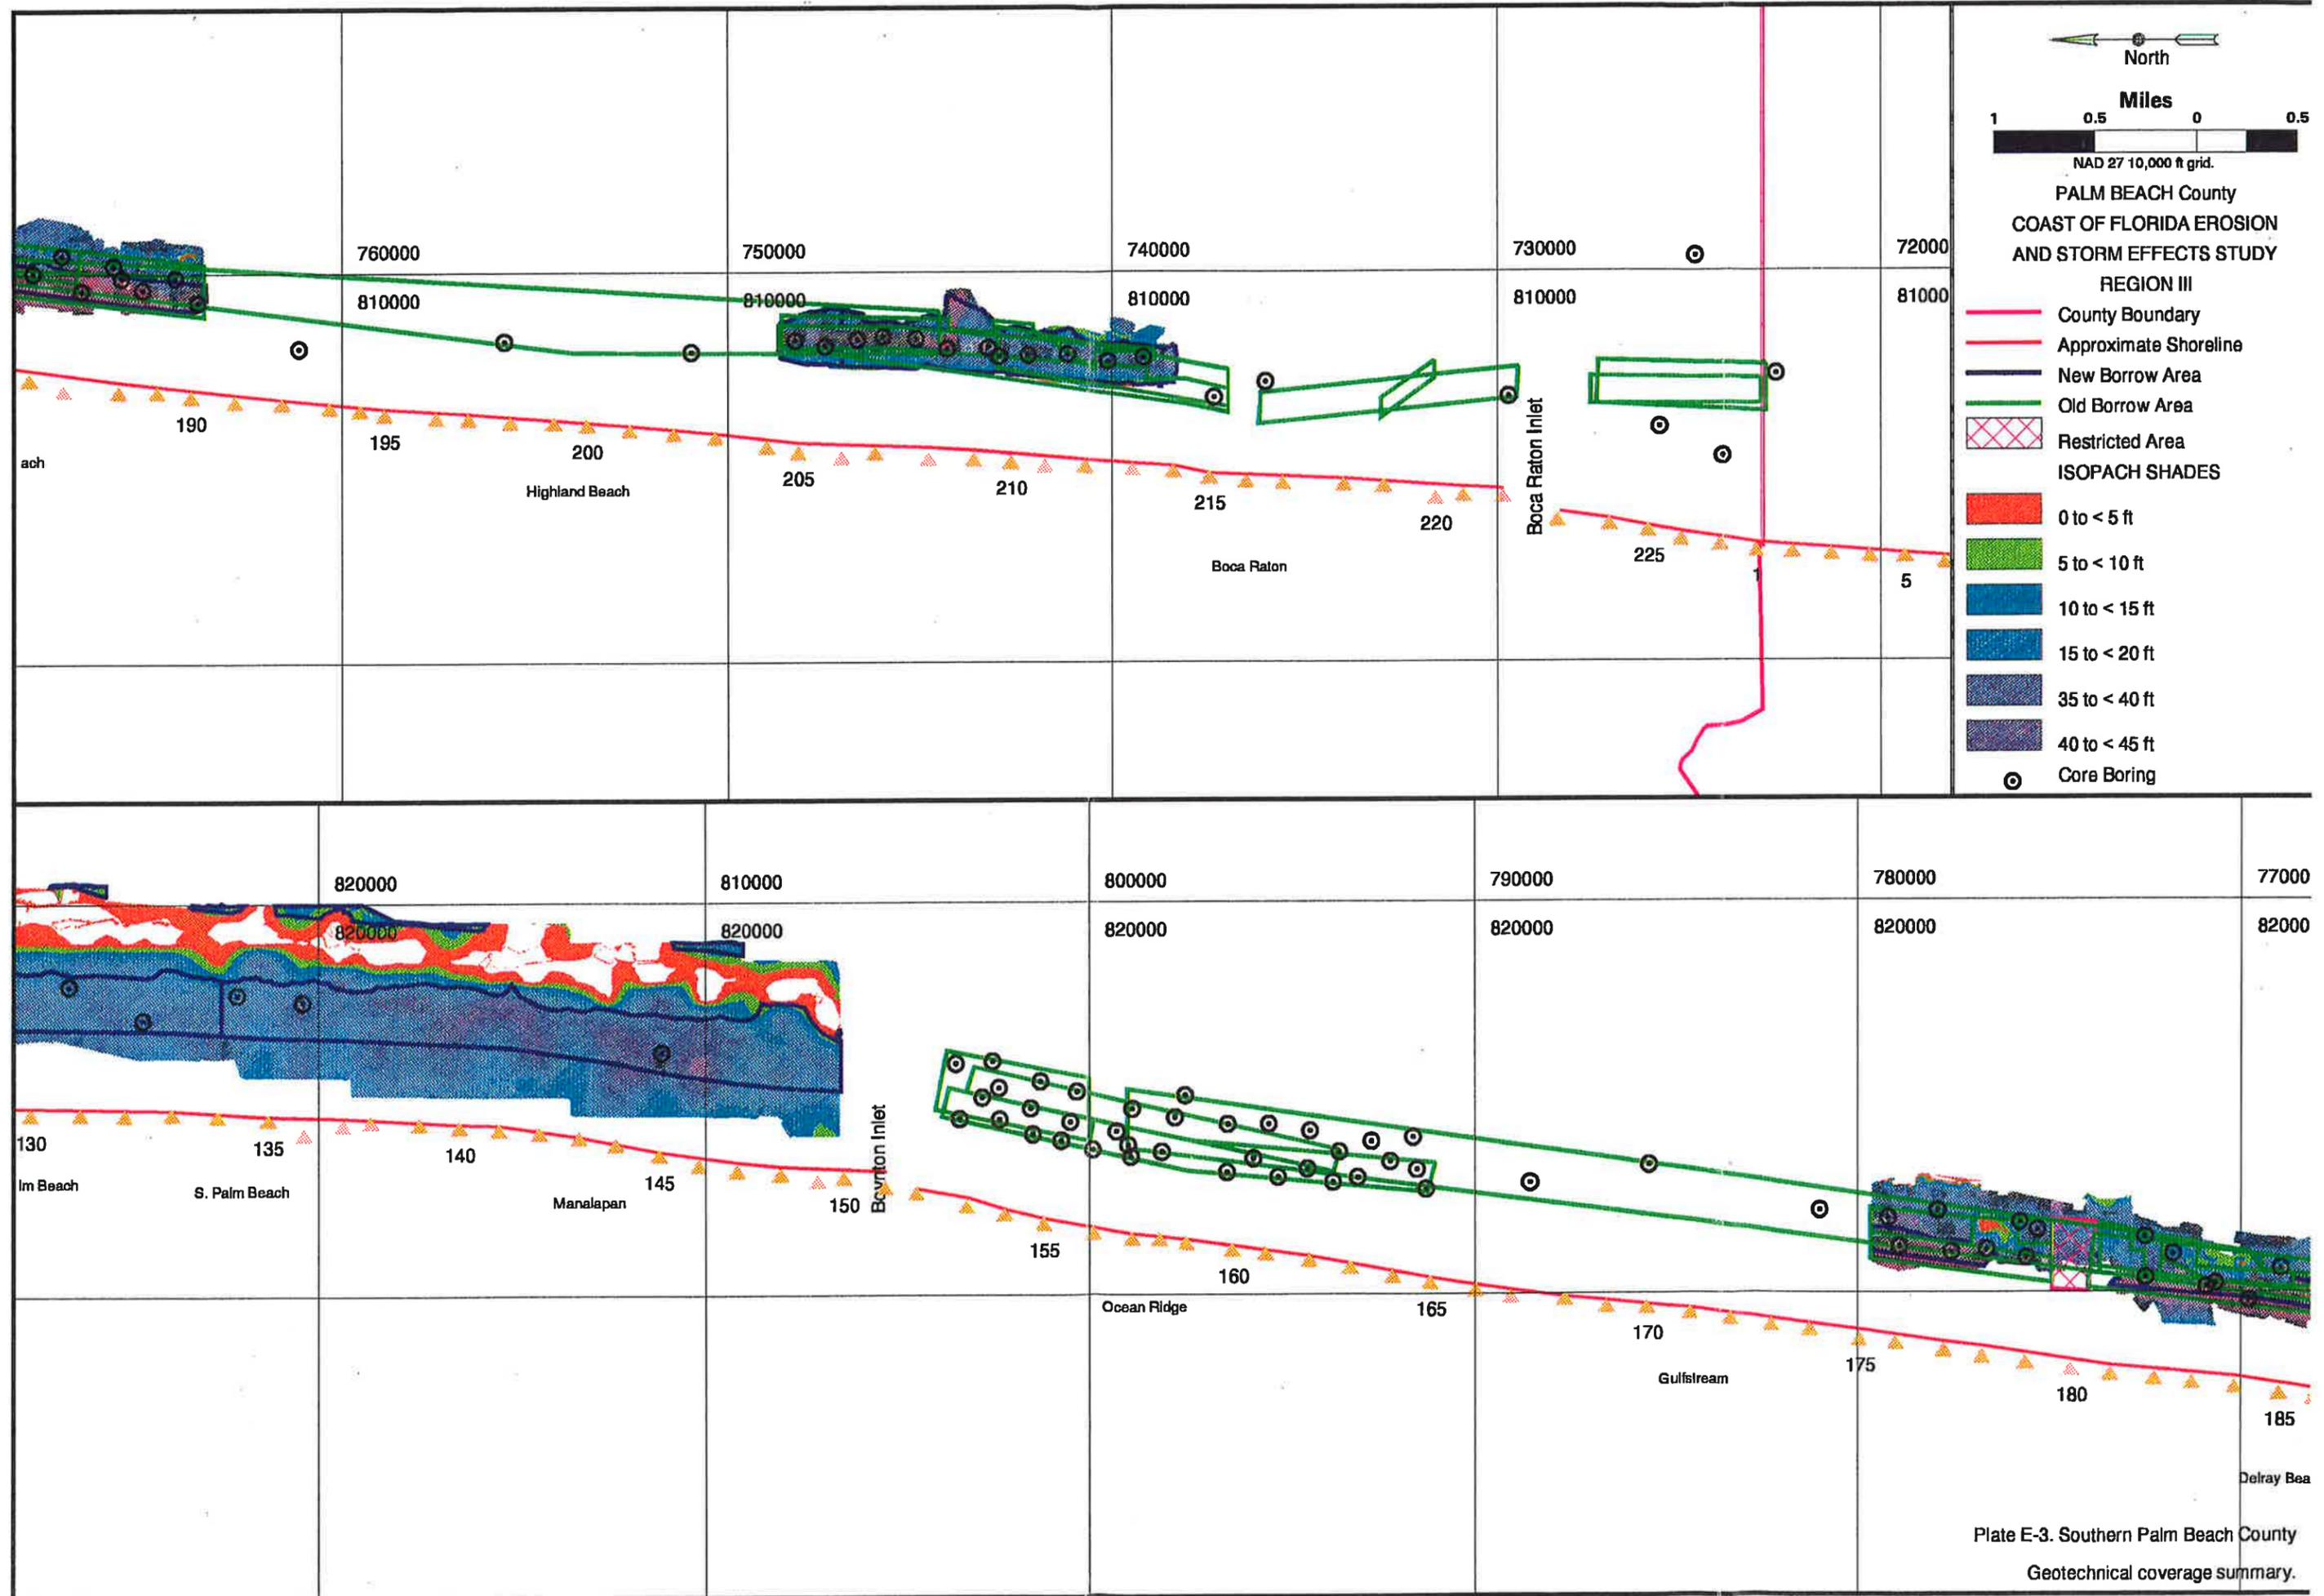
Plate E-3. Southern Palm Beach County
Geotechnical coverage summary.

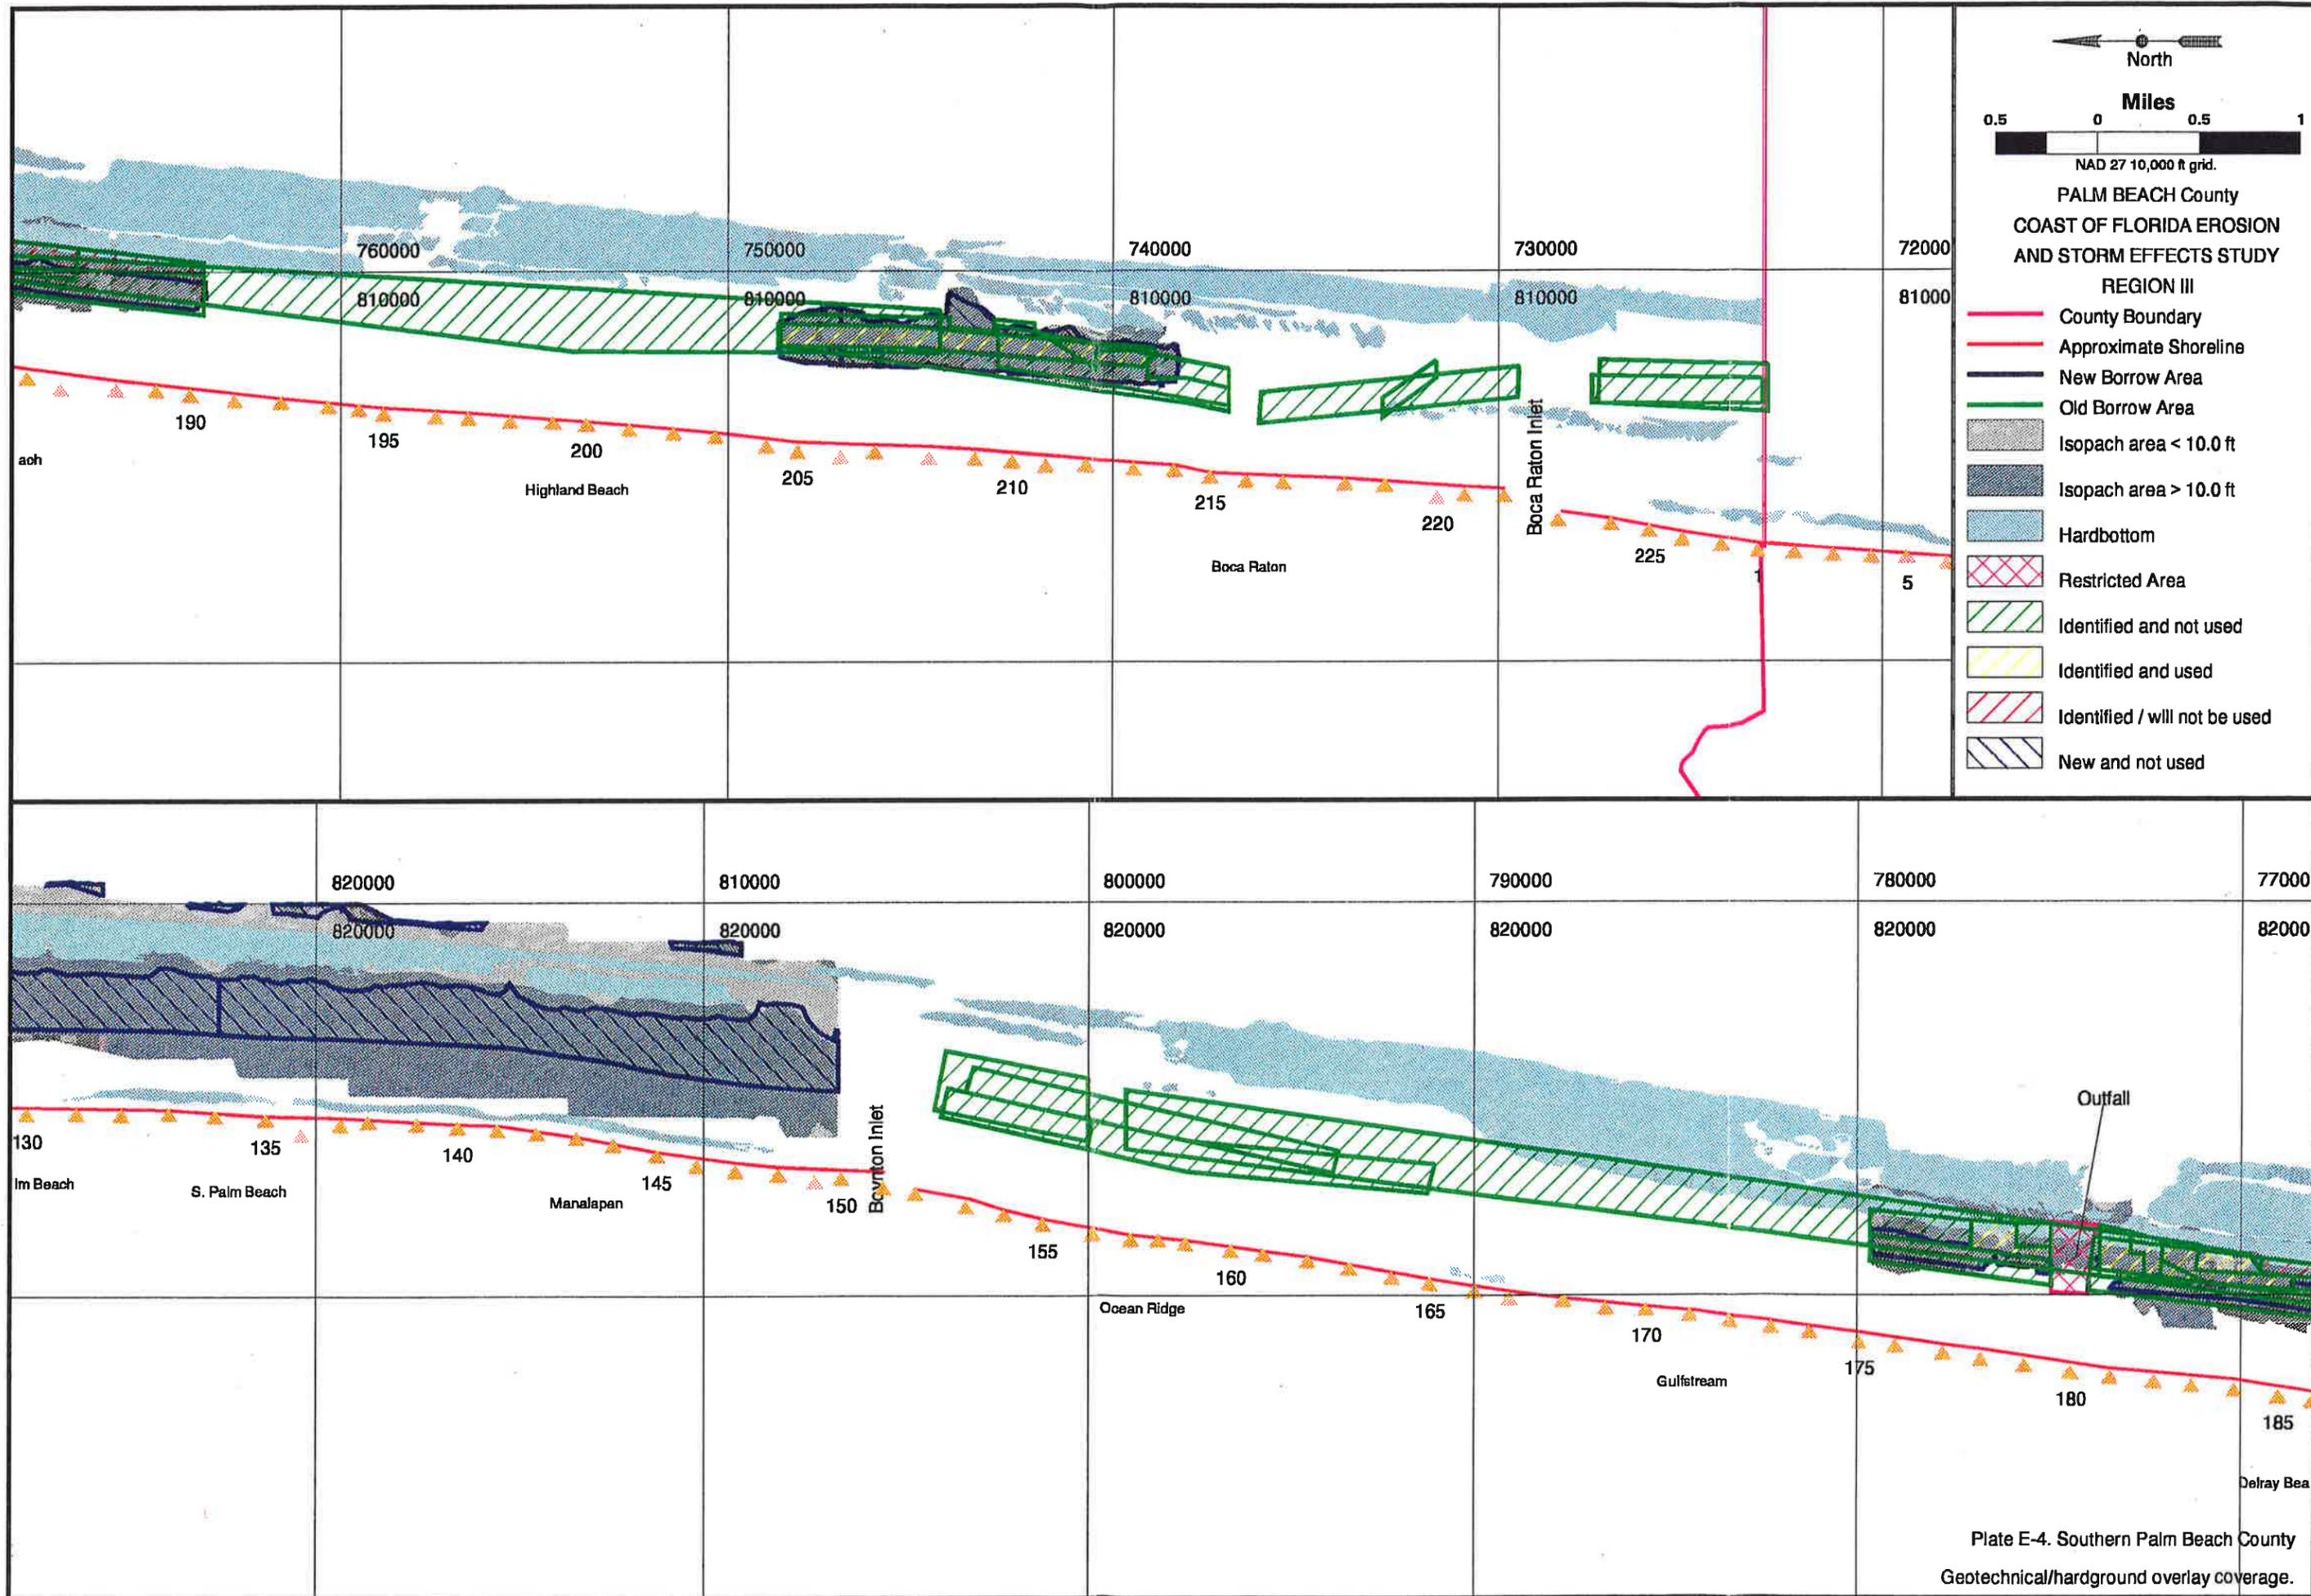
Plate E-4. Southern Palm Beach County
Geotechnical/hardground overlay coverage.
